VERMONT YANKEE NUCLEAR POWER CORPORATION

LICENSEE EVENT REPORT (LER)

FACILITY NAME (1)
VERMONT YANKEE NUCLEAR POWER STATION

TITLE (4)
HPCI/RCIC SYSTEM INOPERABLE DUE TO LOW SPIKING OF LEVEL TRANSMITTER LT-2-3-72B INSTRUMENT LOOP

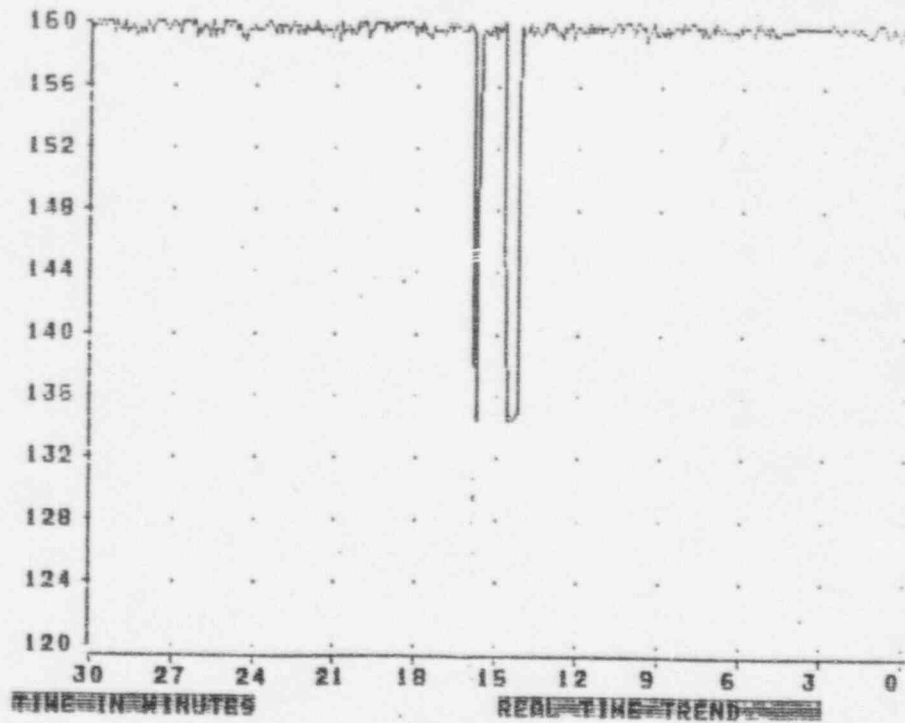
ATTACHMENT 1, - LER 94-008

On 10/03/94 at 1520 hours, with the reactor operating at 100% steady state power, and with the plant preparing for a scheduled maintenance shutdown, several down spikes occurred over a three minute period in the reactor water level instrument loop for LT-2-3-72B. The most significant spikes indicated a 25 inch drop in Reactor water level as recorded on the plant Emergency Response Facility Information System (ERFIS). The step change recorded on Attachment 1 shows a change from 160 inches to 135 inches which was not sufficient enough to generate an Engineered Safety Feature (ESF) system response.

Subsequent evaluation of a process loop computer trend confirmed that the downspiking observed is consistent with one of the reported K1 relay contact failure modes. Subsequent discussions with the equipment manufacturer also suggest that the downspiking experienced is not a typical failure mode for the loop transmitter itself and is more likely to be associated with a malfunction of the master trip unit. In pursuit of the above belief, the master trip unit was replaced on 11/07/94 with a spare trip unit and the original returned to Rosemount for failure analysis. Strip chart trending of the process point was continued for a 3 day period subsequent to the replacement. Data reviewed during this period did not reveal the presence of any additional spiking in the instrument loop, and as a result, monitoring of the loop was terminated on 11/10/94.

REACTOR WATER LEVEL 72B
