SUBJECT: Calvert Cliffs Nuclear Power Plant
Unit No. 1; Docket No. 50-317
Request Relief from ASME Boiler & Pressure Vessel Code Section XI
Requirement IWV-3417(a)

SIMPLIFIED MSIV
HYDRAULIC DIAGRAM

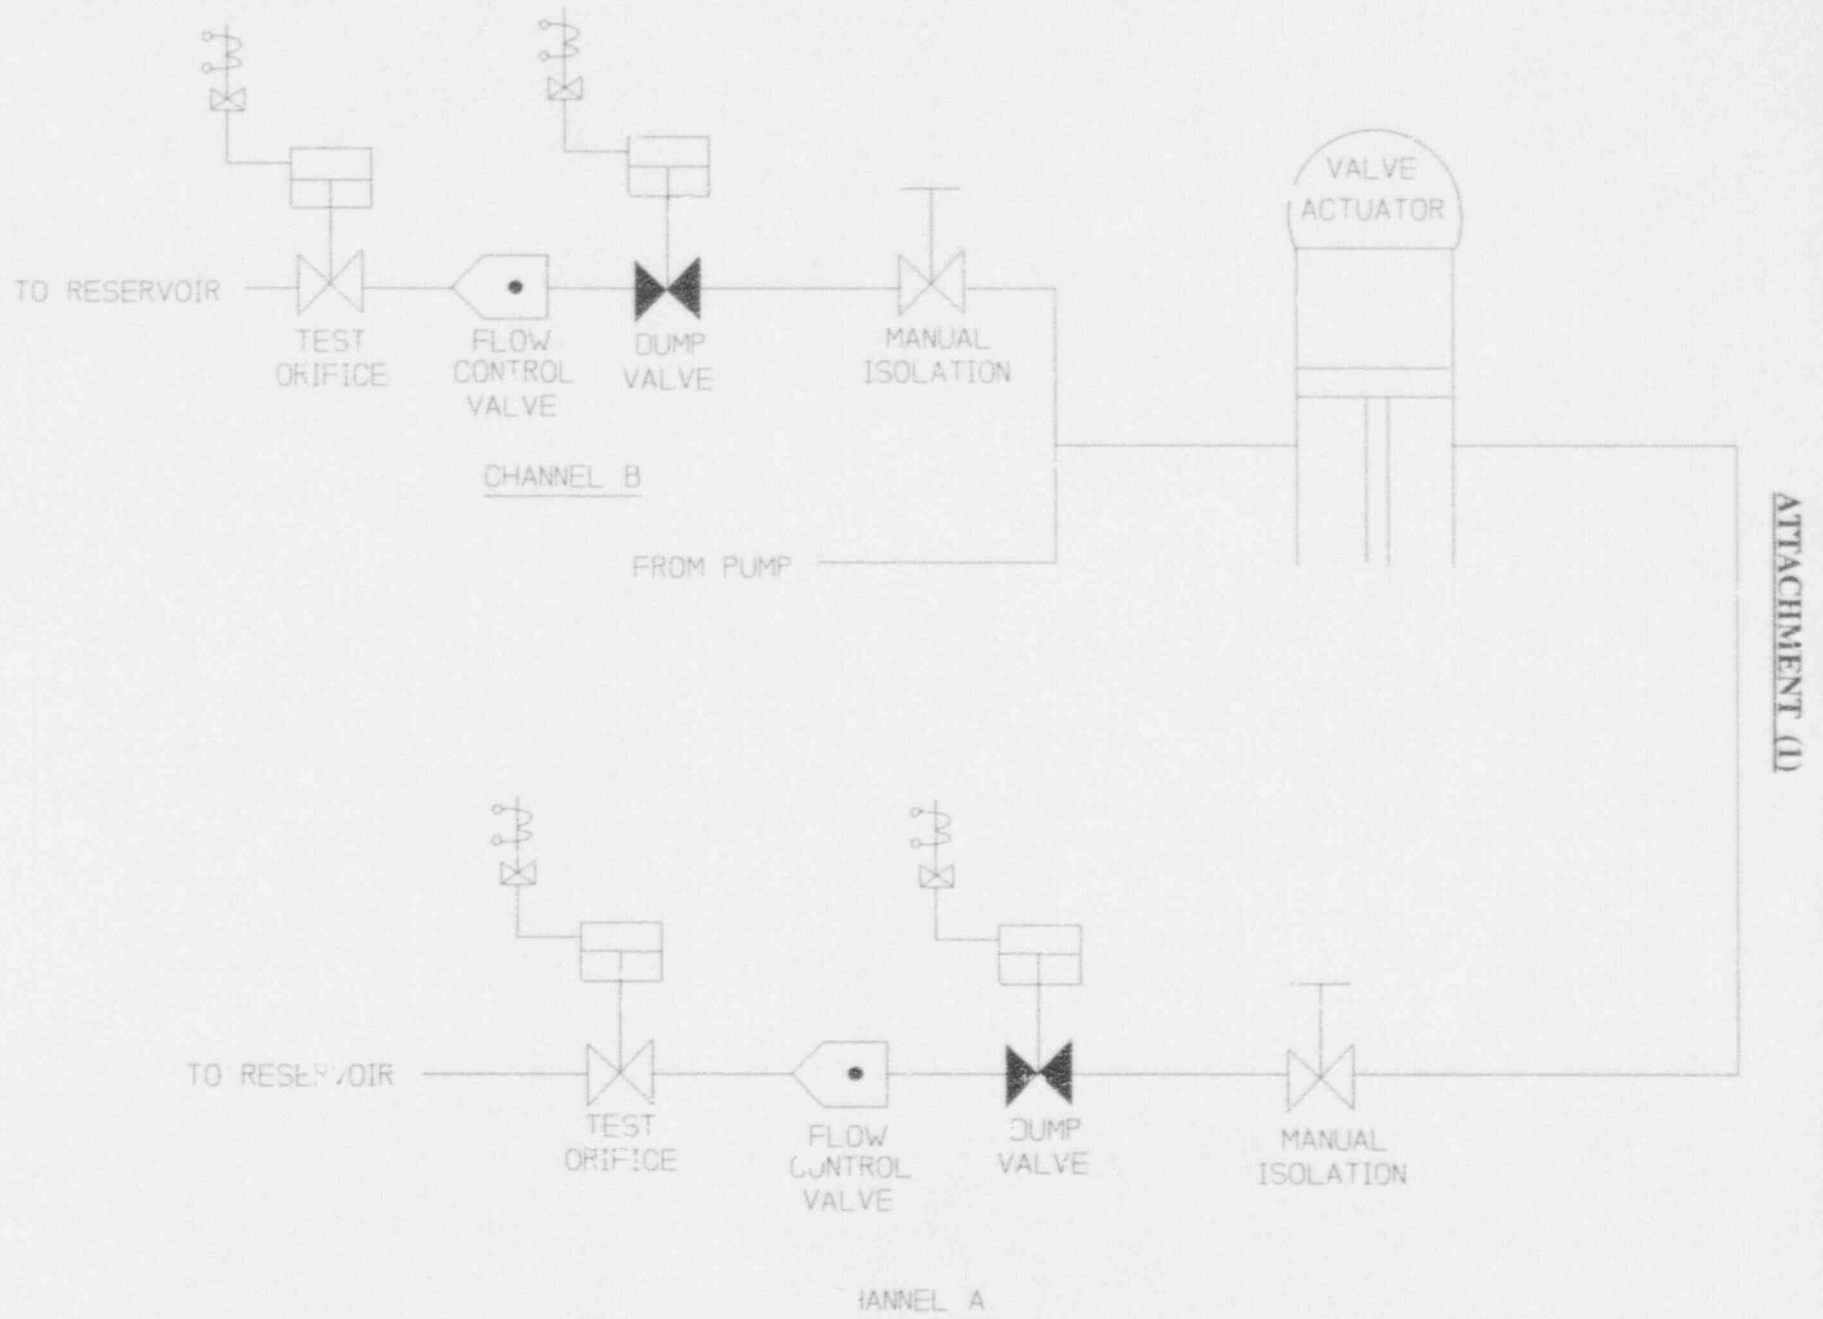
Attachment (1) is a simplified MSIV electric/hydraulic control-circuit diagram. The valve closes when either solenoid valve opens, releasing pilot pressure from under the hydraulic dump valves. When either dump valve opens, hydraulic pressure under the MSIV piston is vented, stroking the valve. The bench-tested maximum closing time is five seconds for one open dump valve. The bench-tested maximum closing time with both dump valves open is three seconds. Normally, both dump valves function to quickly stroke the valve. During a post-installation test under Mode 5 conditions, the valve closed in 4.5 seconds with only one open dump valve.
