Subject: Clinton Power Station - Unit 1
Licensee Event Report No. 92-001-00

LICENSEE EVENT REPORT (LER)

TITLE (4) **Internal Fault In The "B" Phase Main Power Transformer Resulted In A Turbine Generator Trip And An Automatic Reactor SCRAM**

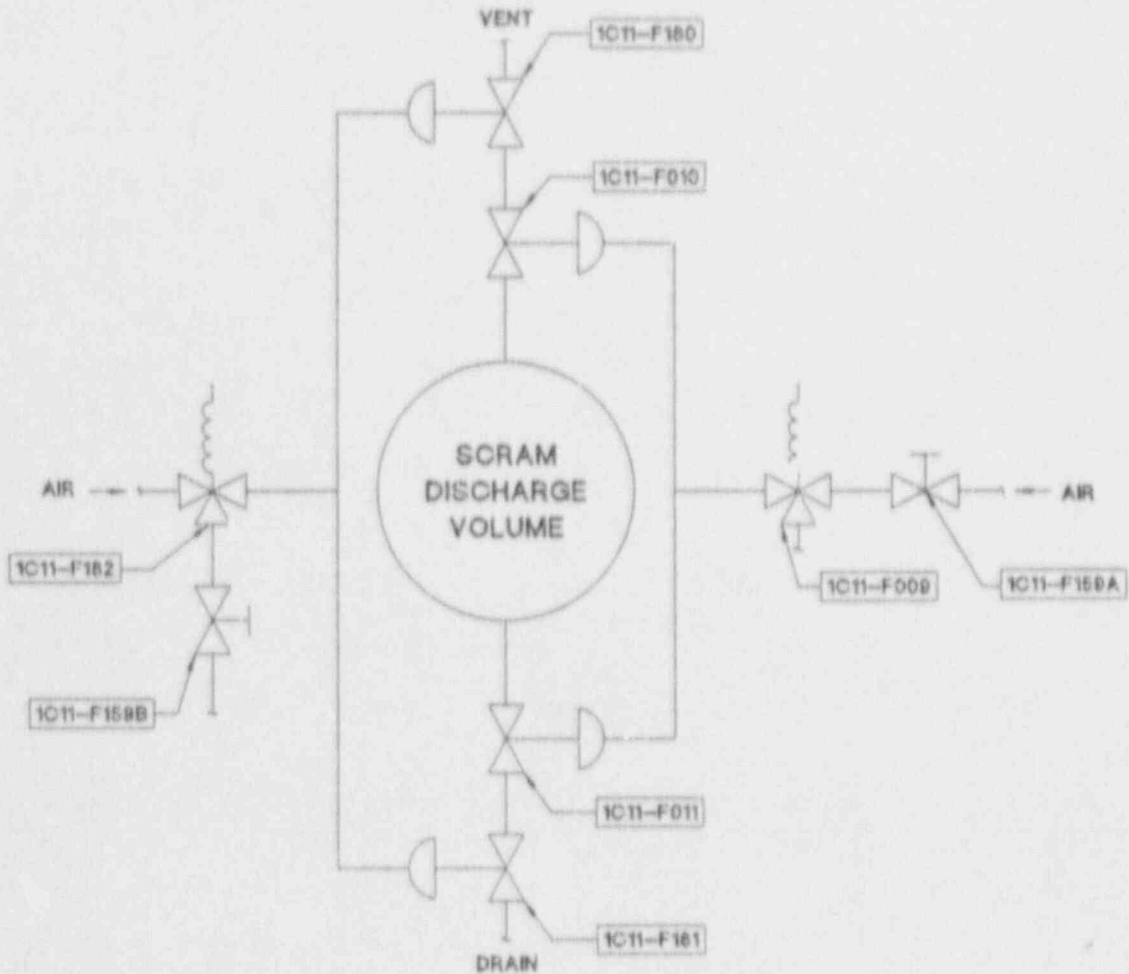
Figure 1

Failure of the SDV Vent Valve and Drain Valve To Open

Subsequent to the event, troubleshooting of the SDV drain and vent valves identified the following deficiencies (refer to Figure 1):

- Air leaked out of the vent ports of the three-way solenoid valves 1C11-F009 and 1C11-F182 when they were energized.

- * Valve 1C11-F011 immediately closed and remained open when the instrument air time delay valve (1C11-F159A) was manually opened about one-eighth of a turn.

- * A small piece (less than 1/16 inch) of foreign material (believed to be solder) was found between the backseat and disc of valve 1C11-F009.
- * The bench settings for valve 1C11-F010 were found to be 6 and 30 pounds per square inch gauge (psig). Bench settings of 6 and 30 psig means that the valve starts to open at 6 psig and is fully open or backseated at 30 psig. The correct opening bench settings for 1C11-F010 are 18.5 and 60 psig.

- * The bench settings for valve 1C11-F011 were found to be 20 and 62 psig. The correct bench settings for 1C11-F011 are 18.5 and 60 psig.
- * Maintenance noted that the SDV vent valve (1C11-F180) operated erratically when stroked repeatedly. The valve stem was found to be bent and galling was noted on the disc and stem. Additionally, the bench settings for 1C11-F180 were found to be 8 and 25 psig whereas the correct bench settings are 3 and 15 psig.

Based on the deficiencies identified above, the cause of valve 1C11-F011 failing to open and valve 1C11-F010 only opening to an intermediate position is attributed to the air leakage past the seat of valve 1C11-F009. In May of 1991, personnel discovered that valve 1C11-F011 took approximately 17 minutes to reopen, and Maintenance Work Request MWR D17319 was written to address the slow reopening time. However, MWR D17319 was not scheduled to be worked until the next refueling outage, currently scheduled to begin March 1992. Based on the findings noted above, the slow opening time of valve 1C11-F011 noted in May 1991 is attributed to the small amount of air leaking past the seat of valve 1C11-F009 and out the vent port. In May of 1991, valve 1C11-F159A provided sufficient air volume to eventually pressurize the air header enough to open valve 1C11-F011, but the leakage past valve 1C11-F009 continued to increase. Valve 1C11-F159A is a throttle valve which creates a time delay for the closing of valves 1C11-F011 and 1C11-F010. In January, due to the increased leakage past the seat of valve 1C11-F009, valve 1C11-F159A at the throttled position was not capable of supplying enough air volume to pressurize the air header completely. Therefore, due to the variance between the bench settings of valves 1C11-F010 and 1C11-F011 and the reduced pressure in the air header, valve 1C11-F010 opened to an intermediate

position and valve 1C11-F011 failed to move from the closed position.

SDV Vent and Drain Valves

Valves 1C11-F009 and 1C11-F182 have been rebuilt per preventive maintenance tasks (PM) PMMRDM003 and PMMRDM004. In addition, the bench settings for valves 1C11-F010, 1C11-F180, and 1C11-F011 were reset to their correct values, and valve 1C11-F180 was rebuilt per MWR D17319.
