Perry Nuclear Power Plant  
Docket No. 50-440  
Response to NRC  
Confirmatory Action Letter

AUXILIARY CIRCULATING WATER  
PIPING SYSTEM ANALYSIS

TO J.P. Eppich ROOM PYE110 FROM M.S. Bridavsky DATE 1/15/92  
PHONE 43718 ROOM ESS  
SUBJECT Analysis of Failed Bolts from the  
Support System of PNFP Circulation  
Water Piping Supply Line to the  
Auxiliary Condensers - Final Report

Re: Perry Nuclear Power Plant  
G/C Report EA-182, Rev. 0  
N71 Pipe Rupture Evaluation

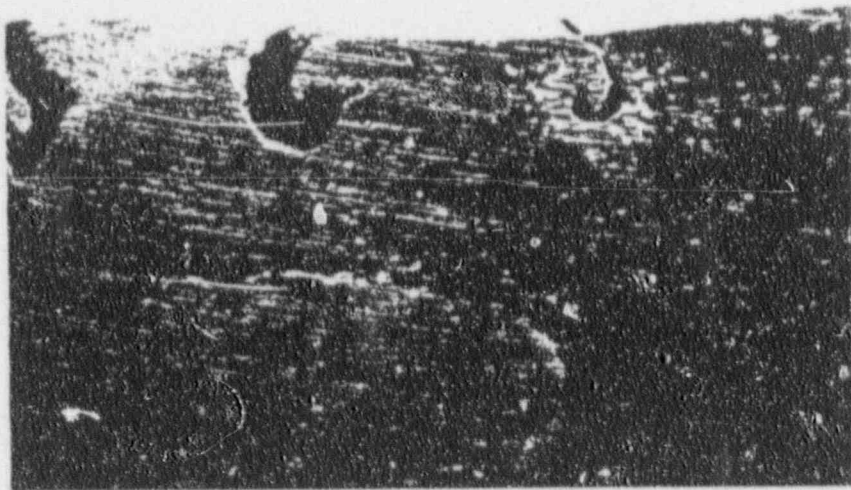
Fig. 1.

1. Two bolts (NE and NW corners) failed below the lower nuts.
2. Two bolts (SE and SW corners) failed between the nuts, within the plate thickness.
3. The threads of three out of four bolts were hammered flat in between the nuts (Fig. 1).
4. All four bolts failed in ductile mode with significant plastic bending.

Crosssections of the bolt with threads  
compressed (hammered).

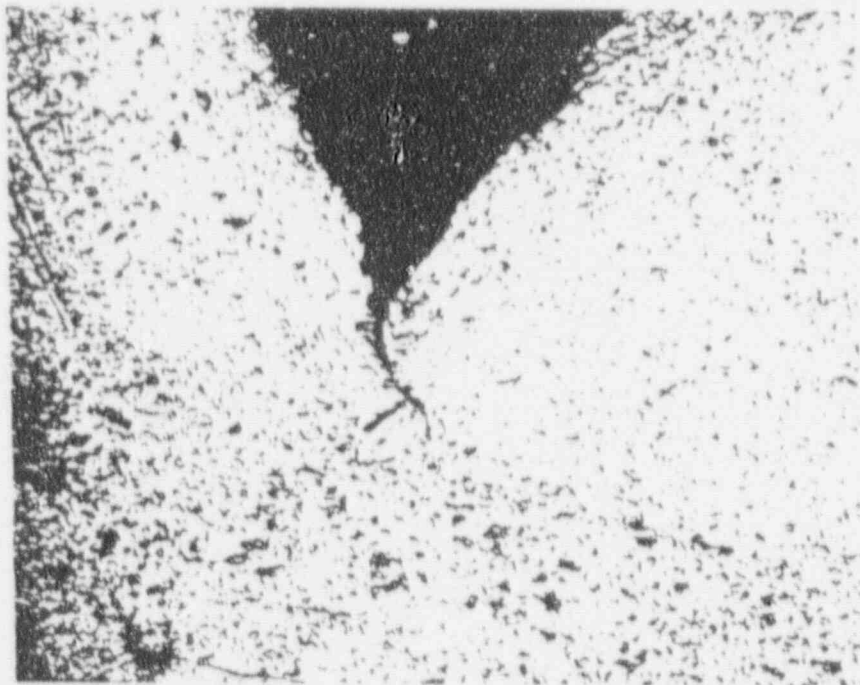
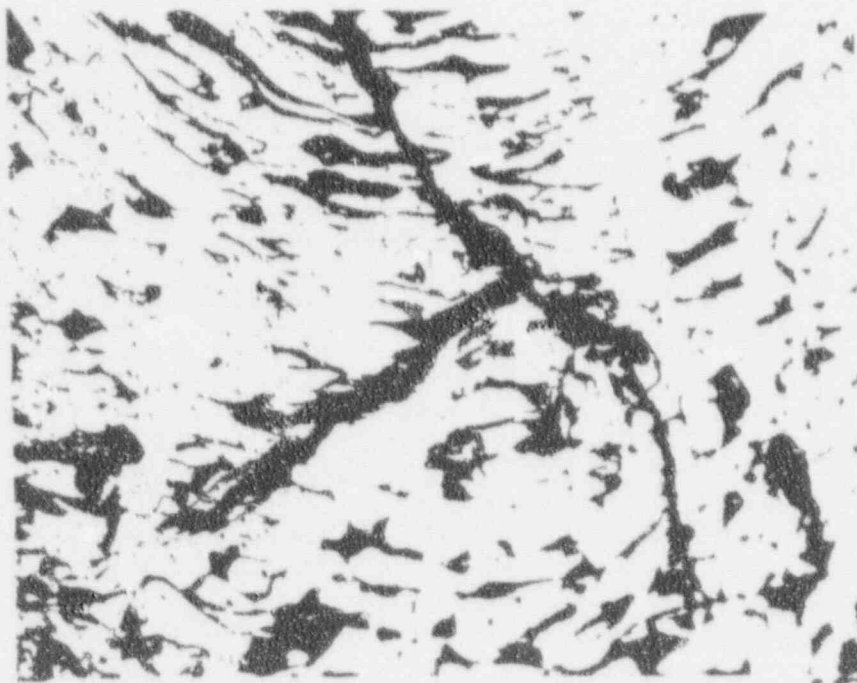
Fig. 2.

5. No signs of fatigue on the fracture surface were found.
6. Fatigue cracks were found at other locations on the bolts with indications of corrosion assistance (Fig. 2).
7. Observations made on the nuts showed that only one nut of each couple was in contact with the plate.
8. Chemical analysis (Table 1) showed that nuts and bolts were made of carbon steel. Very low silicon and aluminum content indicated that rimmed steel was used. The Hilti Drop-in assembly was made from low carbon rimmed steel with high sulfur content added for machinability.

- d. The metallographic analysis of the bolts confirmed the presence of fatigue cracks filled with iron oxide at locations other than the fracture surface. Analysis of one of the cracks was performed on SEM by mapping the iron and oxygen contents. As it can be seen on Fig. 4, the crack is filled with iron oxide. That confirms the corrosion fatigue origin of the crack and its slow propagation.

Typical corrosion fatigue crack.

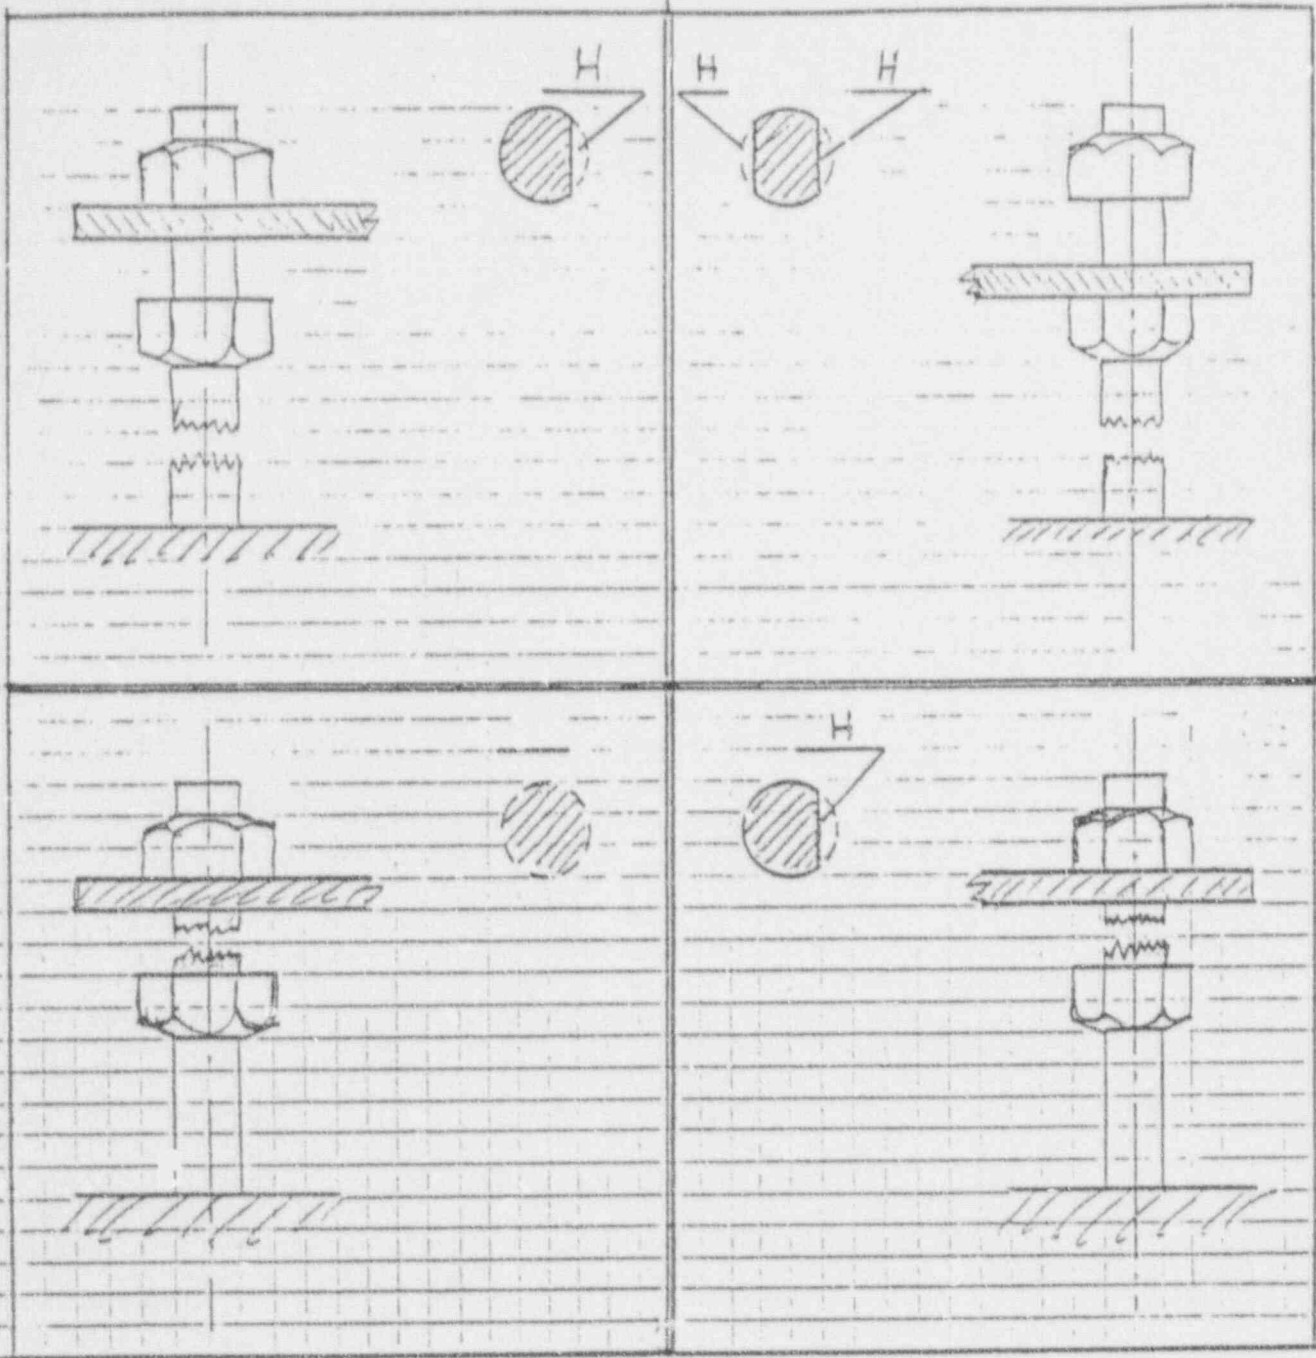
Fig. 3.

- a. The nuts were not tightened down, which allowed the plate to move (see fig. 3).
- b. The plate had a significant lateral movement, which was proven by the signs of friction between the plate and nuts and by the hammered threads.

H - THREADS ARE HAMMERED FLAT

Pictographic presentation of the observations summarized in Table 2 and showing the location of the plate in between the nuts.

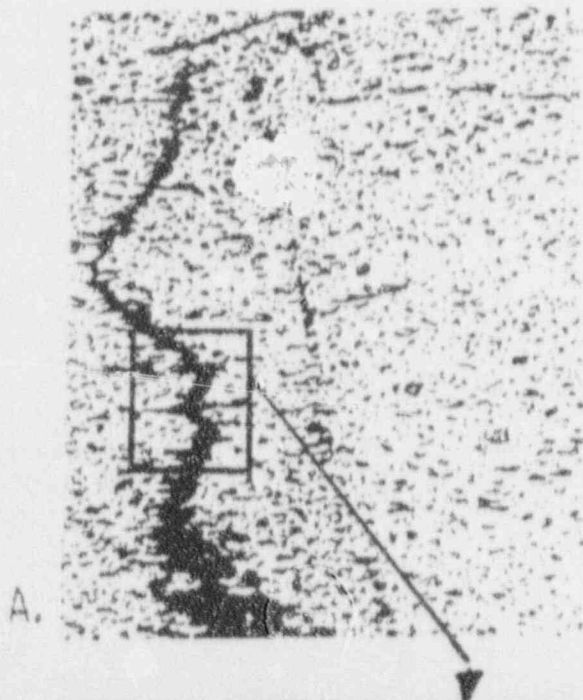
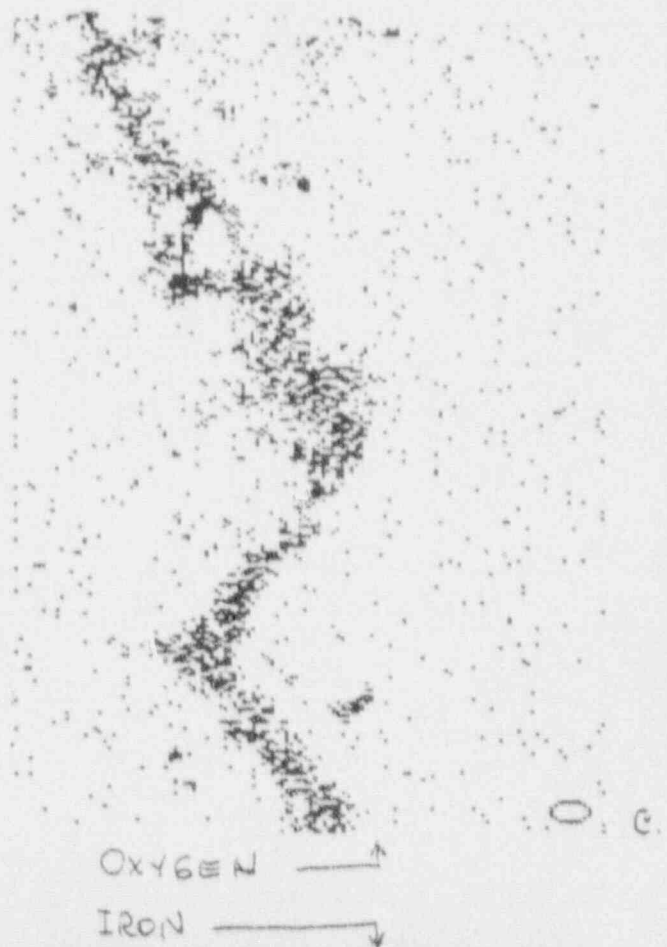
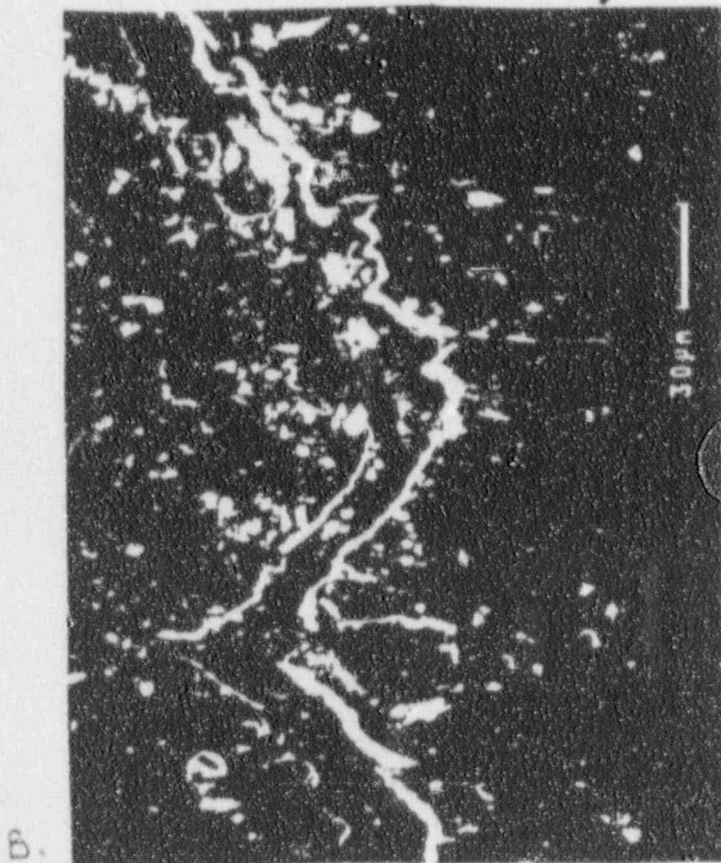
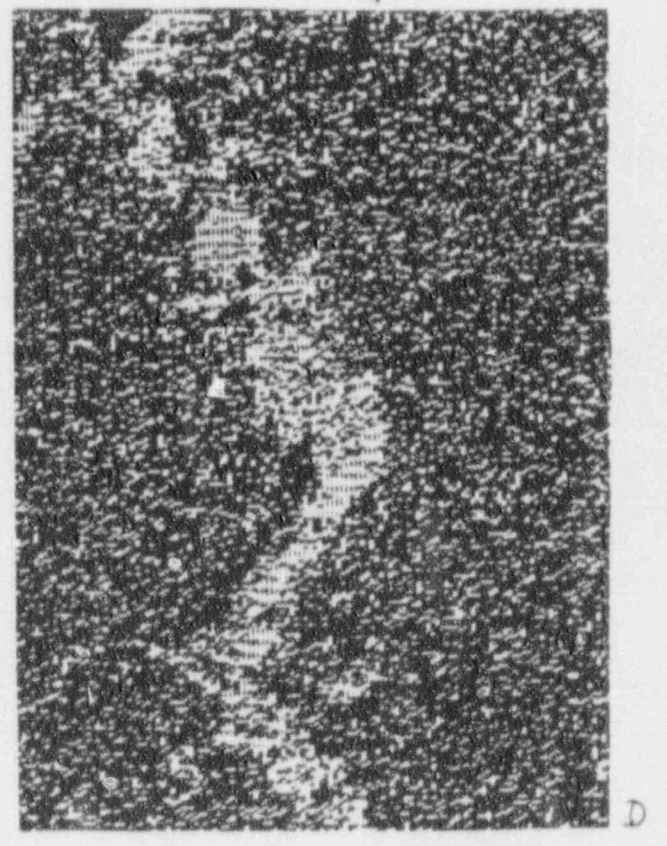
Fig. 4.

Stress corrosion crack and chemical elements distribution.

A. Optical photograph of the crack at magnification 50x.

B. SEM photograph of the part of the crack A at 480x.

C&D. EDS map of oxygen and iron.

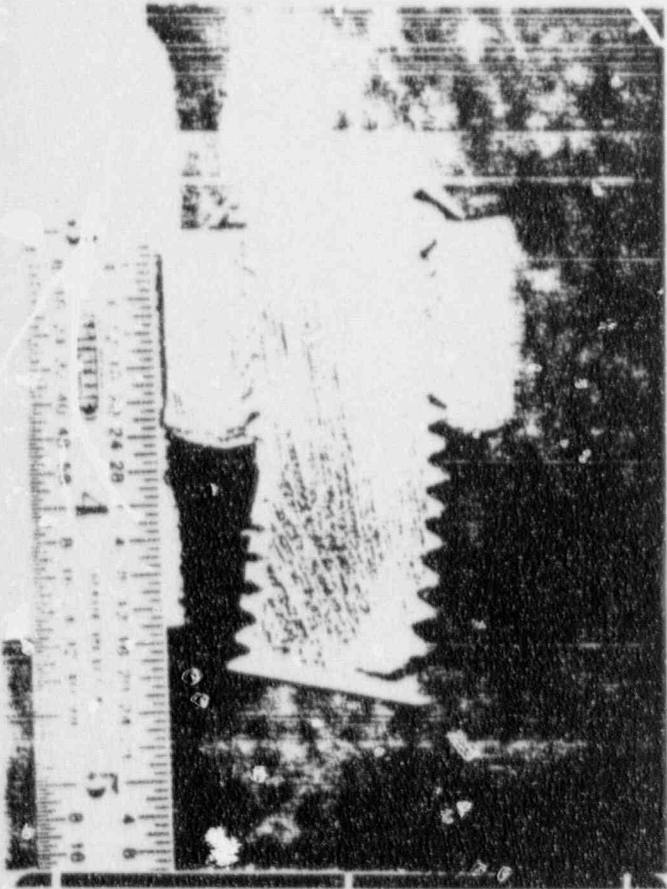
SECTIONED ANCHOR BOLT AND NUT  
NW CORNER

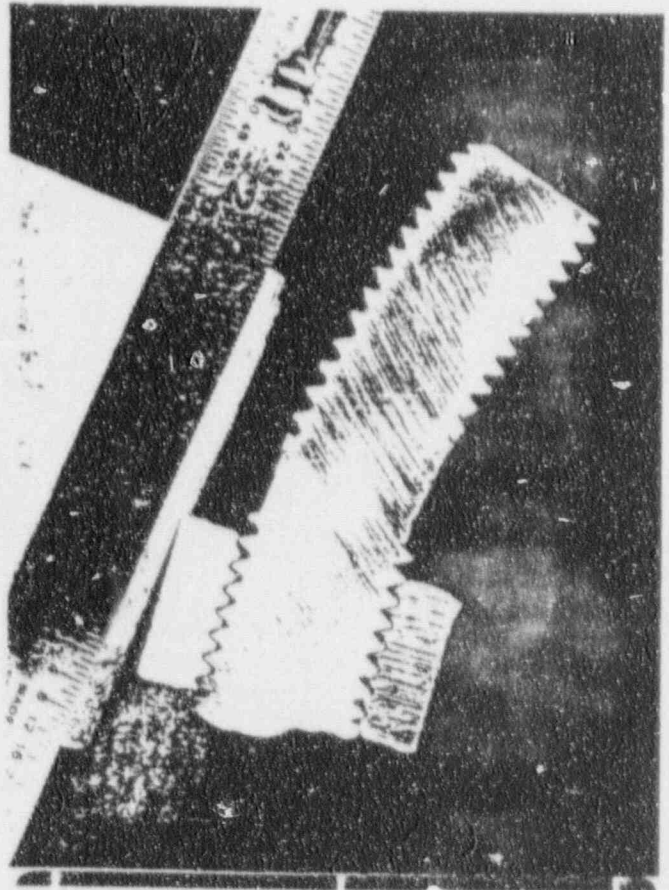
SECTIONED ANCHOR BOLT AND NUT  
NE CORNER

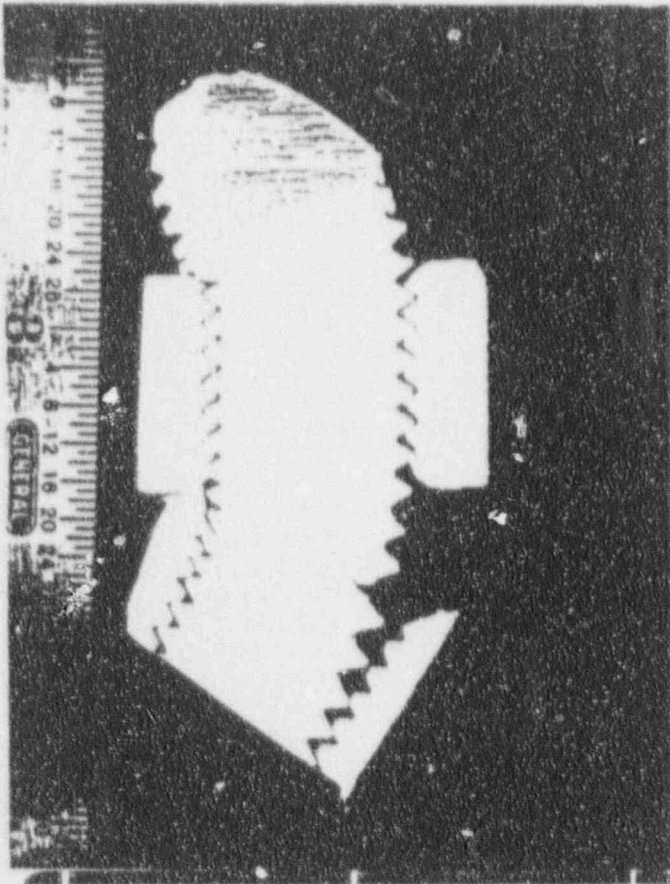
SECTIONED ANCHOR BOLT AND NUT  
SW CORNER

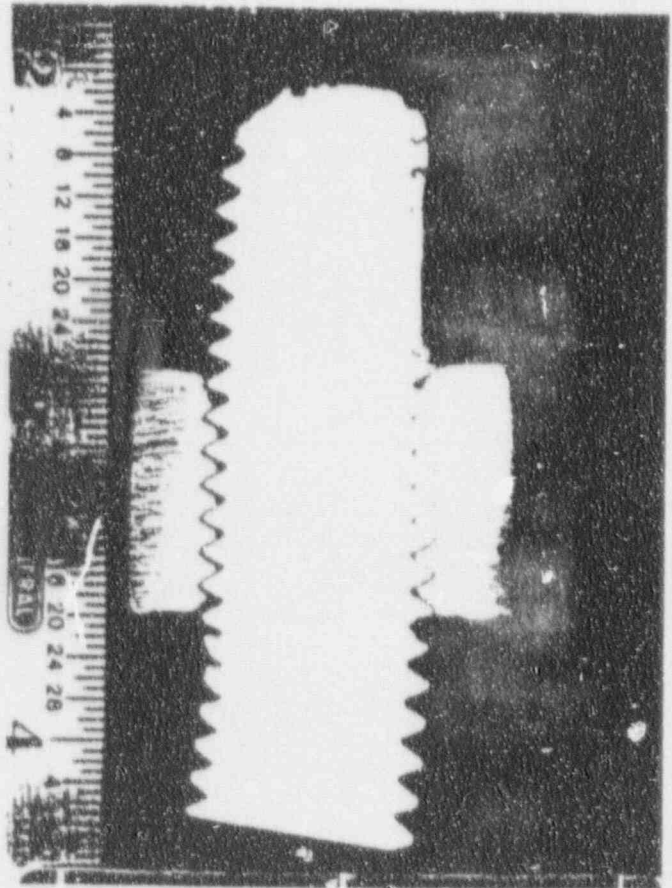
SECTIONED ANCHOR BOLT AND NUT  
SE CORNER

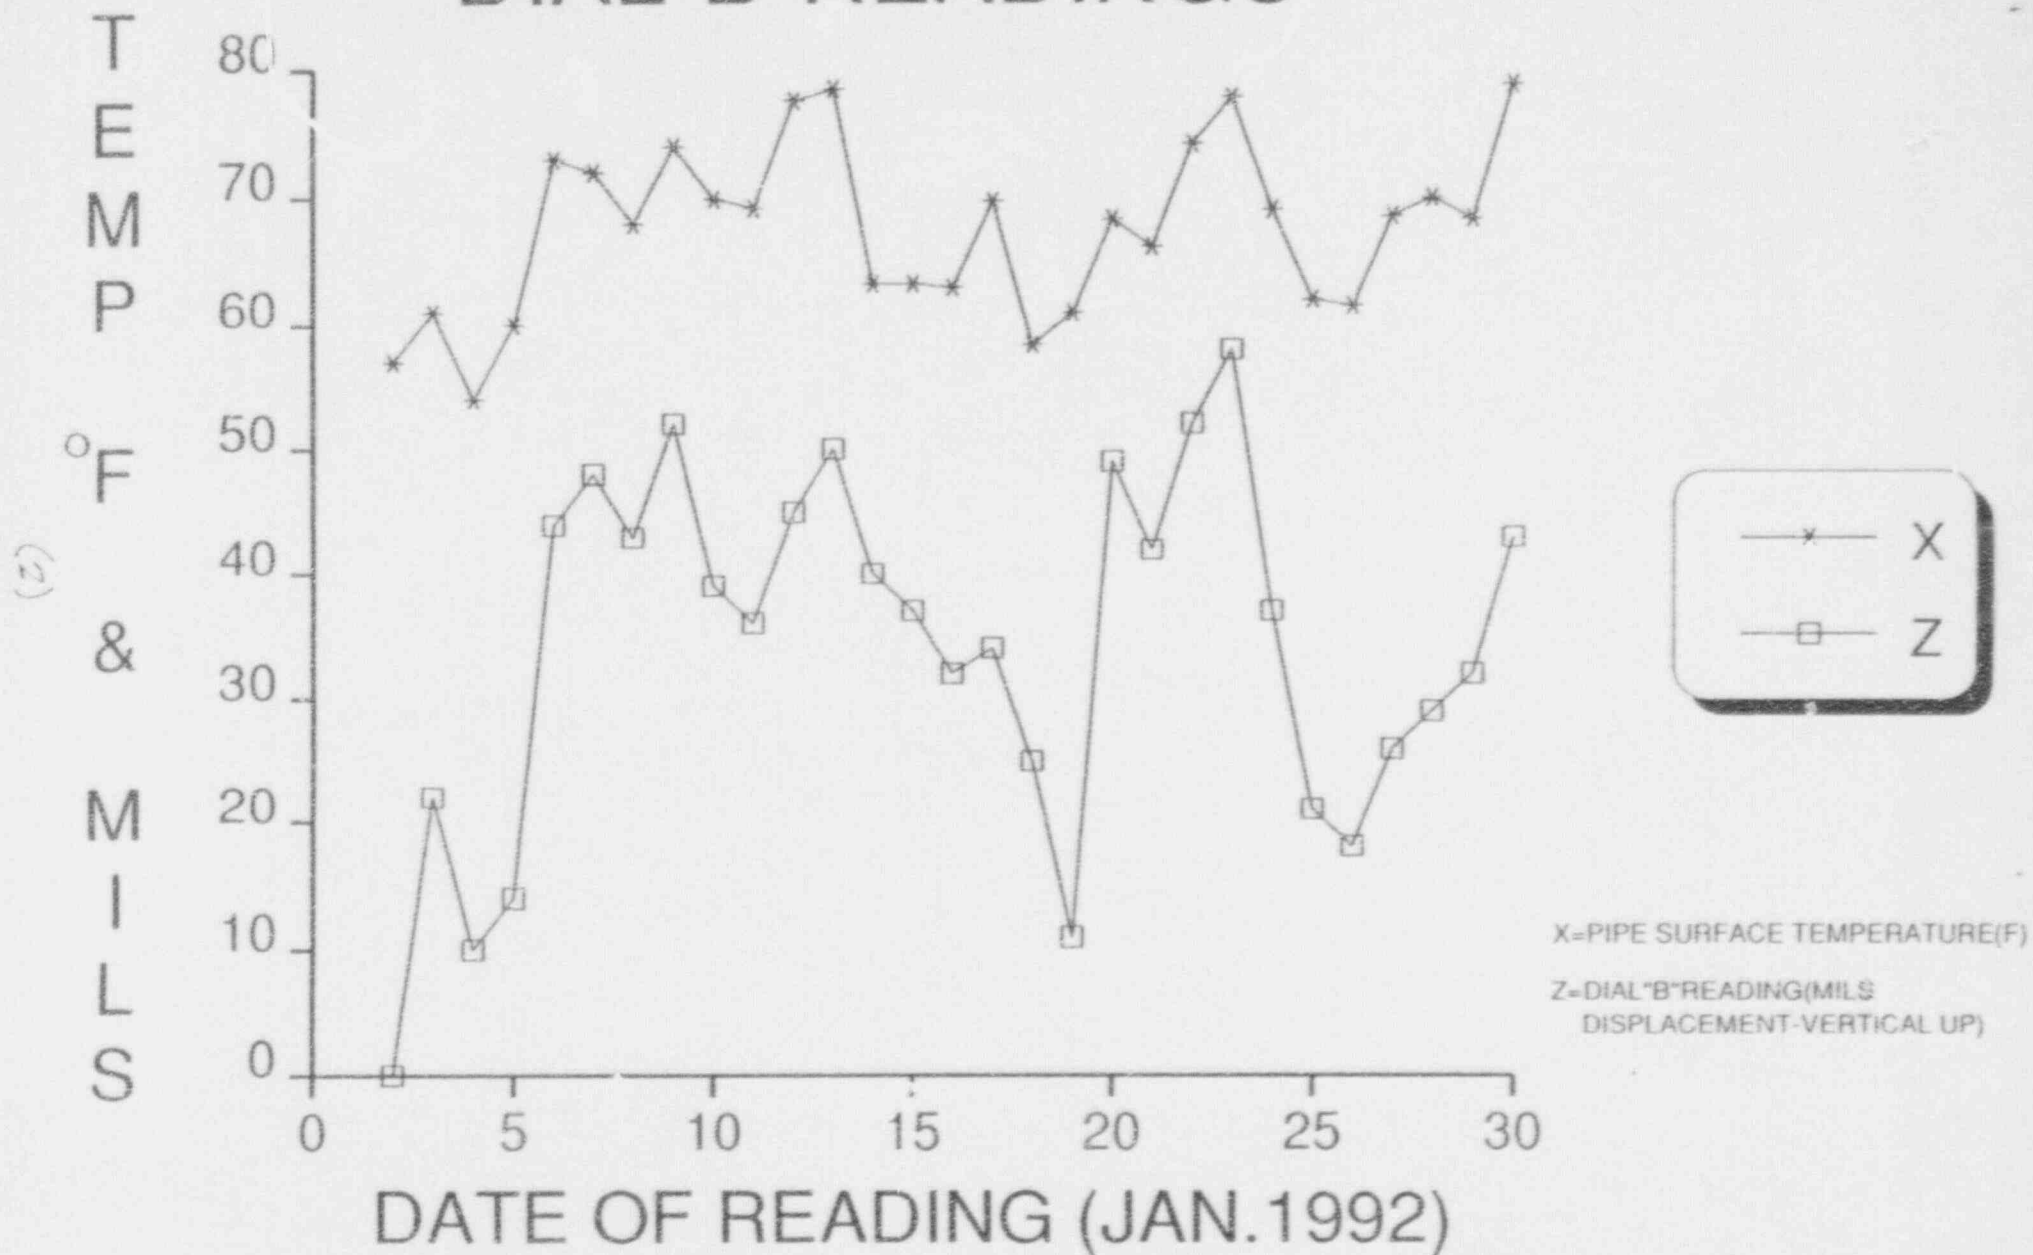
# DIAL "B" READINGS

Refer to Addendum E for plots of Dial Indicator "A" and "B" readings which have been recorded (per TXI-0131) since January 2, 1992 (startup). For reference purposes, the recorded displacements are also plotted against variation in recorded 471 pipe temperature. As can be seen, there is general trending between the two plots. Concerning the baseplate scratch pad for anchor LN71-H0013, no movement has been recorded to date as anticipated.

It should also be noted that the calculated limiting displacement values for the anchor support envelope the recorded N71 displacements to date, Addendum E, with ample margin (approximately 1.6, minimum).
