Subject: Oconee Nuclear Station, Unit 3  
Docket No. 50-370  
287

Duke Power Company  
Oconee Nuclear Station  
Special Report

Unit 3 Refueling Operations  
Fuel Handling Incident  
Fuel Assembly Damaged during Fuel Reshuffling

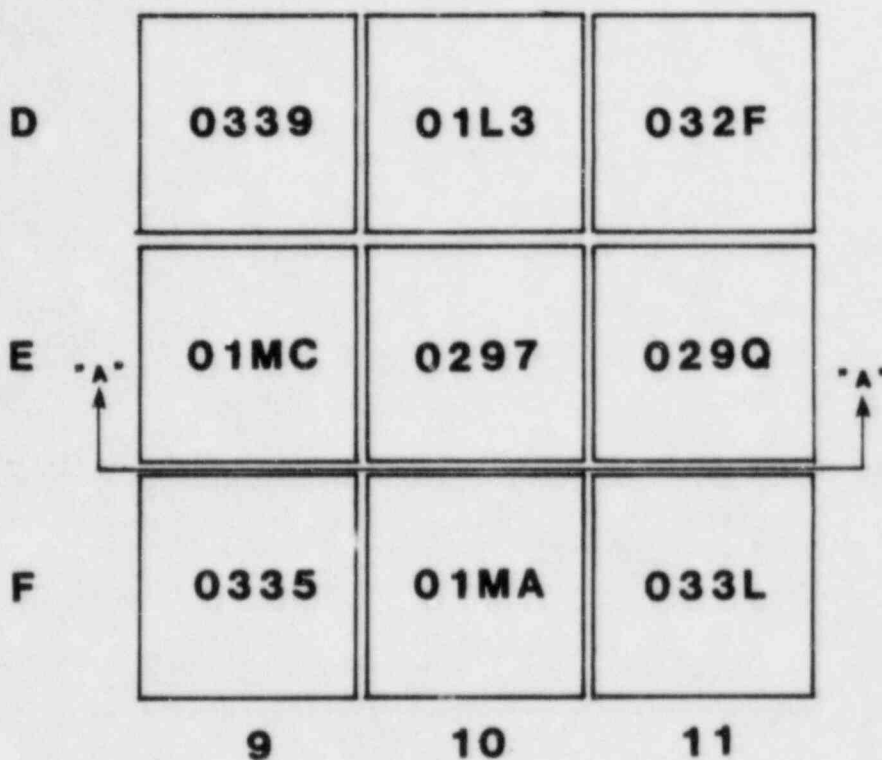
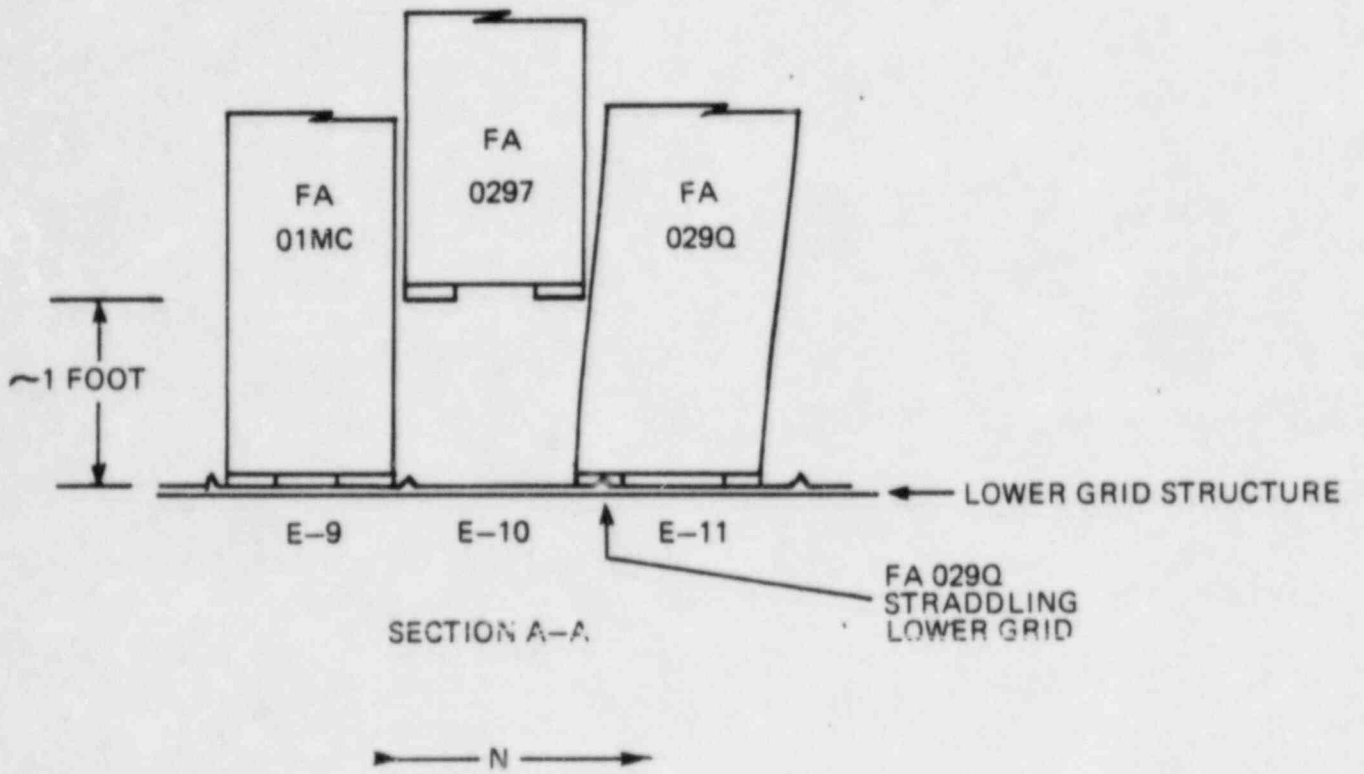
FIGURE 1  
SHEET 2 of 2

To verify full insertion of a FA, the Z-Z tape reading, which gives vertical displacement, is utilized. The Z-Z tape reading was correct, and thus the FA was assumed to be properly aligned. However, FA No. 029Q was not properly set in the lower grid. The lower end fitting of FA No. 029Q straddled the lower grid structure of the core in such a manner that the FA was partially occupying core location E-10. Furthermore, FA No. 029Q was sufficiently bowed to give the impression that the FA was properly positioned in core location E-11.

When FA No. 0297 was set in core location E-10, it scraped the lower south side of FA No. 029Q and became stuck approximately one foot from the bottom of the core. Figure 1 is a schematic of the positions of the fuel assemblies at the time of the incident.

Visual inspections were made of the fuel assemblies involved to assess the damage. The primary concern was with FA No. 029Q since this FA was scheduled to be reinserted for Cycle 8, while the others were to be discharged. FA No. 029Q was found to have approximately eight inch long scrapes on all fifteen fuel rods on the lower south side, between the lowest spacer grid and the lower end fitting. A detailed visual inspection of FA No. 01MC and No. 0297 was not performed because they were scheduled to be discharged. An initial visual inspection of FA No. 0297 found a pin hole in one of the rods. No other significant damage to the other fuel assemblies was observed.

Upon determining that fuel assemblies Nos. 0297 and 01MC had become interlocked with each other, both were lowered back into the core and steps were taken to separate them. Precautions to minimize any potential release that might have occurred during the course of events were taken. A visual inspection of the fuel assemblies involved that were to be discharged to the spent fuel pool for permanent storage was performed. A detailed visual inspection and evaluation of FA No. 029Q were performed to assess the impact that the damage to the assembly might have on its use for one more cycle.
