G/C REPORT: EA-182 REVISION 0
PERRY NUCLEAR POWER PLANT (TA #92-0002)

N71 PIPE RUPTURE EVALUATION

JANUARY 31, 1992

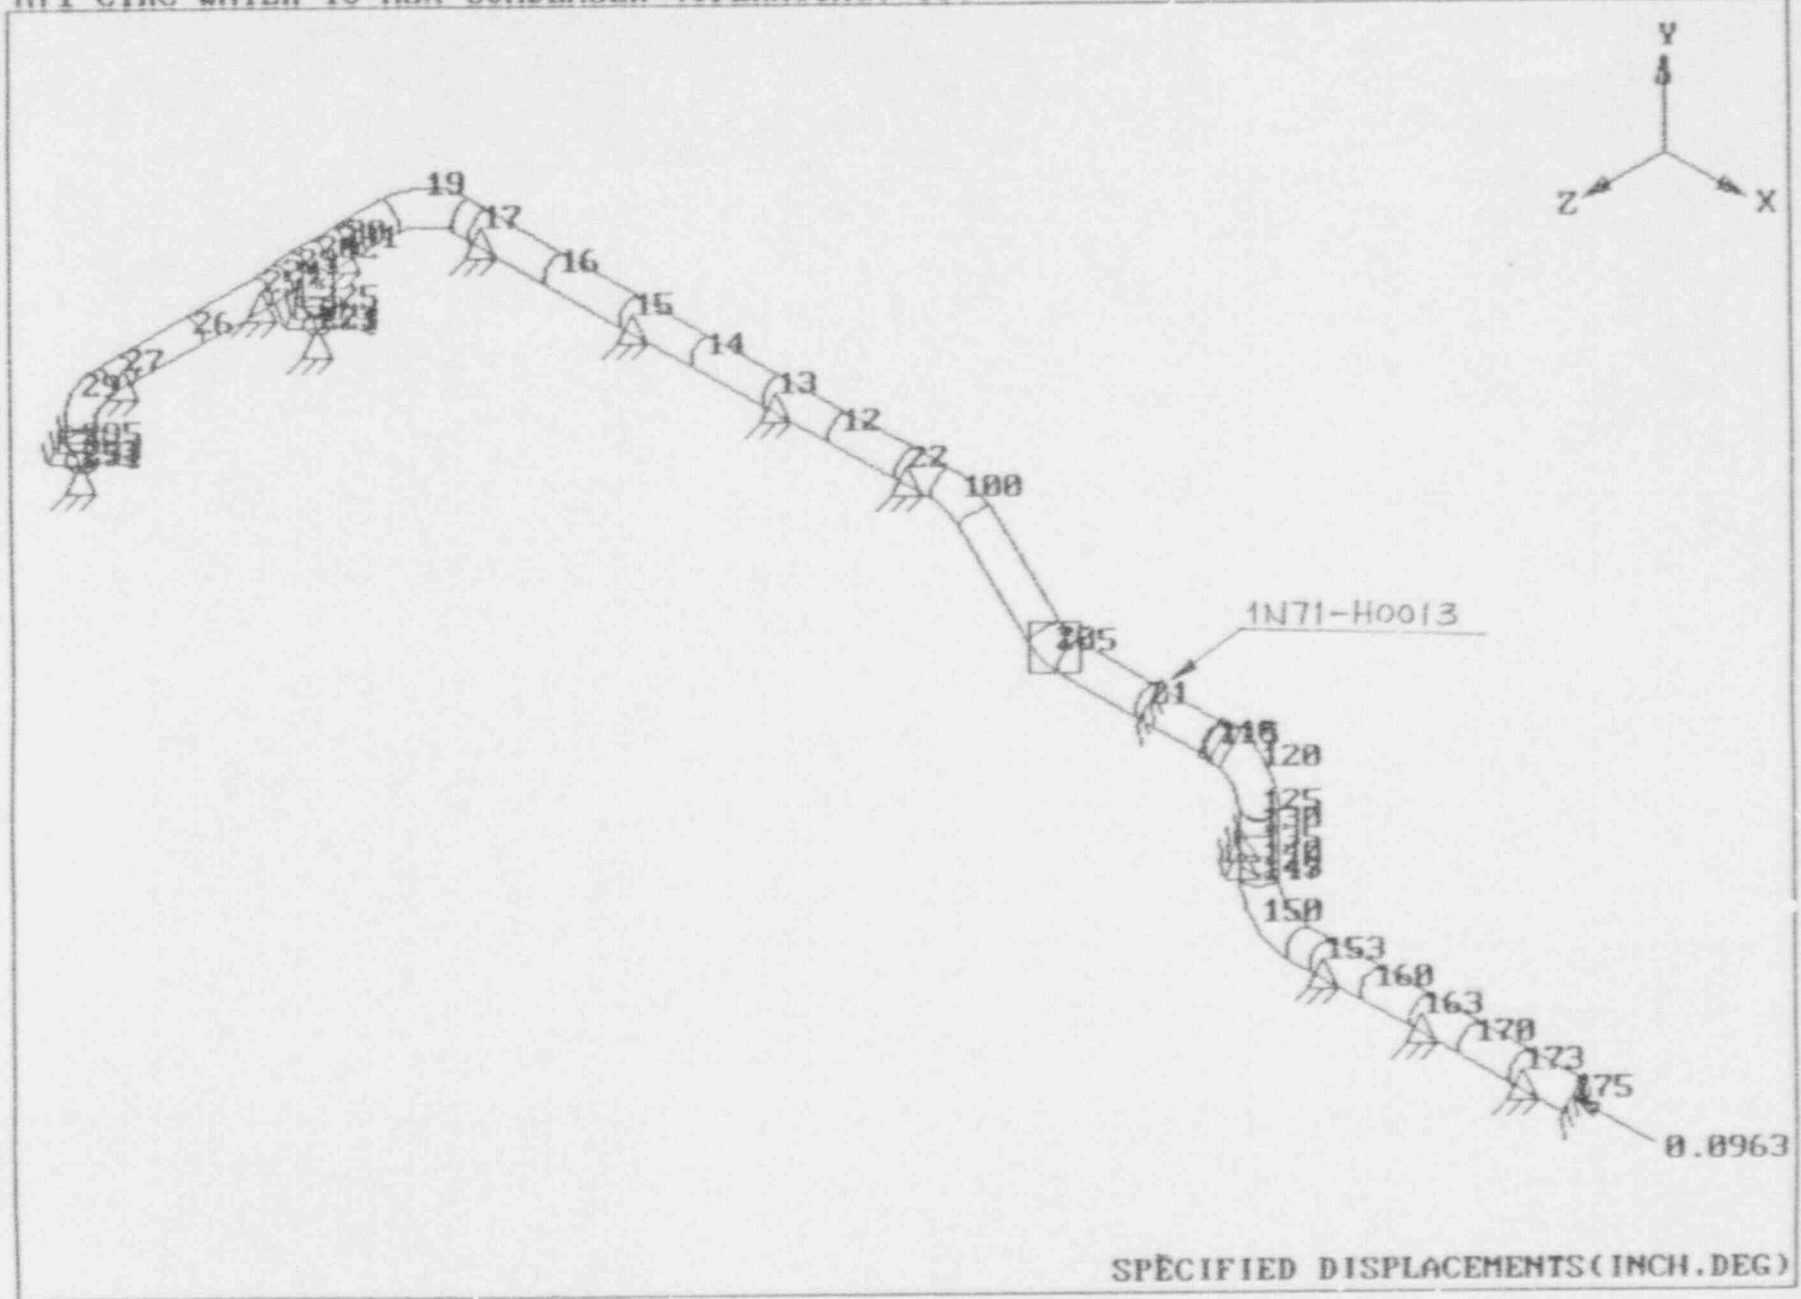
FIGURE 1
PAGE 5A

1. INLET MODEL: (Figures 1 and 2)

The expanded inlet model was run for a design/operating condition with a ΔT of 65°F (30-95°F) above ground, 40°F below ground, and a pressure of 60 psig. Horizontal and vertical soil springs were included corresponding to the values of soil modulus of subgrade reaction of 135 lb/in² vertical and 70 lb/in² lateral as previously determined.

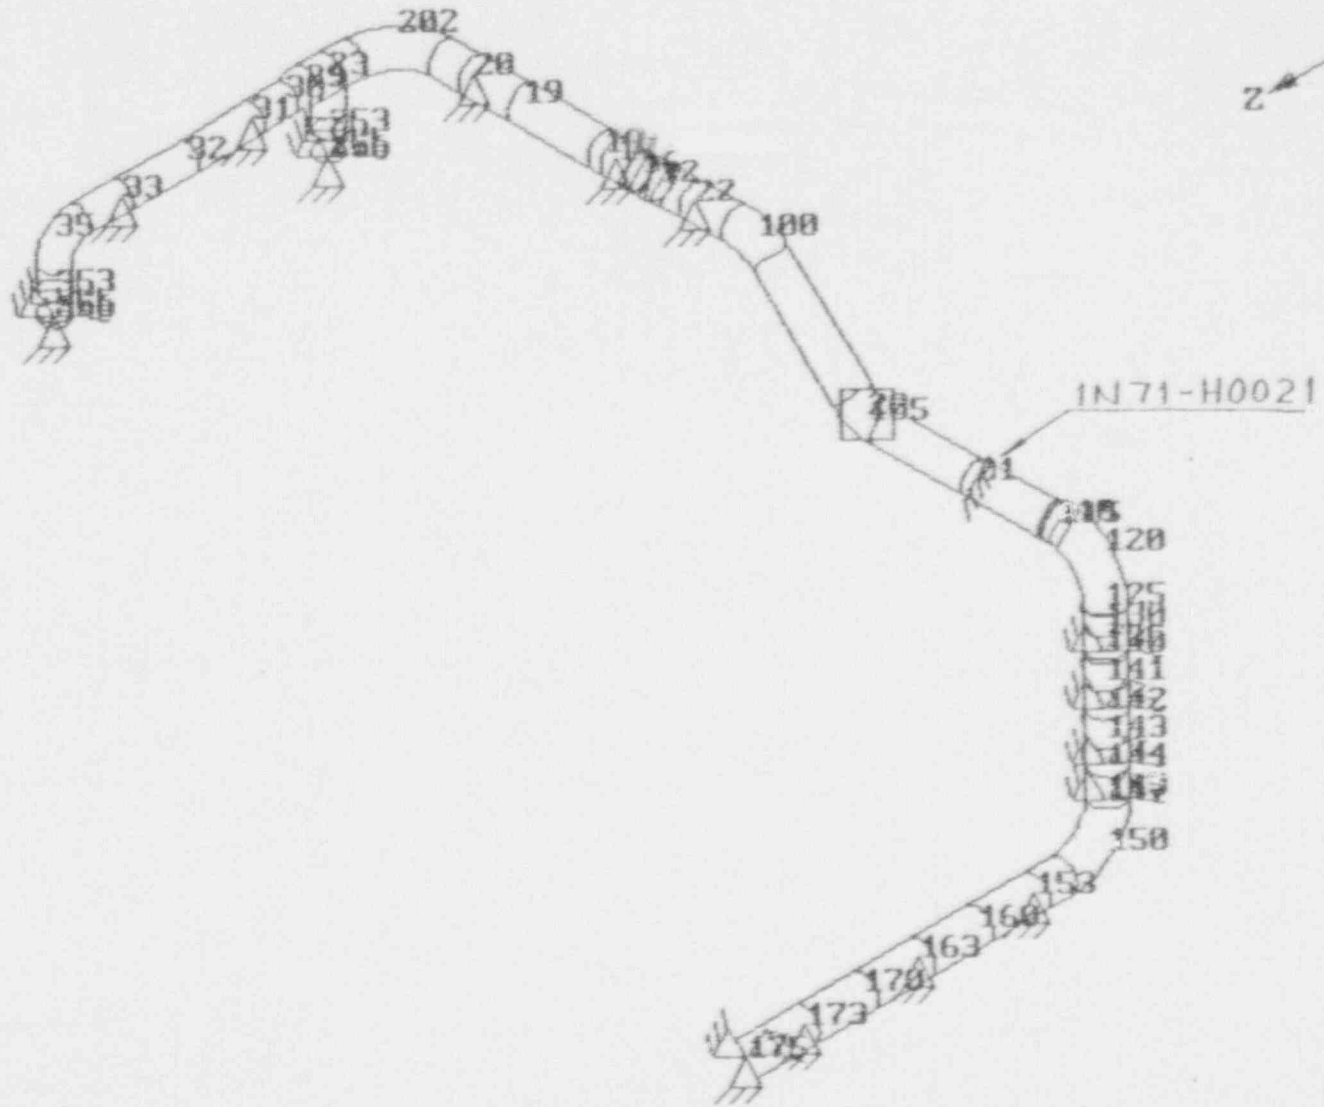
FIGURE 3
PAGE 5C

2. OUTLET MODEL: (Figures 3 and 4)

A separate model was utilized for the Circulating Water Auxiliary Condenser outlet piping because of differences in configuration both above and below grade. The outlet piping was analyzed at a 12°F higher temperature than the inlet piping and at a pressure of 39 psi. As was done for the inlet piping, concurrent maximum loadings resulting from a flow transient analysis were included in the analysis.
