TENNESSEE VALLEY AUTHORITY

May 24, 1984

RESPONSE - NRC INSPECTION REPORT NOS.
50-259/84-11, 50-260/84-11, AND 50-296/84-11
RICHARD C. LEWIS'S LETTER TO H. G. PARRIS
DATED APRIL 27, 1984

259, 260, 296/84-11-01

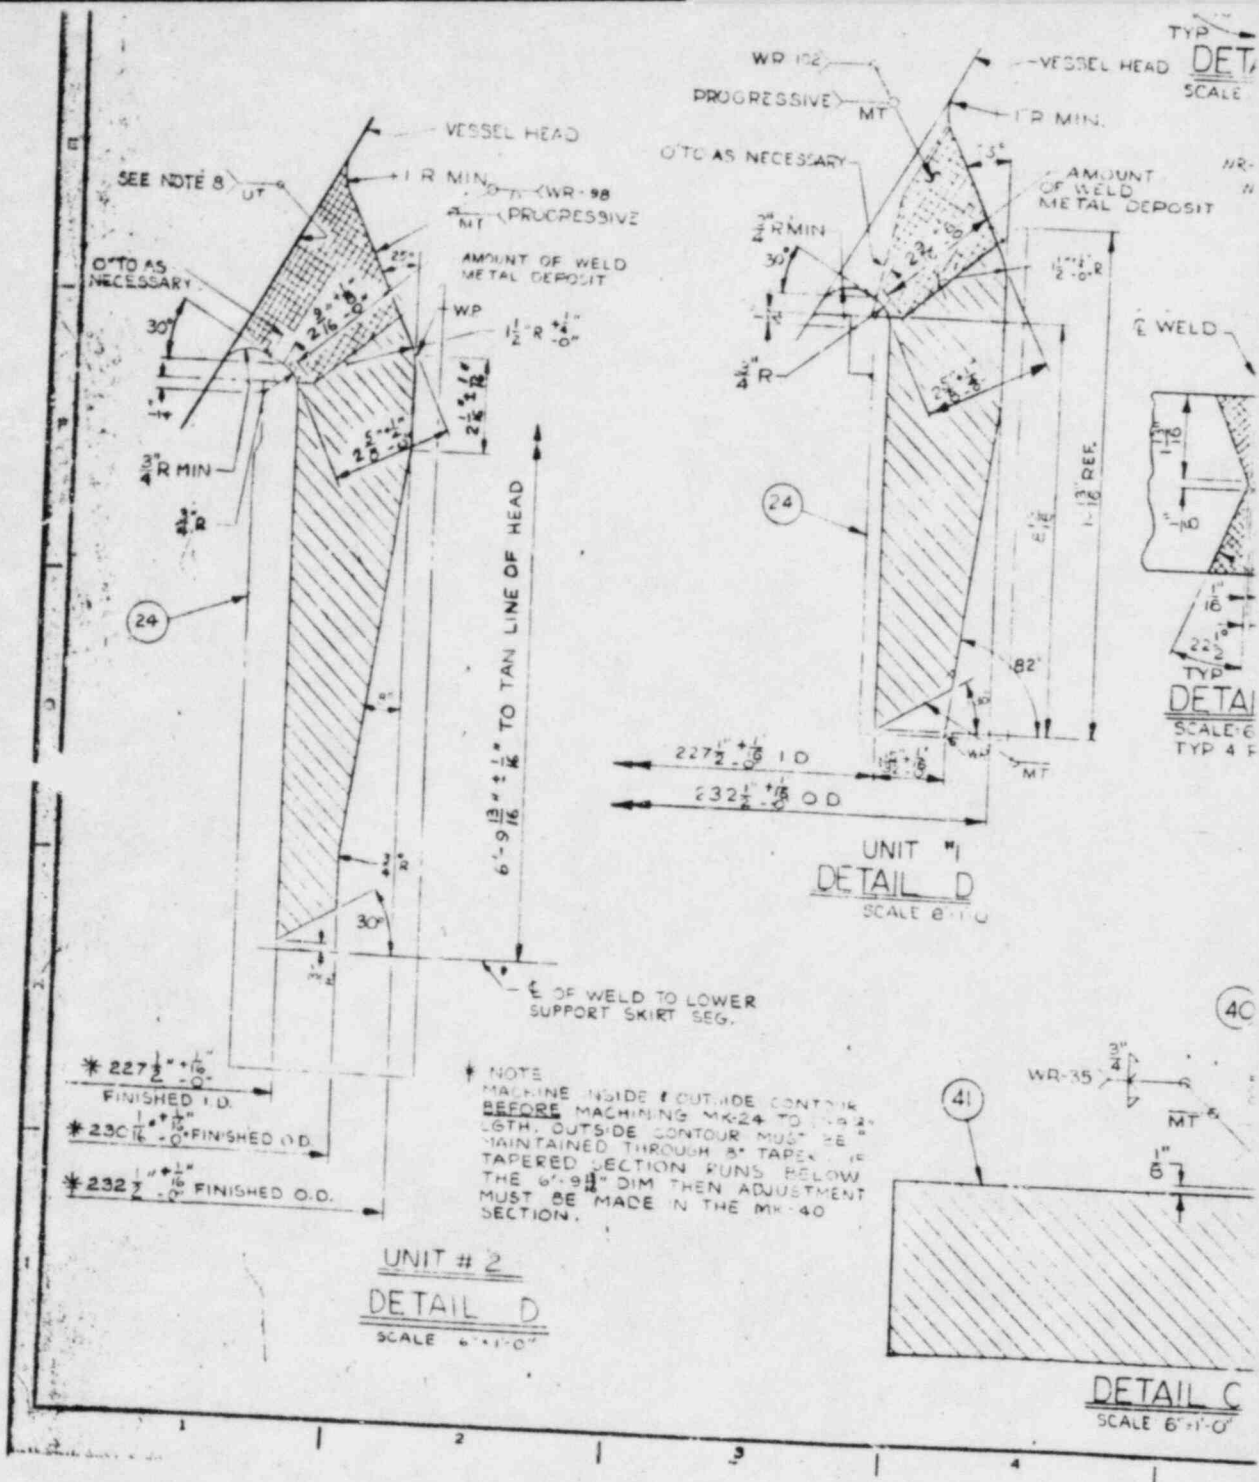
- ATTACHMENT III -

- b. A copy of the manufacturer's fabrication drawing is included as Attachment III. Review of Detail D of this drawing indicates the weld and adjacent base material are approximately 2-1/2 inches thick. The base material thickness then decreases approximately 1/8 inch per inch as the measurement point is moved downwards away from the weld. It is likely the measurement recorded on the examination report was taken in the tapered area rather than adjacent to the weld, resulting in a smaller reading. While there is no requirement to make the thickness measurement, the examination report as written now is not clear and subject to question. TVA will therefore add an inspection to the in-service inspection plan for the next scheduled outage to recheck the wall thickness adjacent to the weld. If the wall thickness is verified

to be as shown on the drawing, the examination report will be corrected. If the wall thickness is found to be too thin for the calibration block used, a reexamination using the correct calibration block will be performed. These corrective steps should be completed by February 1985.
