**SG Structural Inspection Plan
In Support
of Braidwood-1 and Byron-1
3.0 Volt IPC**

**COMMONWEALTH EDISON COMPANY
SEPTEMBER 1995
REV.0**

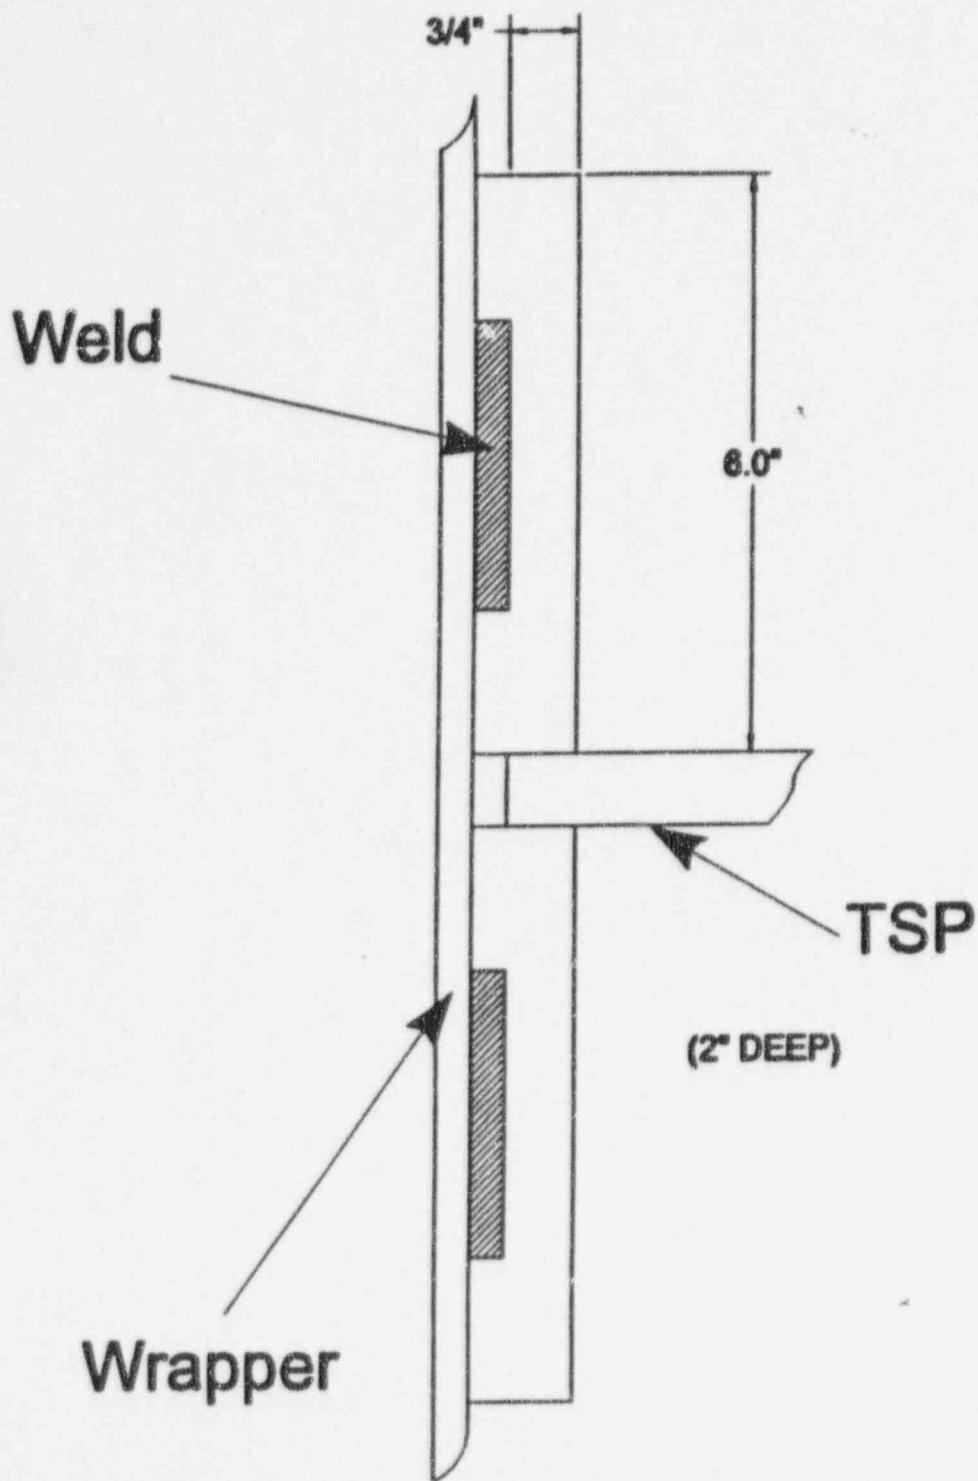
FIGURE 3

The TSP vertical support bars have longitudinal welds on each side attaching the bars to the wrapper (see Figure 3). These welds provide a factor of 6 margin against the largest SLB load on any bar. Therefore, only 1/6 of the total weld length or 1/3 of one weld must be structurally sound to support the TSP displacement analyses. Since less than one weld without cracks is acceptable, each weld, rather than each bar, can be considered to be an inspection sample.

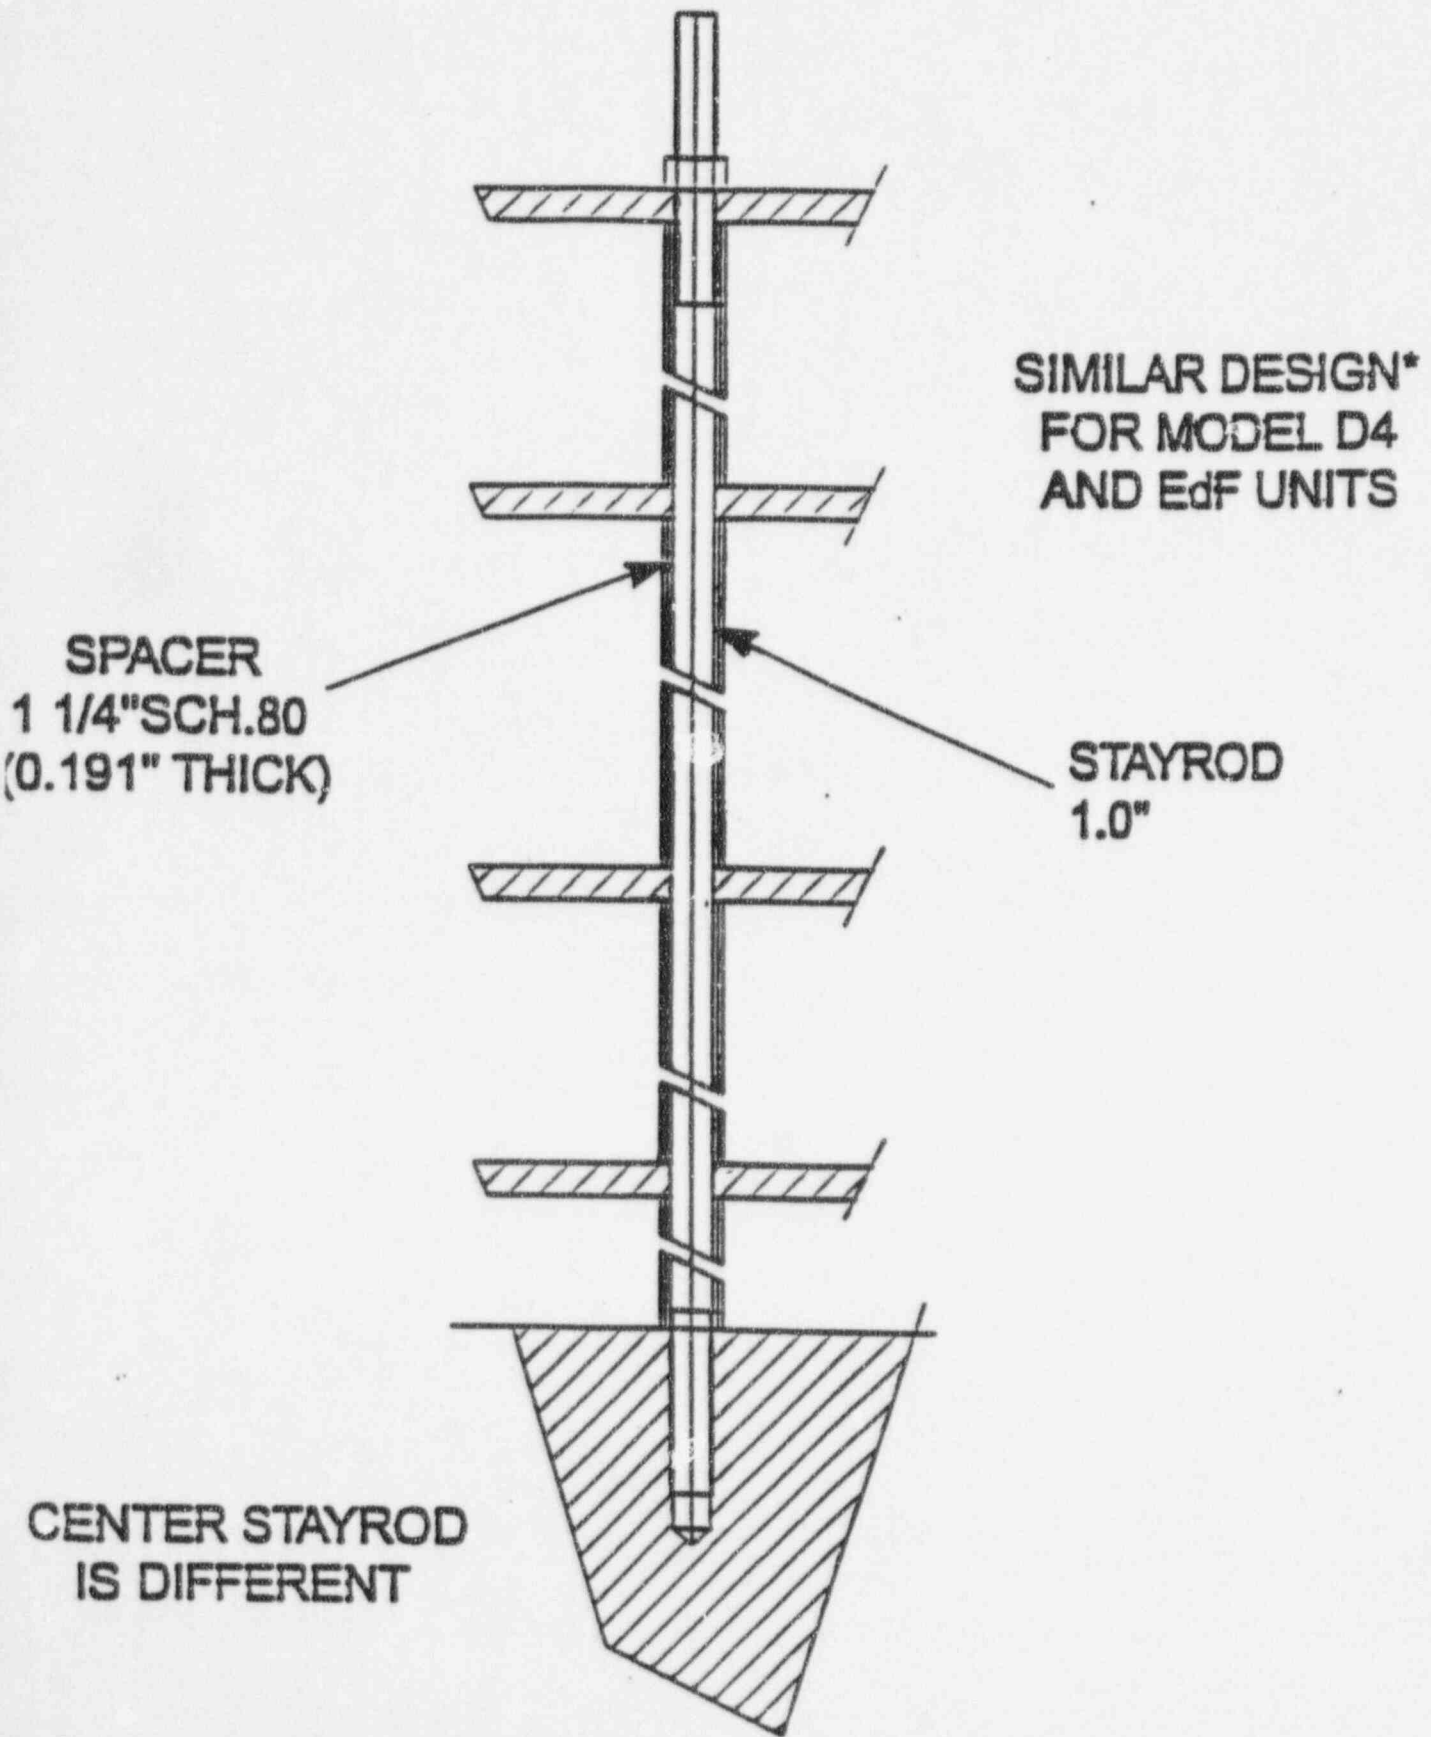
FIGURE 4

There are 5 stayrods on each of the hot and cold legs that extend from the tubesheet to the top TSP. Figure 4 details a typical stayrod configuration. In addition, there is a stayrod at the center of the SG that extends from the top of the preheater divider (plate 8) to the top TSP. For limiting TSP displacements, only the 5 stayrods in the hot leg and the stayrod at the center of the SG are critical to limiting hot leg displacements. The stayrods are 1.0" diameter carbon steel rods. The spacers are 1.25" schedule 80 carbon steel (0.191" thick) and hold separation distance between each TSP.

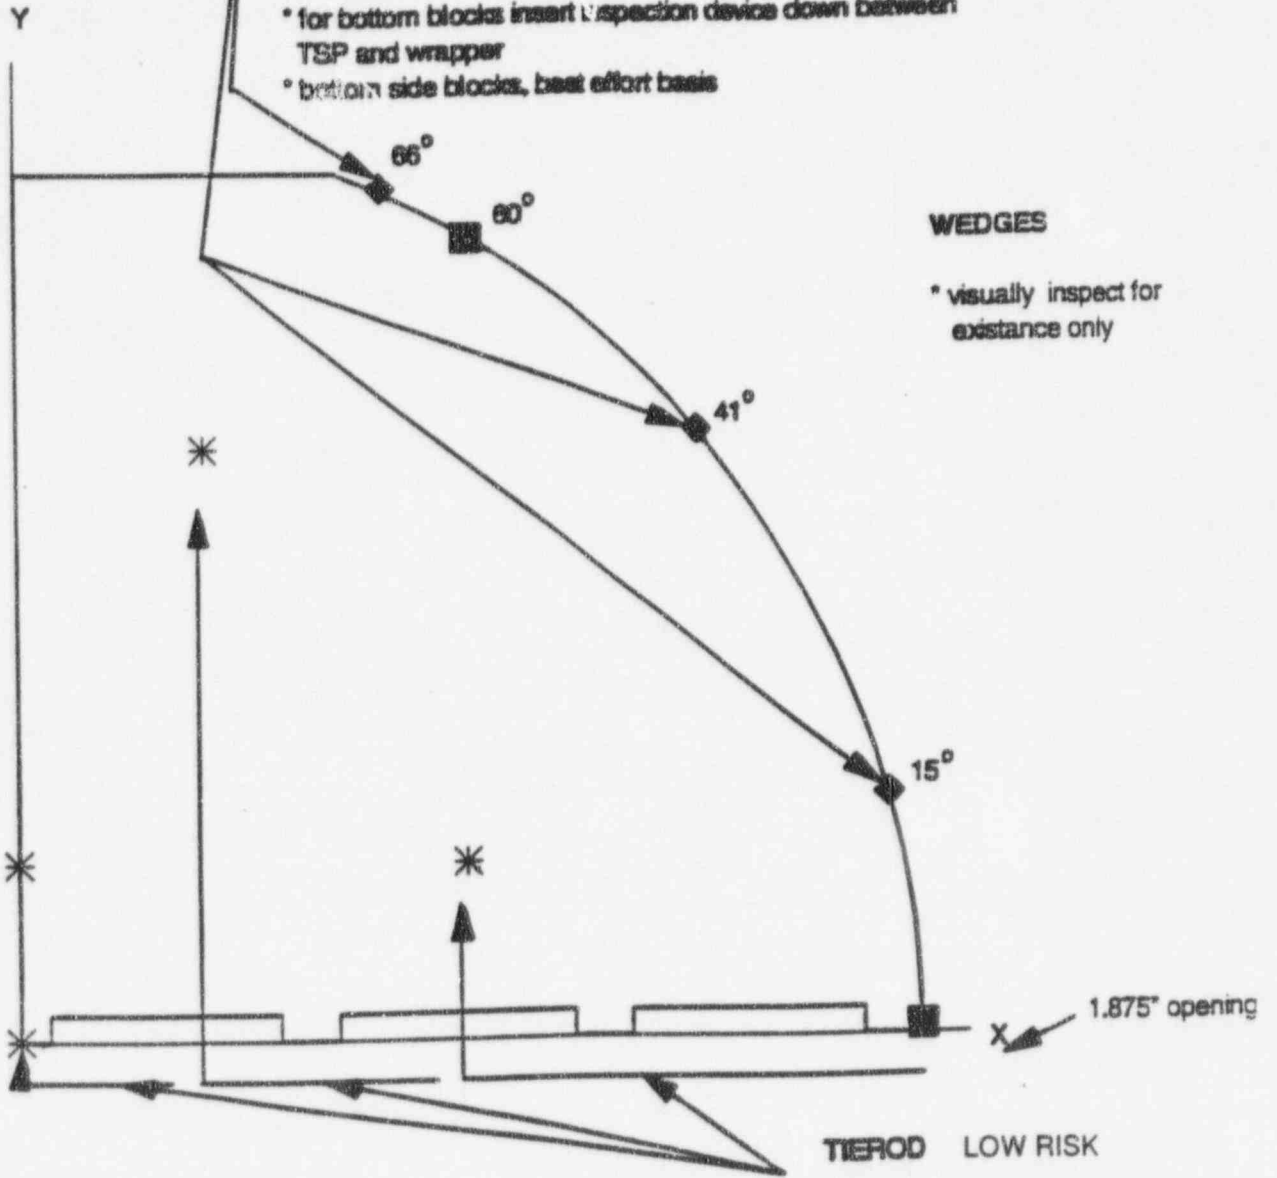
Plate P (11H) Support Locations

- * clean weld area, top side of TSP
- * inspect weld area with video probe or camera
- * for bottom blocks insert inspection device down between TSP and wrapper
- * bottom side blocks, best effort basis

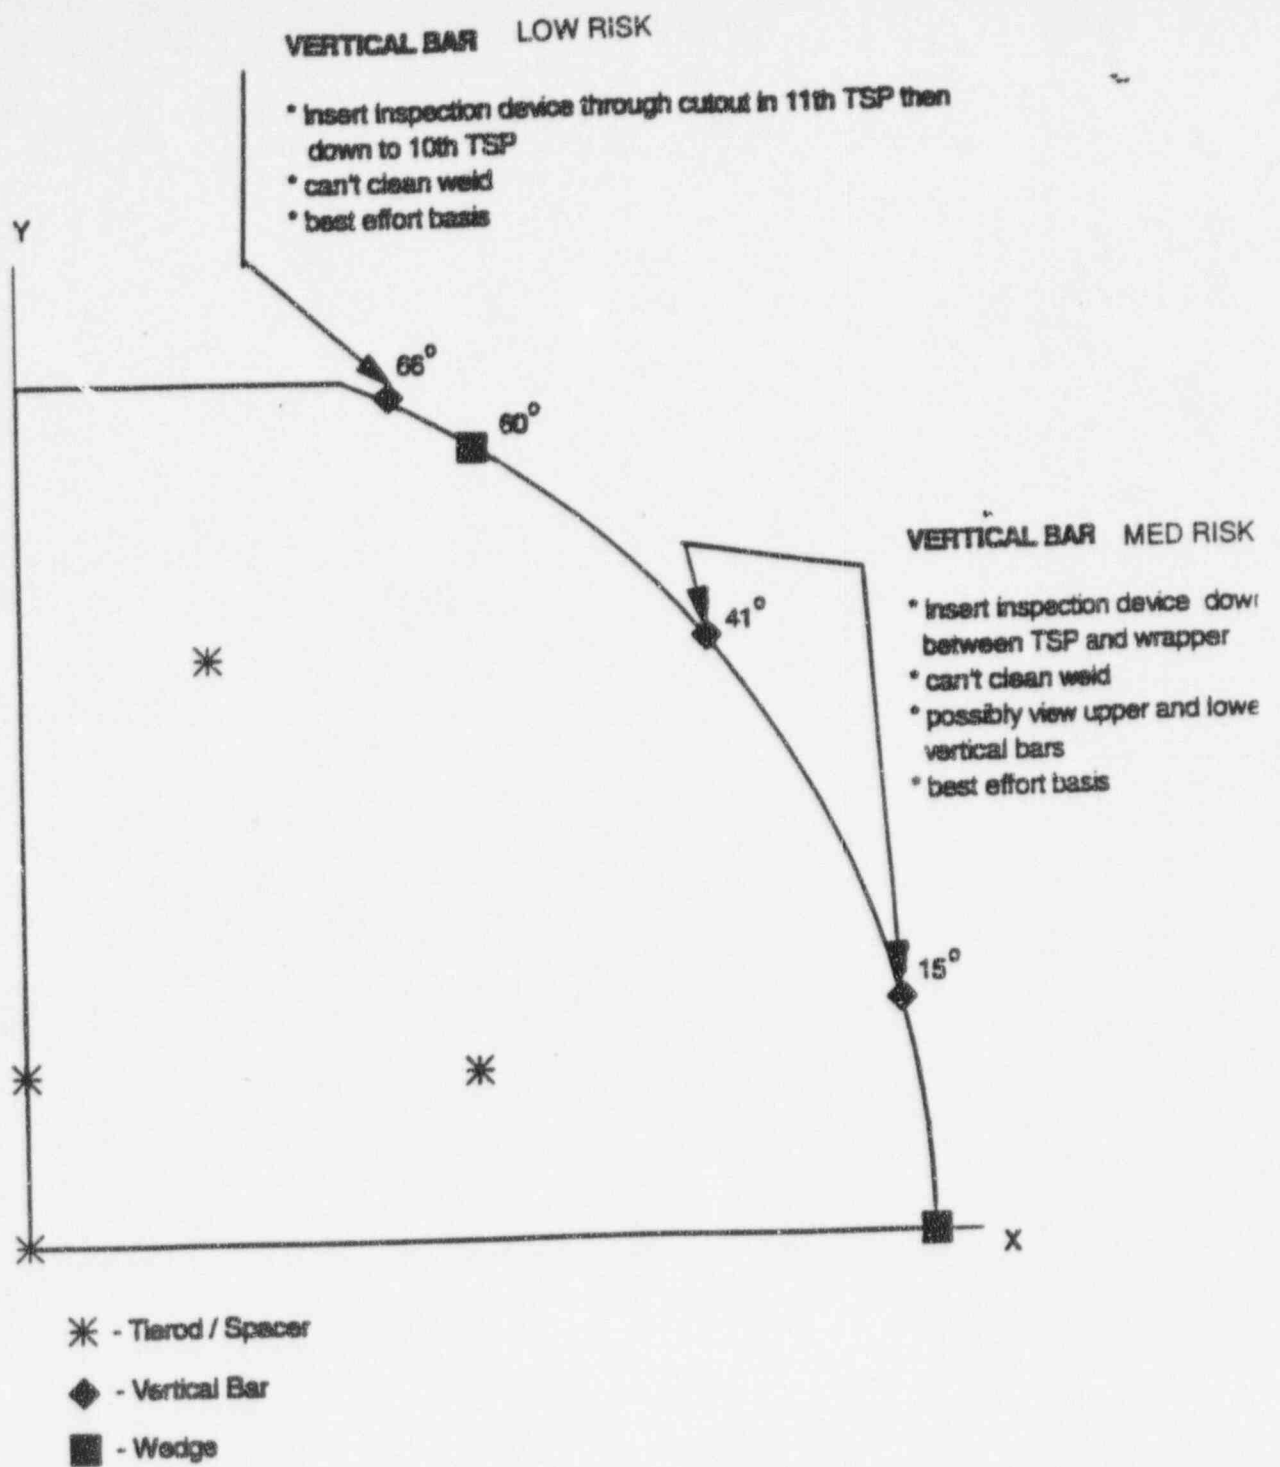
Plate N (10H) Support Locations

- * Insert inspection device through cutout in 11th and 10th TSP then down to 9th TSP
- * can't clean weld
- * can only view one side of bar and weld
- * best effort basis

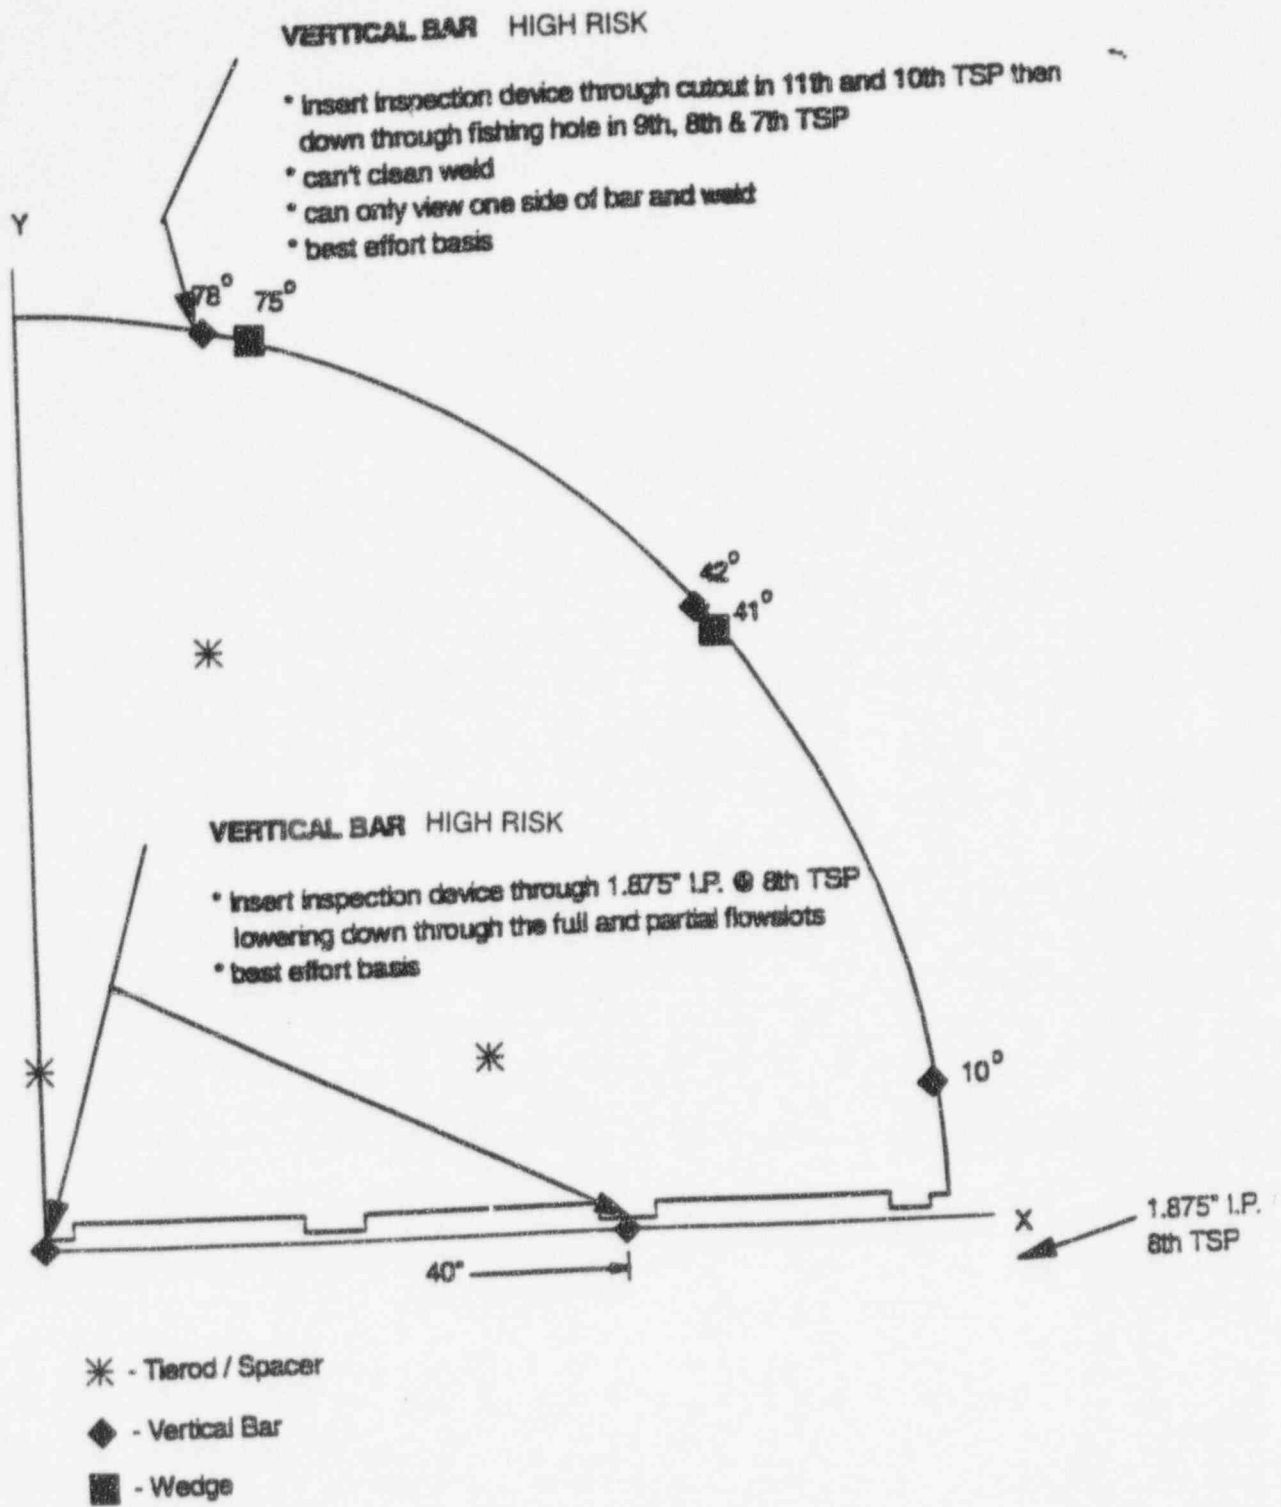
Plate F (5H) Support Locations

- * Insert inspection device through cutout in 11th and 10th TSP then down through fishing hole in 9th, 8th, 7th, & 5th TSP
- * can't clean weld
- * can only view one side of bar and weld
- * best effort basis
