AEOD ENGINEERING EVALUATION REPORT*

UNIT: Edwin I. Hatch 2
DOCKET NO.: 50-366
LICENSEE: Georgia Power Company
NSSS/AE: General Electric/Bechtel

EE REPORT NO.: AEOD/E411
DATE: May 22, 1984
EVALUATOR/CONTACT: C. Hsu

SUBJECT: FAILURE OF ANTI-CAVITATION DEVICE IN RESIDUAL HEAT REMOVAL
SERVICE WATER (RHRSW) HEAT EXCHANGER OUTLET VALVE

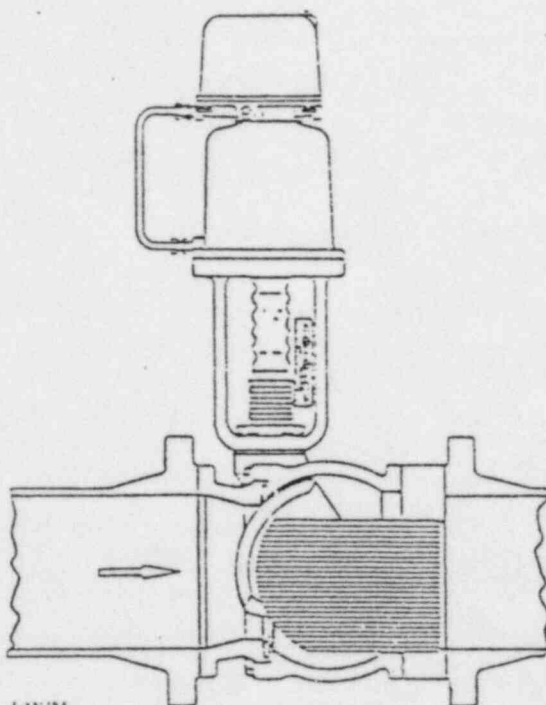
Figure 1. Typical Installation of Anti-Cavitation Device
in Fisher Vee-Ball Valve

The anti-cavitation device is installed within the control valve to prevent cavitation damage to the valve and adjacent components. Cavitation is formation and subsequent collapse of vapor bubbles in the liquid flow stream, within valve pathway, due to pressure fluctuation as a result of throttling of the valve. The collapsing bubbles generate a crackling noise and vibration, and can mechanically damage valve components and the pipe wall. This damage can lead to failure of the control valve, particularly the valve disc and seat ring. The anti-cavitation device, which was installed in the control valve of the RHRSW system at Hatch 2, consisted of a bundle of tubes attached to a flange. The tubes can prevent the flow stream from reaching its potential minimum cross sectional area as it passes through the valve, thus maintaining maximum pressure internal to the valve and reducing the likelihood of vapor bubble formation.

The control valves used in the RHRSW system at Hatch 2 are Fisher Vee-ball control valves. These are a ball type of throttle valve with a V-notch ball design. These valves, similar to a plug valve, are quick opening needing only a quarter turn of its V-notch ball from full open to full close. The configuration of waterway in the valve is essentially an unrestricted, straight through flow design providing greater flow than other types of valve to ensure a non-clogging operating for raw water application. With the installation of an anti-cavitation device within the valve as shown in Fig. 1, that part of the control valve became somewhat restricted, creating a dead end to stop and accumulate sludge or impurities suspended in incoming cooling water. Once the accumulation reaches the port sealing surface, it is likely that the sealing surfaces could be impaired and become restricted due to the movement of V-notch ball that could render the control valve inoperable. Furthermore, if some of the tubes become bent in the installation, the bent tubes tend to rest on the sealing surface or stick to the V-notch ball, either of which could obstruct rotation of the V-notch ball and cause the valve to be stuck. Should the valve be stuck in the closed position, the system, which utilizes the control valve, would become inoperable due to no flow in the system.
