APPENDIX J

DIESEL GENERATOR FAILURE REVIEW AND ANALYSIS

This appendix describes the scope and results of the licensee's investigation to determine the causes for the unexpected 1A emergency diesel generator shutdowns during the incident. It describes the maintenance performed on the emergency diesel generator during the refueling outage before the event, the post-incident review and troubleshooting efforts, and the sensor testing program to determine the root cause of the sensor malfunctions.

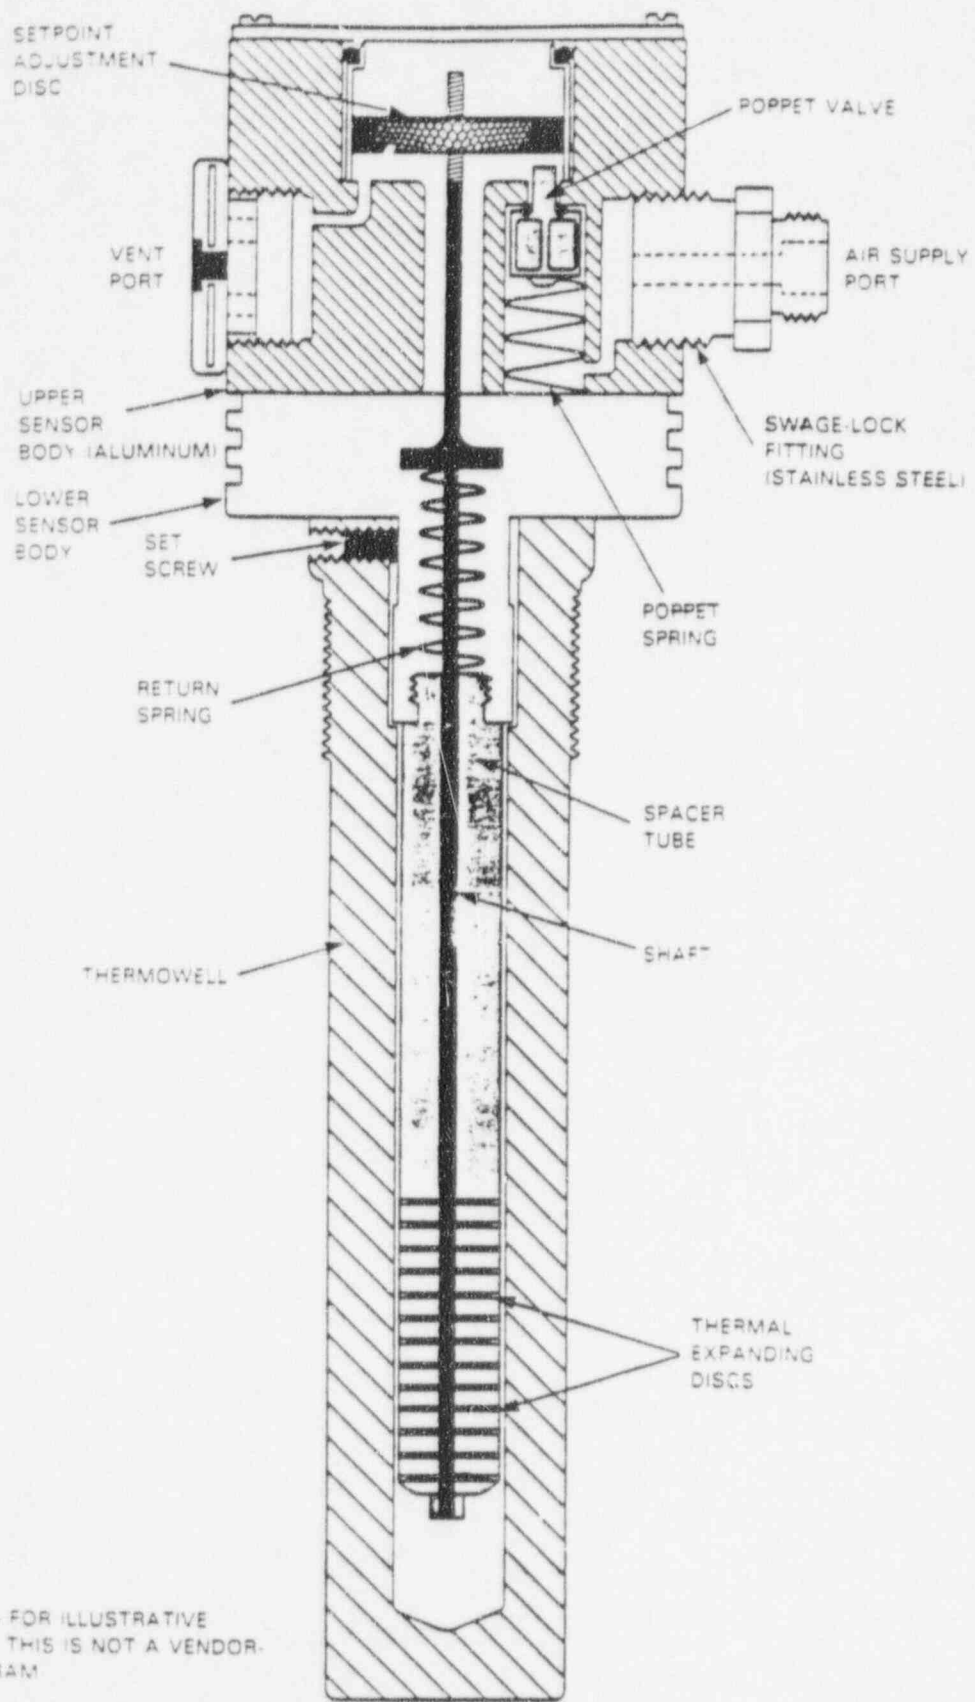
Figure J.2 Calcon Pneumatic Temperature Sensor (Model A3500-W3)

The temperature sensors are manufactured by California Controls Company (Calcon). The sensor is shown in Figure 3.9. A cross-sectional diagram of the sensor is provided in Figure J.2. The same sensor (Model A3500-W3) is used to sense both jacket water and lube oil temperature. The sensor is mounted in a stainless steel thermowell and is held in place by a set screw. A combination of 1/4-inch and 3/8-inch sensing lines provide 60 psig control air from the engine pneumatic control logic to the sensor when the emergency diesel generator is running. The sensor air supply line is attached to the sensor by a stainless steel Swage-Lock fitting. The sensor is designed to block air flow when monitored temperature is below the setpoint value ($200\text{ }^{\circ}\text{F} \pm 4\text{ }^{\circ}\text{F}$ for both jacket water and lube oil), and to vent the air supply to atmosphere when the setpoint is exceeded.

The effect of the spacer tube loosening is to lower the trip setpoint. As the spacer tube loosens, the sensor shaft is pulled downward, reducing the gap between the setpoint adjustment disc and the poppet valve stem. This results in a decrease in the temperature required to cause the sensor to vent. The spacer tube is supposed to be tightly secured to the sensor body, using a thread-locking compound to prevent separation. The Wyle testing concluded that the trip setpoint decreases approximately $80\text{ }^{\circ}\text{F}$ for each full turn of the spacer tube away from the sensor body. Several temperature sensors have been found with loose spacer tubes. A loose spacer tube would be considered a probable cause for premature sensor actuation, however, it is not clear that this type of problem could cause the intermittent behavior of the jacket water temperature sensors believed to have occurred during the incident.

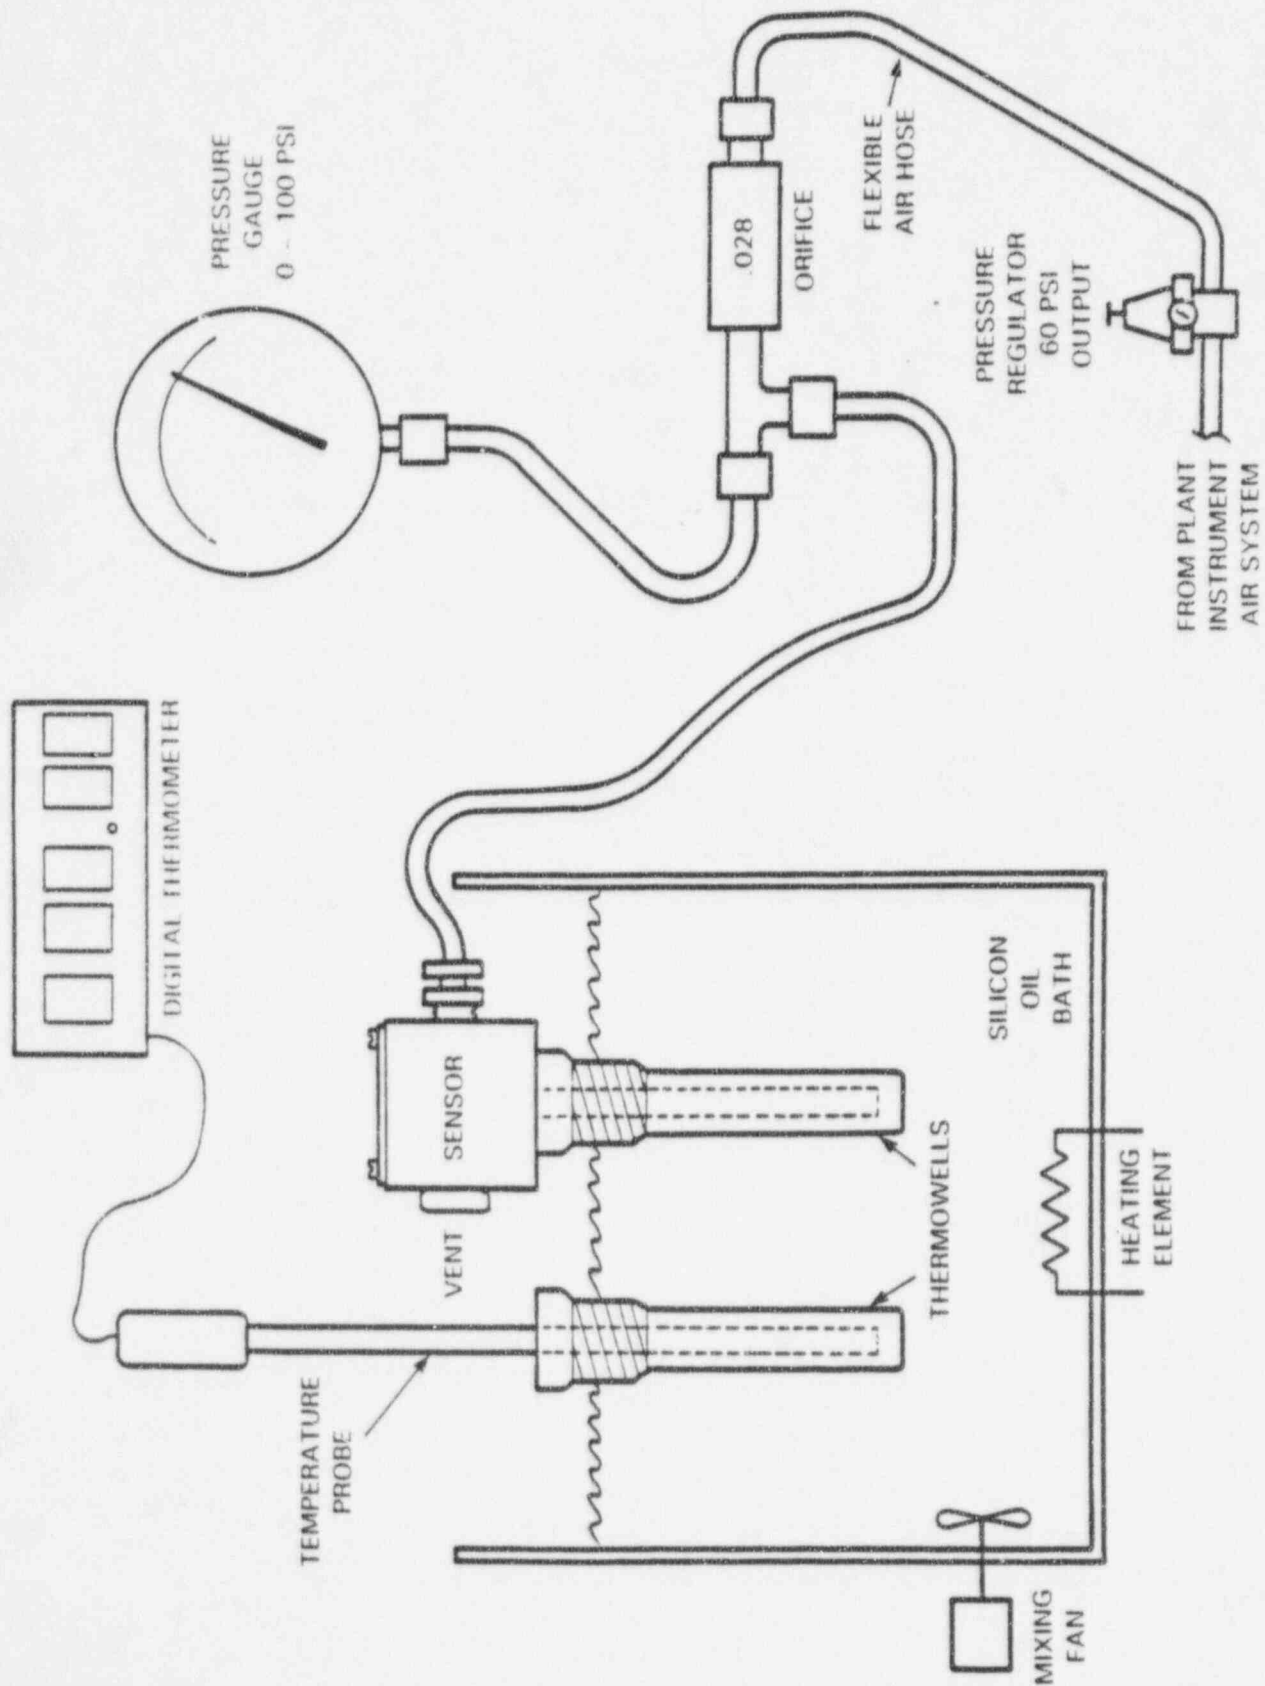
Figure J.3 Temperature Sensor Calibration Configuration

Sensor calibration appears to be somewhat dependent on the individual I&C technician performing the calibration. For example, the amount of tapping on a sensor during calibration may vary between technicians. If the trip setpoint was found within tolerance, but near its high or low limit, the technician performing the calibration would decide whether or not to attempt to adjust the setpoint closer to its expected value. For calibrations performed before the incident, it is not clear whether the sensors were transported back to the emergency diesel generators from the I&C shop in or out of a thermowell. This could be significant because the tip is the most delicate part of the sensor, and jarring it can potentially cause a 5 °F to 10 °F change in the setpoint. Twisting the tip of the sensor probe has the same effect as rotating the setpoint adjustment disc. Although the guidance provided with the maintenance work orders requires the sensors to be calibrated in a thermowell, the licensee could not confirm that all technicians used thermowells. Some test results have shown that calibration accuracy is not significantly affected by not using a thermowell. Differences in air supply pressure and bath temperature heatup rates could also have some effect on setpoint determination. The as-left setpoint values recorded on the data sheets are the average of three separate calibration checks. Some technicians record the values from all three checks on the calculation sheet and show the average value calculation. Other technicians simply record the average value on the data sheet without showing data from the individual checks. The Team found no evidence that the licensee had reviewed sensor calibration history data for identification of possible trends or failure mechanisms that could lead to reduced sensor reliability.

It appears conceivable that some combination of inconsistencies in the calibration process such as described above could result in setpoint miscalibration of several degrees. However, it seems doubtful that these factors could account for a decrease in the trip setpoint of over 35 °F (from 200 °F to below 165 °F), the difference needed to cause sensor actuations leading to the emergency diesel generator trips during the incident. The licensee requested a vendor representative to observe their sensor calibration process to determine if the calibrations had somehow contributed to the root cause for the trips. The emergency diesel generator 1A jacket water temperature sensors had all been calibrated within several weeks of the incident. The licensee indicated that the only recommendation made by the vendor was to transport the sensors in thermowells when moving them between the I&C shop and the diesel generators.
