Omaha Public Power District
1623 Harney Omaha, Nebraska 68102
402/536-4000

May 31, 1984
LIC-84-160

Steam Generator Tube Incident

VISUAL INSPECTION
AND LABORATORY ANALYSIS

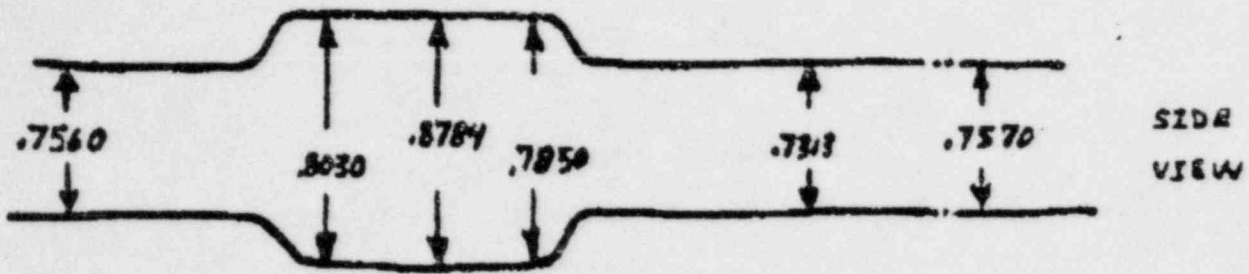
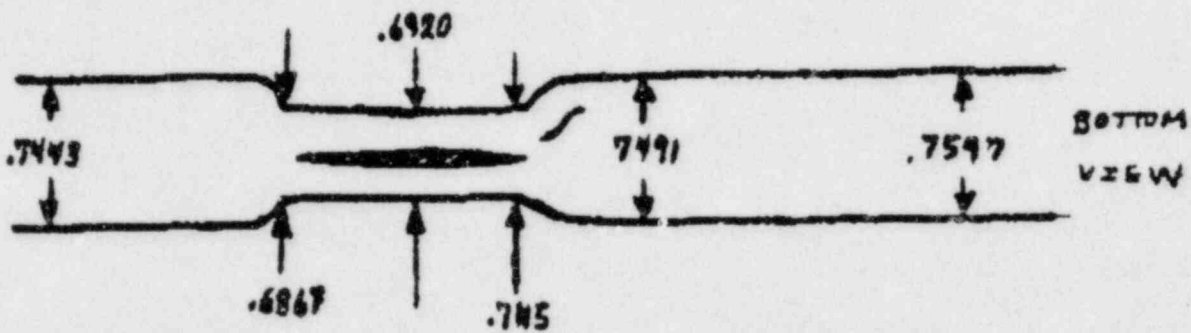
FIGURE 1. Dimensional Measurements

Figure 1 illustrates the dimensional measurements around the defect region. These measurements were taken before descaling and, as such, include the thickness of residual deposits. The measurement data indicate that the tube was ovalized. The major axis (6-12 o'clock) was elongated by 0.046-0.122 inch, while the minor axis (3-9 o'clock) was compressed by 0.045-0.070 inch diametrically.

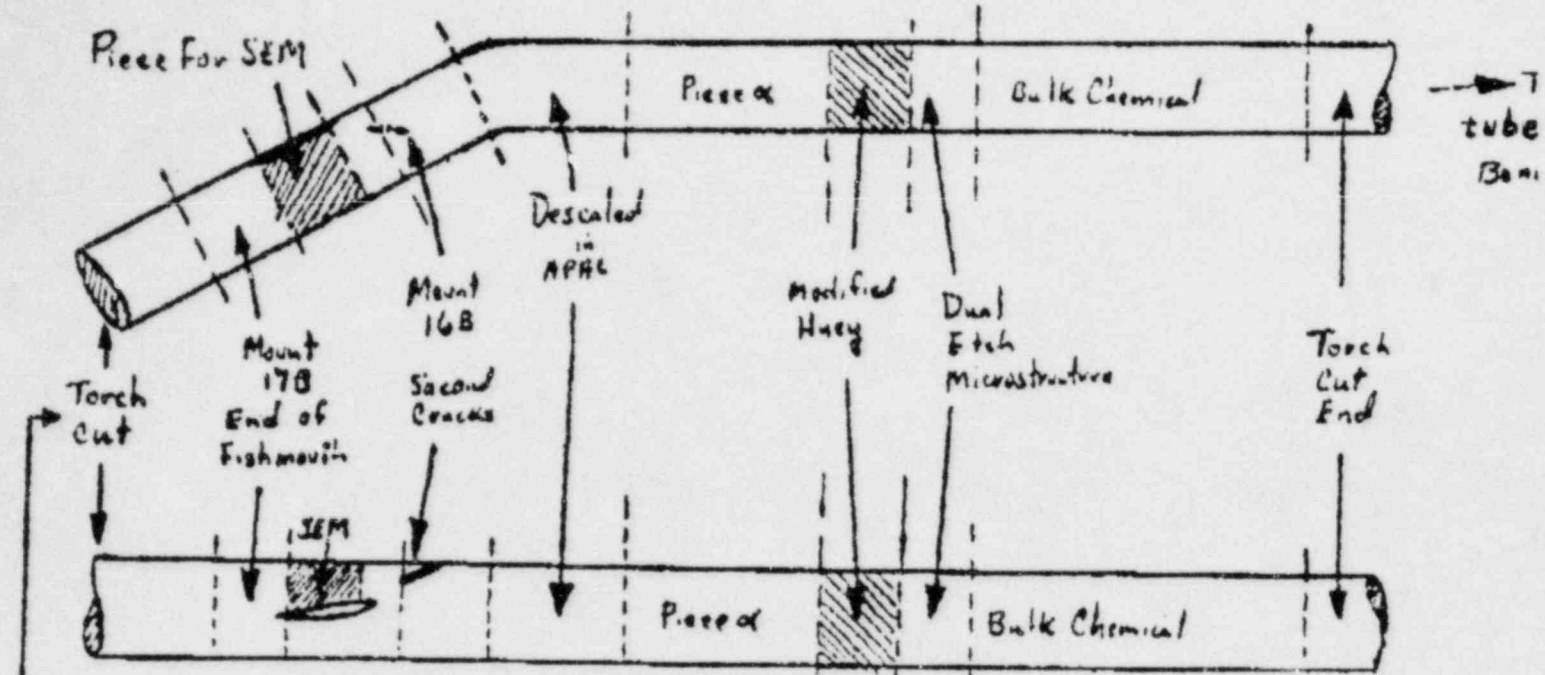
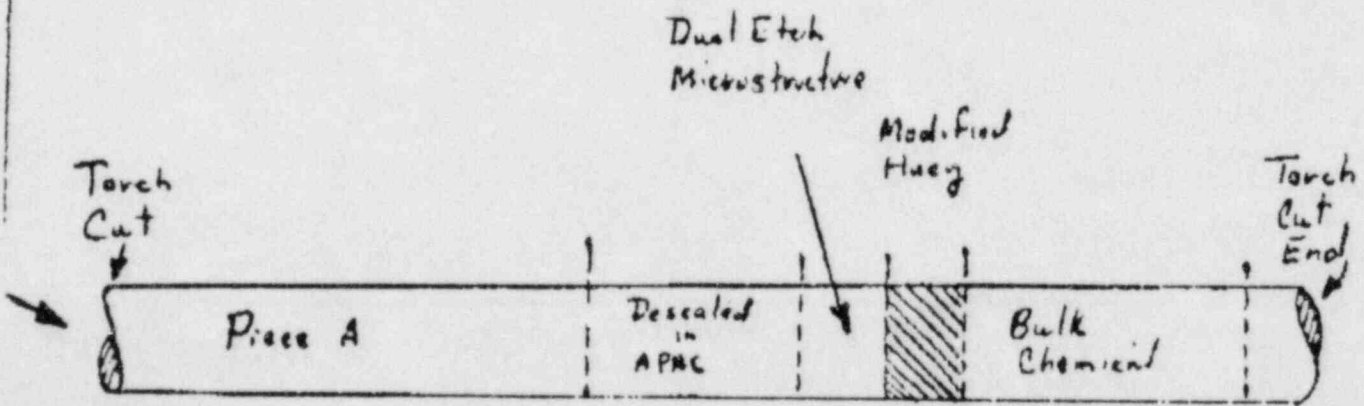
FIGURE 2. Sectioning Diagram

Cutting of the tube sections labeled 23B and 23C is shown in Figure 2, along with relative lengths and disposition of each piece.
