ATTACHMENT C  
PHILADELPHIA ELECTRIC COMPANY  
PEACH BOTTOM ATOMIC POWER STATION  
UNIT 3  
DOCKET NO. 50-278

SAFETY EVALUATION FOR THE  
OPERATION OF PEACH BOTTOM  
ATOMIC POWER STATION UNIT 3

SUBJECT: Safety Evaluation for the Operation of  
Peach Bottom Atomic Power Station Unit 3

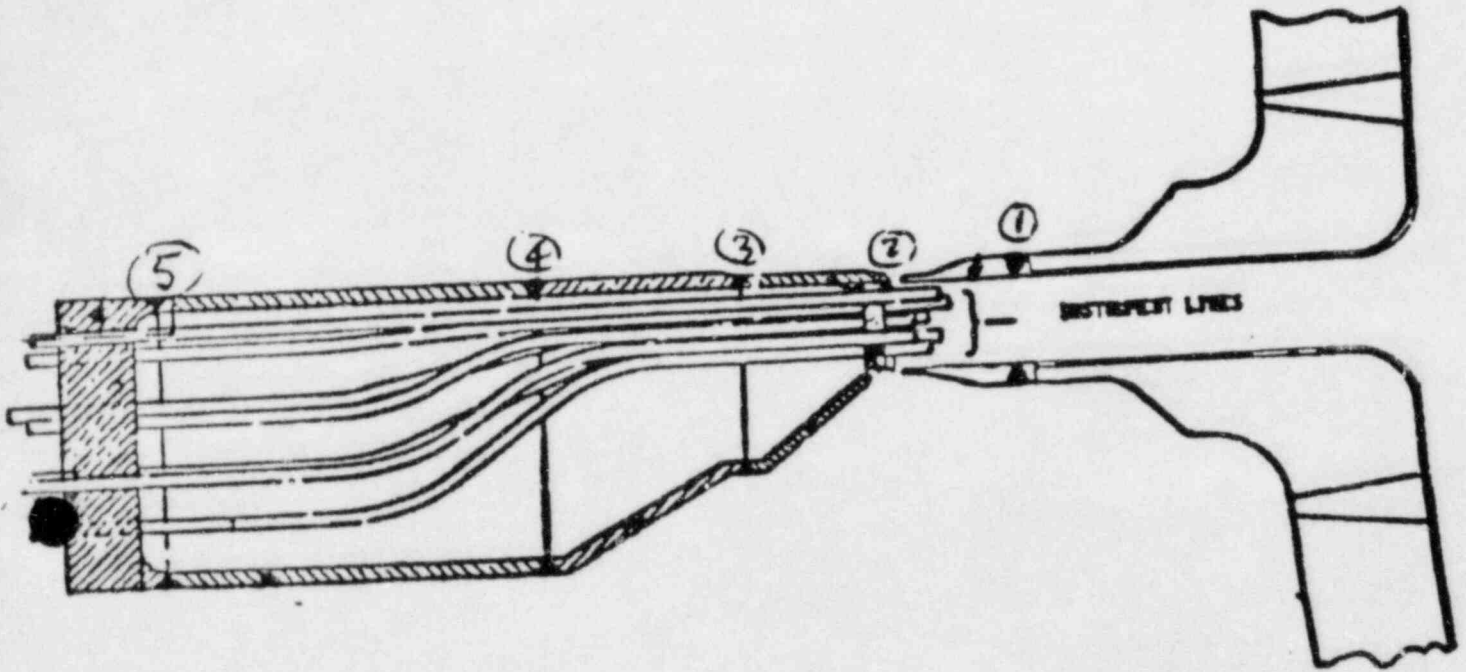
FIGURE 1

Philadelphia Electric Company performed inspections of the Peach Bottom Unit 3 jet pump instrumentation penetrations in response to I.E. Information Notice 84-41 and NRC Generic Letter 84-11. As part of this program, ultrasonic examinations were performed on the five welds associated with each jet pump instrumentation penetration. Circumferential crack-like indications were found on weld No. 2 on each of the two jet pump instrumentation penetrations (see Figure No. 1). In addition to the crack-like indications, the "B" loop No. 2 weld also showed three pin-hole leaks.

The "A" loop circumferential indication was in the 12 o'clock position on the safe-end side of the No. 2 weld. The "B" loop circumferential indication with three pin-hole leaks was in the 12 o'clock position on the reducer side of the No. 2 weld. The pipe material at both of these locations is 4" nominal, Schedule 80 TP-304 Stainless Steel. The minimal wall thickness of these welds is 0.337".

JET PUMP INSTRUMENTATION  
SEAL AND SAFE END

Overlay weld procedures were prepared to perform these temporary repairs with the concurrence of the on-site representative of the Hartford Steam Boiler Inspection and Insurance Company. Both welds received the weld overlays as recommended by General Electric Company. These overlays were made to provide additional structural reinforcement and prevent potential leakage.

General Electric Company recommended applying a 0.125" thick by 1.5" long overlay on each weld to assure leak-free operation for a minimum of 18 months of full power operation.
