Baltimore Gas and Electric Company
Calvert Cliffs Nuclear Power Plant
1650 Calvert Cliffs Parkway
Lusby, Maryland 20657
410 586-2200 Ext. 4455 Local
410 260-4455 Baltimore

September 11, 1995

SUBJECT: Calvert Cliffs Nuclear Power Plant
Unit No. 1; Docket No. 50-317
Supplemental Information; Request for Temporary Relief from ASME Boiler &
Pressure Vessel Code Section XI Requirement IAW-5250

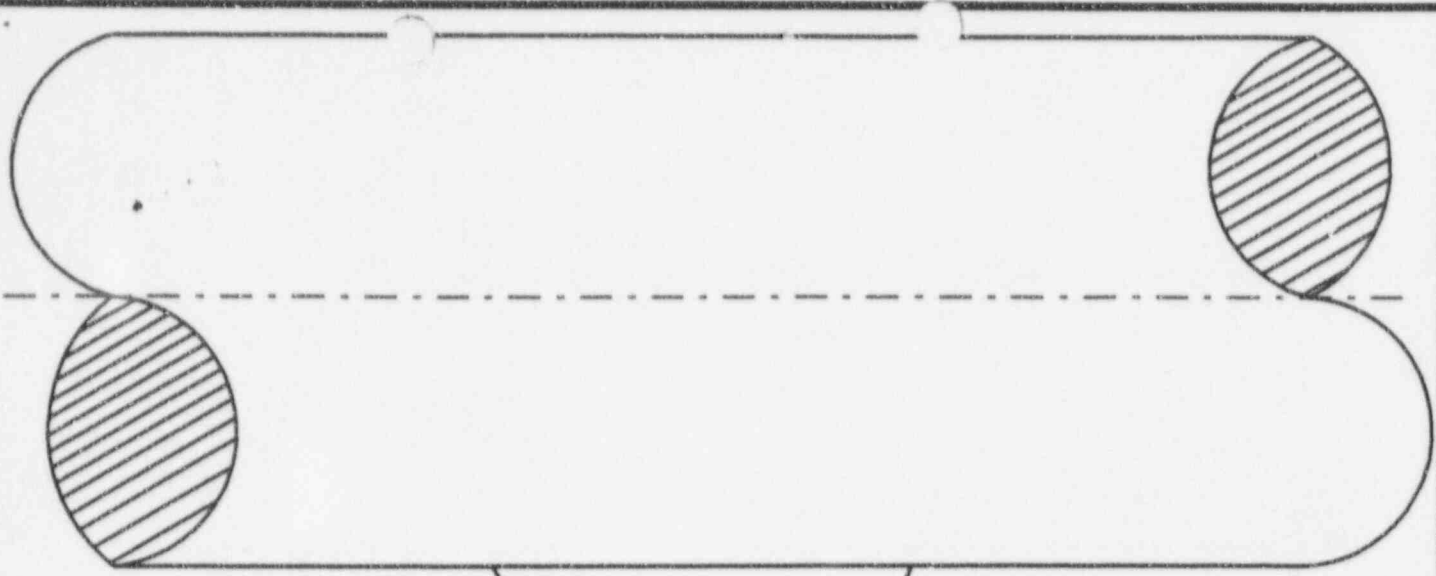
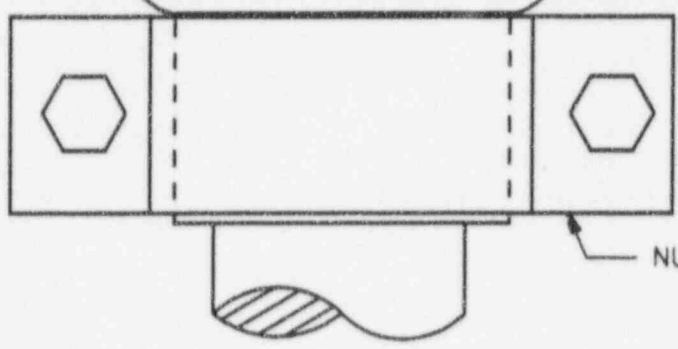
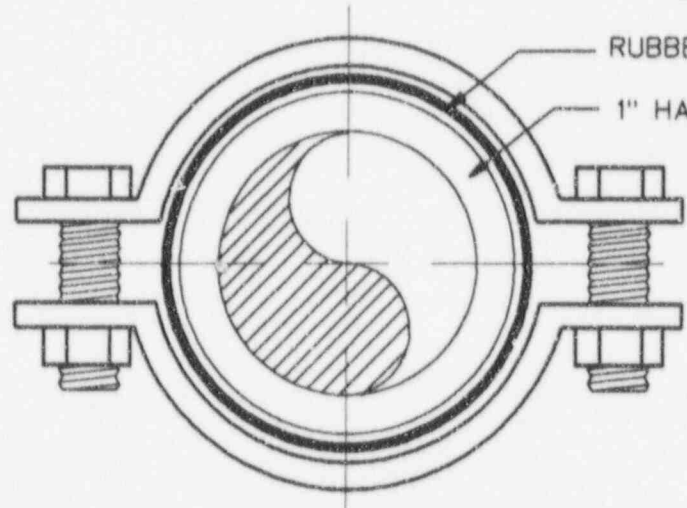
COUPLING THROUGH
WALL NON CODE REPAIR

A description of the leaking half-coupling was provided in Reference (a). The additional degradation was discovered by the team performing the follow-up ultrasonic examination of the saltwater pipe in the area of the half coupling. The half-coupling now has a visible through-wall hole at the location of the previous flaw. The flow of water from the hole has not changed substantially because as the flaw has continued to degrade, the resultant hole has become clogged with biological growth.

GRINNELL CLAMP FIGURE
NUMBER 212 OR EQUIVALENT
FOR 1/2" PIPE

RUBBER SLEEVE
1" HALF COUPLING

In order to prevent leakage into the service water room from the continued degradation of the half-coupling, we plan to install a rubber-lined pipe clamp around the flawed portion of the half-coupling (see Attachment 1) should the leakage significantly increase. The clamp will have no effect on the structural integrity of the 36" saltwater pipe, and is a reversible leakage limiting device.
