AUGMENTED INSPECTION TEAM REPORT

U.S. NUCLEAR REGULATORY COMMISSION

PERRY UNIT 1 CIRCULATING WATER PIPE BREAK

INSPECTION REPORT NO. 50-440/91026(DRS)

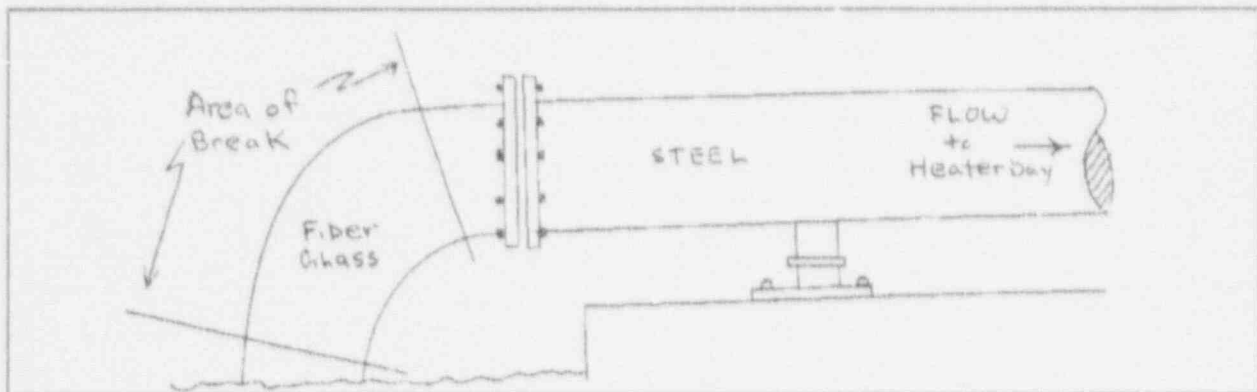
On December 22, 1991, at 1:50 am, a 36 inch fiberglass pipe carrying circulating water from the cooling towers to the auxiliary condenser broke at the point where the pipe exits the ground, makes a 90° bend, and transitions from fiberglass to steel. It was located outside the plant in the North plant yard approximately 20 feet from the turbine building heater bay. Water from the pipe break entered the plant via electrical conduit which originated in manholes in the transformer yard and caused some minor flooding (up to 6 inches) of areas inside the plant. The leak was subsequently stopped when operators secured the pumps to the broken line. Reactor operators manually scrammed the reactor from 100 % power at 2:00 am. An Alert was declared under the plant's emergency plan at 2:59 am due to ground water in the heater bay being above the 590 foot level. The plant was placed in cold shutdown and the Alert was terminated on December 22, 1991, at 11:04 am.

Auxiliary Circulating Water Pipe
