Northeast  
Nuclear Energy

Reference: Facility Operating License No. DPR-65  
Docket No. 50-336  
Licensee Event Report 94-040-02

# LICENSEE EVENT REPORT (LER)

TITLE (4)  
Ventilation Design Deficiency Affecting Enclosure Building Integrity

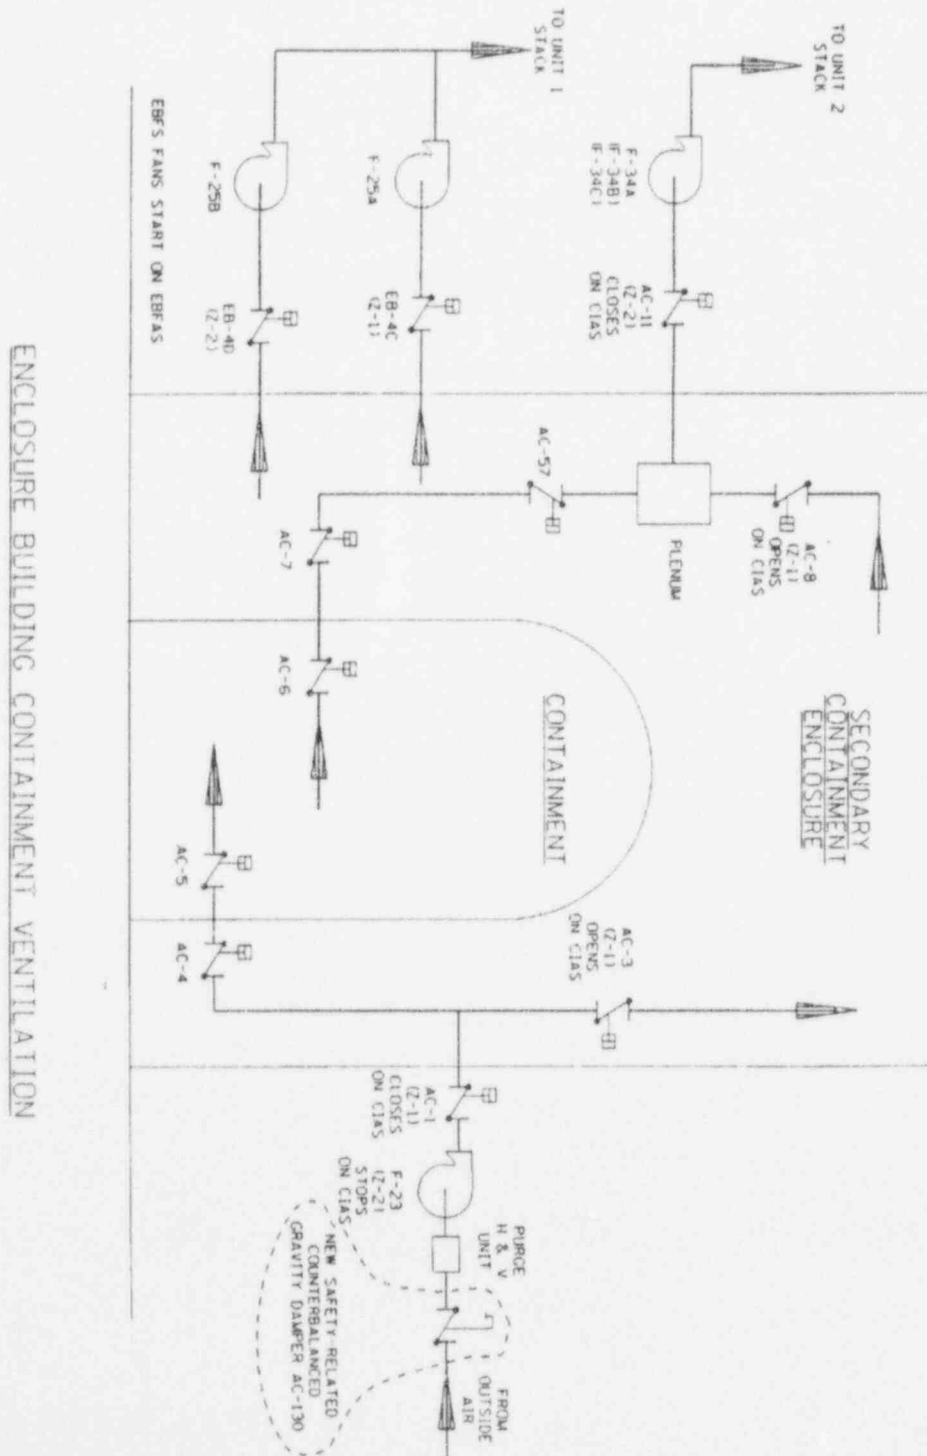
The first single failure problem scenario deals with AC-1. (Reference attached drawing for clarification). If the Enclosure Building is being purged, and a complete failure of facility 1 Engineered Safety Actuation System (ESAS) operation is postulated, then AC-1 will remain open and EBFS fan 'A' will not get a start signal. EBFS fan 'B' will attempt to draw down the Enclosure Building to the required negative of 0.25 w.g. and most likely would not achieve this requirement.

The second problem deals with AC-11. If the Enclosure Building is being purged and damper AC-11 fails to close (either facility 2 ESAS or mechanical damper failure), then fans 34A, B, and C (main exhaust fans) will have a direct suction on the Enclosure Building atmosphere (AC-8 is open for the purge) and will result in an unfiltered release which may exceed 10CFR100 limits for offsite dose - post LOCA.

The root cause of the Enclosure Building Purge deficiencies is the original design of the system. The Enclosure Building purge system was not originally designed for single failure, coincident with purging operations. The system does have isolation signals to individual components in the flow path.

Since postulating a single failure during purging operation is beyond the original licensing basis of the plant, no further corrective action is required. However, after the single failure vulnerability was identified by our engineering staff, it was decided to install a gravity damper in the supply duct to provide redundant isolation capability and preclude the potential for an unmonitored release path. This modification is currently scheduled to be completed in October 1995.
