DATA SHEET 1  
REACTOR TRIP REPORT

UNIT NO. 2

REPORT NO. Z-90-001  
 TRIP DATE 7-20-90  
 TRIP TIME 0820

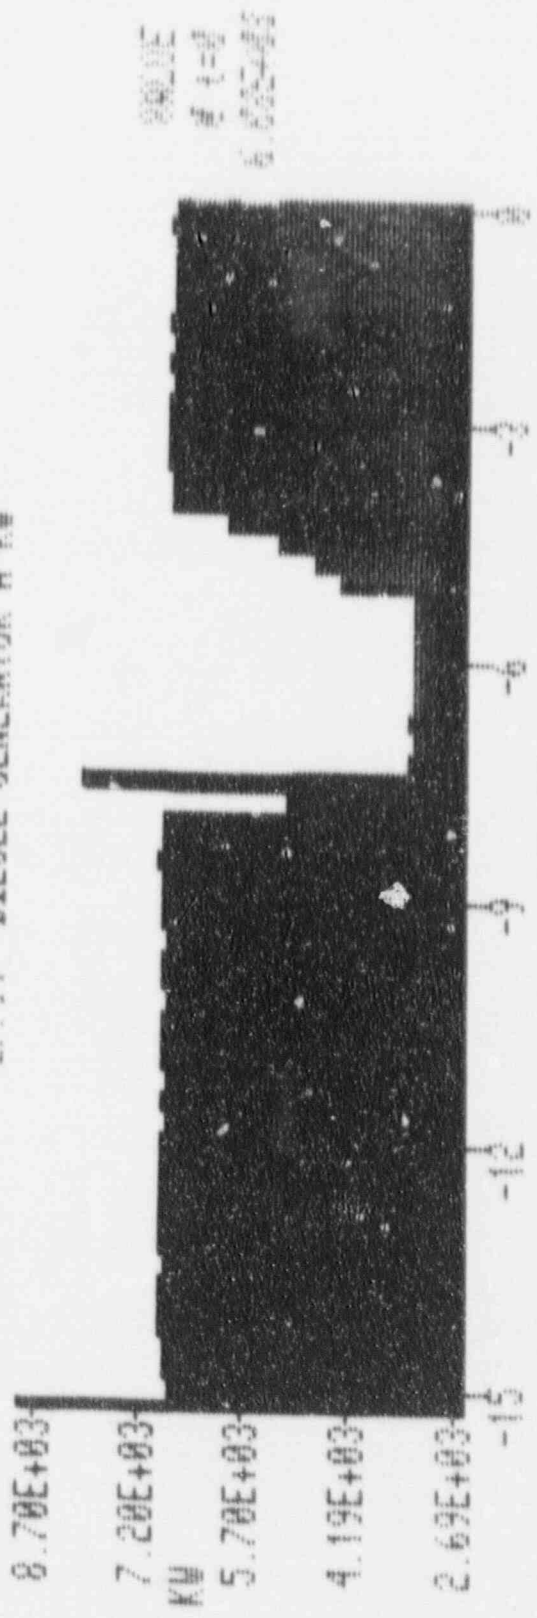
07791 DIESEL GENERATOR A KW

CARD # 1-90-0097		UNIT 1 (X) UNIT 2 ( ) COMMON ( )	
1: DESCRIPTION OF DEFICIENCY		(ADDITIONAL SHEETS ATTACHED? YES NO)	
While testing the sequences in S4S mode and the Diesel run, The Diesel changed from Parallel mode to Unit mode. This caused the diesel to load to 8 meg watt for 30 sec. The Control room operators reacted quickly and put the Diesel back into Parallel mode. The Functional test for the sequences was run the first time when the engine was NOT running. The Problem			
LOCATION OF THE DEFICIENCY? Sequencer/Diesel		was not seen close to the diesel	
WHAT IS AFFECTED BY THE DEFICIENCY? The Diesel		being in Unit mode	
load of 8 meg watt for 30 sec. did not damage the generators.			
HOW WAS THE DEFICIENCY DISCOVERED? Control Room Operator			
EVENT TIME 0257	DATE 3/13/90	DISCOVERY TIME 0257	DATE 3/13/90
DISCOVERED BY? Control Room/Da. Hines		WORK # 41564093	DEPT ENG Support

3: TECHNICAL SUPPORT REVIEW	
NSAC EVALUATION REVIEW (CHECK APPROPRIATE BOX) DATE RECEIVED: 3/14/90	
A	NOT A DEFICIENCY. SEND COPY TO RESPONSIBLE DEPT., CLOSE ORIGINAL
B	REPORTABLE DEFICIENCY. REPORT #
C	<input checked="" type="checkbox"/> DEFICIENCY, NOT REPORTABLE
EXPLANATION:	
Problem apparently occurred due to an inadequately prepared functional test (i.e. did not contain adequate precaution to not perform the test while the diesel was operating). Per the Engineering disposition in Block 4, no damage occurred to the diesel.	
RESPONSIBLE DEPT: Engineering Support	
NSAC REVIEWER: H. R. Smith	DATE: 3/14/90
NSAC SUPERVISOR: RMD	DATE: 3/14/90

4: DISPOSITION, FOR DEFICIENCIES IN ITEM 3C ABOVE ONLY.	
USE-AS-IS	
The Diesel Generator is designed to handle short duration overloads. One of the rating design points is 7.7 meg Watts for 2 hours. A load of 8 meg Watts for 30 seconds DOES NOT affect the operation of the Diesel Generator System.	
Do. Hines 2/17/90 Tom Miller 3/13/90	
CAUSE CODE: <sup>ILL 3/17/90</sup> ++ B4	EVENT CODE: IV (ATTACH SHEETS FROM 00058-C)
CAUSING DEPT(S): ENGINEERING SUPPORT	
DEPARTMENT MANAGER:	DATE:
