U.S. NUCLEAR REGULATORY COMMISSION

Report No. 50-461/91026(DRP)

Facility Name: Clinton Power Station

Inspection Conducted: December 31, 1991 - February 3, 1992

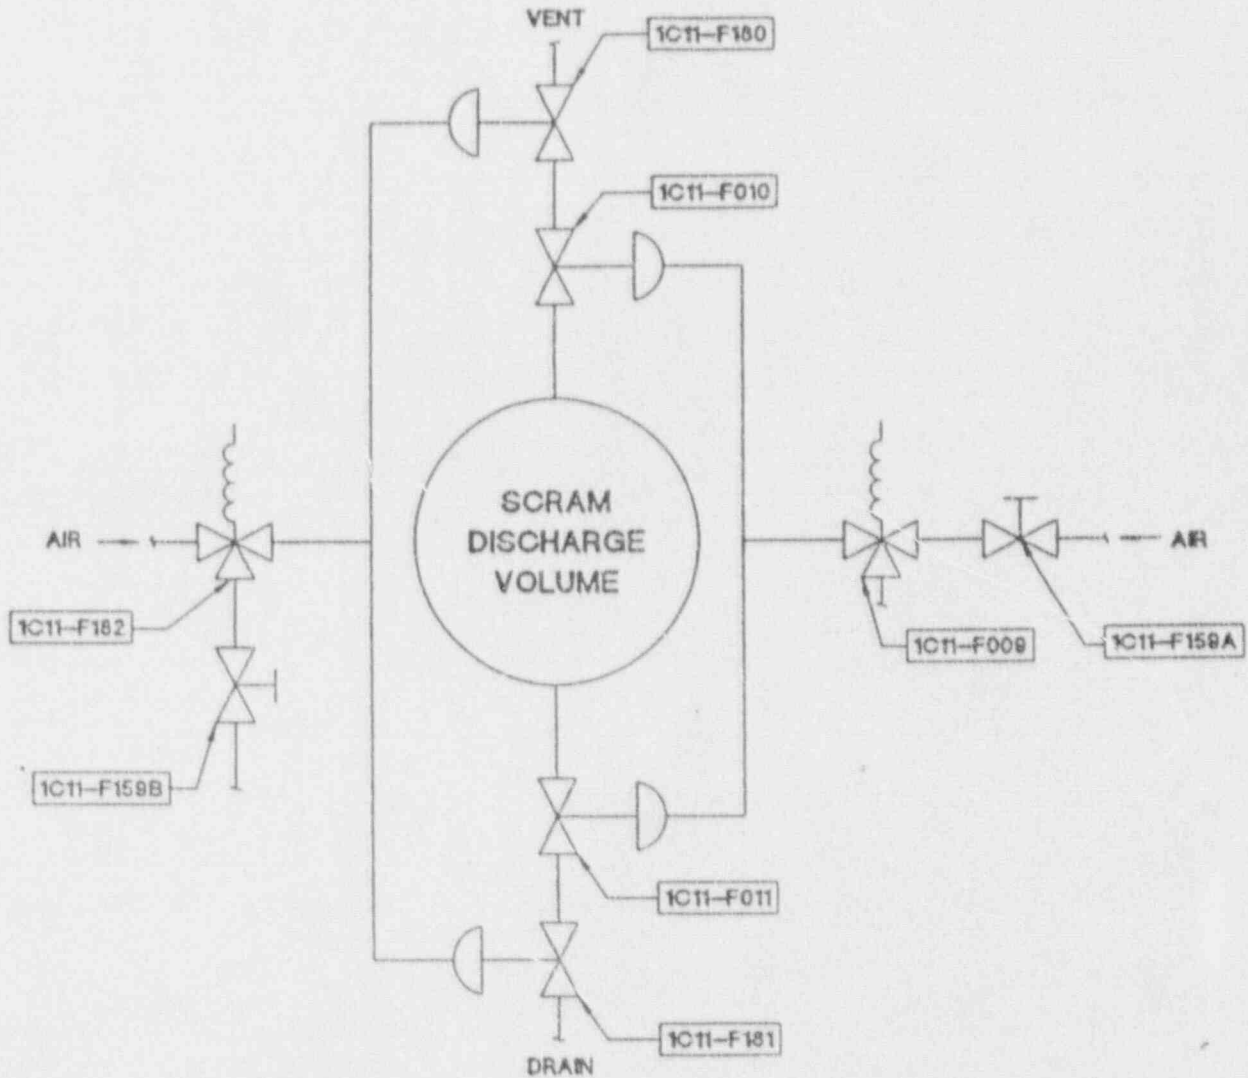
Figure 1

Following the scram on January 4, 1992, reactor operators noted that valves 1C11-F010 and 1C11-F011 (see figure 1) did not automatically open when the scram was reset. Valve 1C11-F010 was found open, but the valve position indication open limit switch was not made up. When the limit switch was tapped, it repositioned. Valve 1C11-F011 was found closed. Valve 1C11-F011 was manually opened to drain the SDV. The scram was subsequently reset.

- The 1C11-F009 and 1C11-F182 valves were leaking air. A small piece of foreign matter (believed to be solder) was found between the back seat and the disk of valve 1C11-F009;
- The actuation pressure of valve 1C11-F010 was found set too low, at 6 to 30 psi (i.e., lift off seat at 6 psi and fully back seated at 30 psi), rather than 18.5 to 60 psi;
- The actuating pressure for valve 1C11-F011 was found set at 20 to 62 psi;
- Valve 1C11-F180 was found to have a bent stem and galling was observed on the disk and stem. The actuating pressure was found set at 8 to 25 psi, rather than 3 to 15 psi; and

- Valve 1C11-F159A was found throttled closed further than required. The method of locking the valve was ineffective because the valve hand wheel could be moved with the locking device in place.

The failure of valves F010 and F011 to open at the same time was caused by the combination of air leaking by the back seat of valve F009, the lower set pressure of valve F010, and the reduction in air flow from valve F159A. As little as 1/8 of a turn significantly affected the amount of air valve F159A passed. These factors allowed valve F010 to open while valve F011 remained closed.

During normal system operation, valves F010 and F011 close first and open second. Valves F180 and F181 close second and open first. Valves F159A and F159B were adjusted to control the timing between these valves.

Corrective actions taken included: rebuilding valves F009, F180, and F182; resetting the actuating pressure of valves F010 and F011; developing a new means of locking valves F159A and F159B and providing positive indication of these needle valve's position; and revising the quarterly procedure to record the opening and closing times, to detect degradation. Based on these corrective actions, the inspectors have no further concerns on this issue.
