AFFIDAVIT

I, Charles C. Stokes, am providing this statement of my own volition in response to various Pacific Gas and Electric (PG&E) submittals to the NRC. This is intended to follow up on issues which I have raised in prior statements to the Commission and which I feel must still be addressed in detail by PG&E Diablo Project management before Unit 1 is allowed to go beyond 5% power. In some cases my comments suggest necessary methodological steps to obtain adequate correction action on my allegations, largely confirmed by Mr. Yin. In other cases, my comments expose false or misleading statements by PG&E in their response to Mr. Yin's inspection report.

In response to PG&E letters on the subject of **Tube Steel Radius and Flare-Bevel Welds** as addressed in the April 7, 1984 and April 11, 1984 to the members of the Appeal Board, and PG&E letter No.: DCL-84-083, DCL-84-164, DCL-84-166, and DCL-84-190.

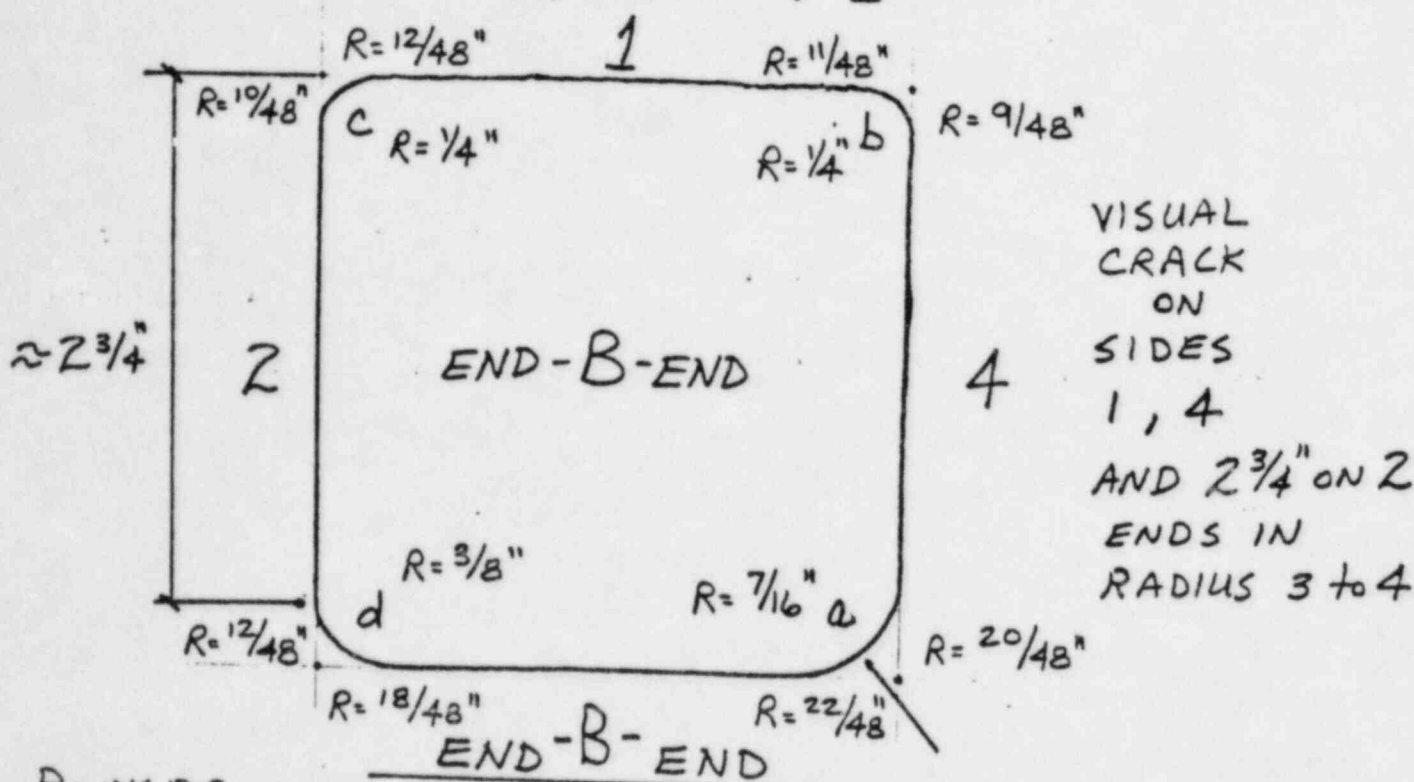
ATTACHMENT 1

This tubing (Attachment 1 sketches) not only has a corner radius less than 2t but has only one (1) corner which is 2t. Three corners are less than 2t, of which two (2) are only 1t as I and others have confirmed. It measures 1t using the Straight Ruler Method (per PG&E) and using the Concave Radius Gage Method. An additional flaw exists, which before seeing this piece, not even I was aware of. The tube wall has what appears to me to be a lamination crack running all the way around its' perimeter. This lamination crack is almost exactly at the center line of the tube wall.

VISUAL
CRACK
ON
SIDES
1, 4
AND 2 3/4" ON 2
ENDS IN
RADIUS 3 to 4

R-INSIDE MEASURED
W/FILLET GAUGES

I can't provide PG&E or the NRC with an easy way to resolve the lamination problem. There is one question that should be addressed before any other. Should this defective steel be allowed to remain in the plant, or should a through search be made and all defective materials be removed from the plant? To accept this condition "as is" without compromising public safety, several questions must be satisfactorily addressed. First, Welding-What joint configuration, effective throat, or wall thickness will govern the failure mode which is the most critical? Second, member stresses-What section properly will be used in the analysis of member stresses? Third, how will confidence be established that this is the only defective material in the plant?

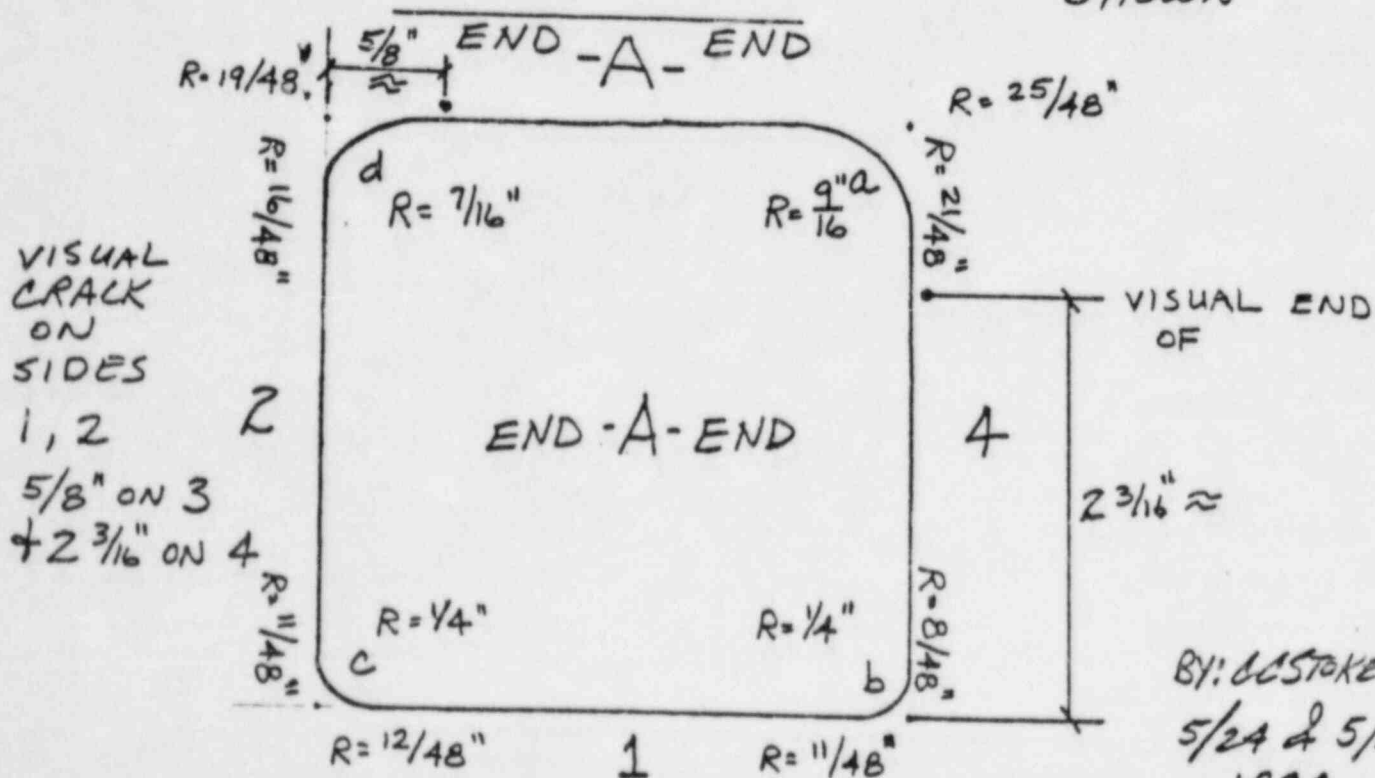
VISUAL
CRACK
ON
SIDES
1, 2

5/8" ON 3
+ 2 3/16" ON 4
