GULF STATES UTILITIES COMPANY

River Bend Station - Unit 1
Docket No. 50-458

Please find enclosed an Informational Report concerning cracks discovered in welds in the hydraulic control unit piping at River Bend Station - Unit 1. This report is submitted to inform the NRC of these conditions and document GSU's investigation and corrective actions.

INTRODUCTION

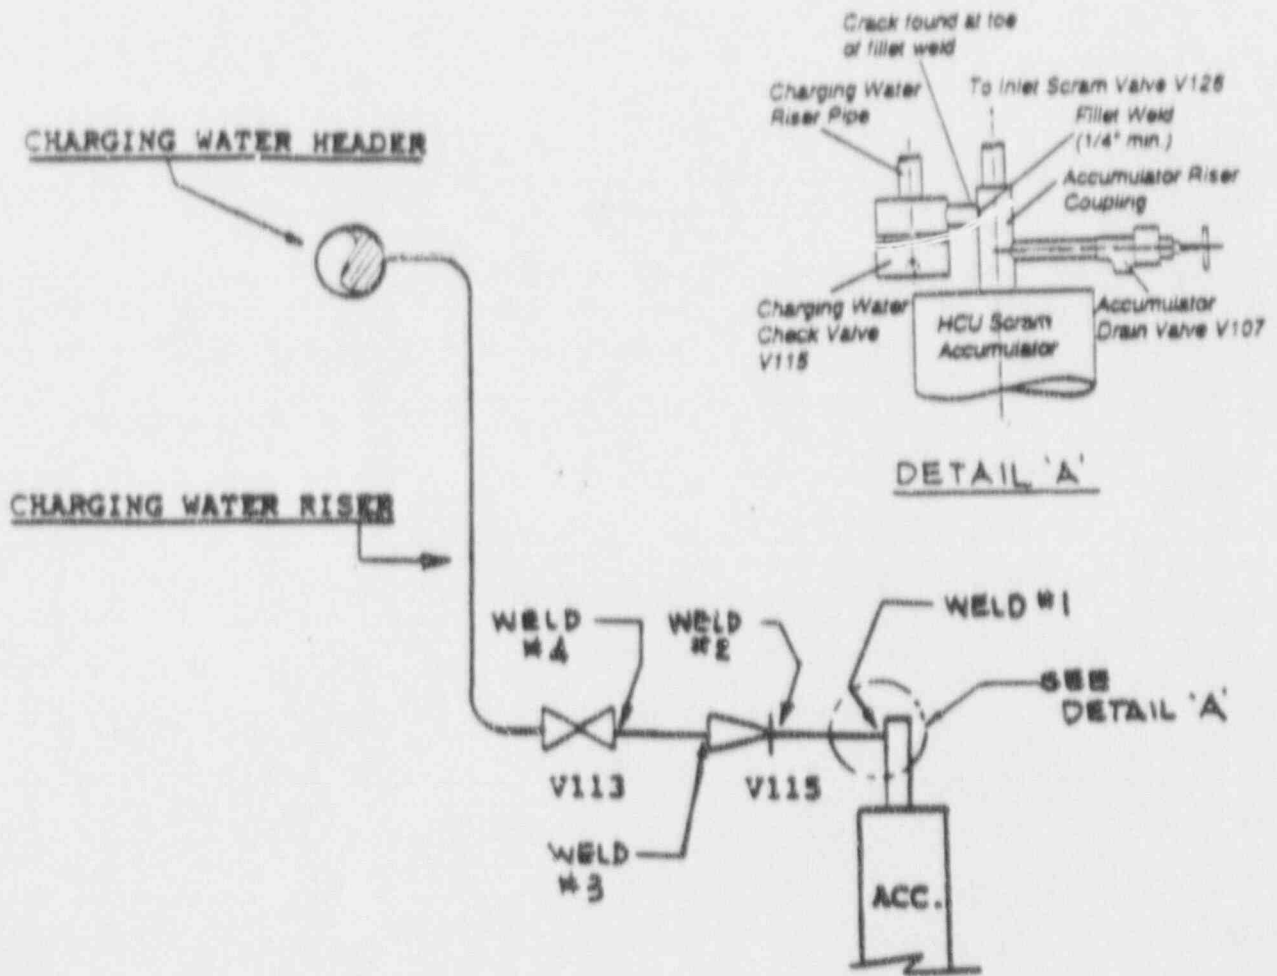
FIGURE 1

On February 28, 1991 hydraulic control unit No.36-21 was found leaking. After closer examination of the HCU, it was noted that the water was spraying out from a circumferential crack in a short, horizontal segment of charging water piping between the accumulator pipe coupling and the charging water check valve, near the toe of the weld (see Figure 1, weld #1). This was documented on condition report (CR) 91-0074. The plant was not operating at the time of discovery.

The leaking pipe was replaced and liquid penetrant test (PT) examinations were performed on the remainder of the HCUs (144 units) at the location of the leak (weld #1, Figure #1). Sixteen additional linear indications were discovered and reworked; none were leaking (See Table #1).

A metallurgical evaluation was performed on the cracked pipe nipple. The study concluded that the failure mechanism was most likely due to low cycle fatigue at the toe of the weld. General Electric issued Rapid Information Communication Services Information Letter (RICSIL) No.056 to document the problem.

Tests to collect piping and structural vibration data were conducted during the reactor shutdown scram and the mid-cycle 4 (MDCY4) outage that followed. Through analysis of this data it has been determined that the cracking is due to piping vibrations caused by a hydraulic transient phenomenon of unknown source in the system. It has also been determined that the vibrations emanate from the charging water header down into the vicinity of the cracking, rather than up from the scram water accumulator. The investigations are continuing.

2. As described below, PT examinations were conducted on the next three welds upstream of weld #1 prior to restart from the MDCY4 outage (see Figure 1). Note that these welds were determined to be susceptible to cracking from review of available pipe stress analyses. All (100%) of the weld #2 and #3 locations were inspected and a selected sample of the weld #4 locations were inspected (only when an indication was found in either of the corresponding weld #2 or #3 locations). All indications were reworked accordingly and no indications were found in any of the inspected welds at location #4. Table 2 summarizes the results of these inspections.

Cracking of the HCUs at RBS is determined to be caused from low cycle fatigue due to a fluid transient of unknown origin which occurs during full core reactor scrams from power. Cracking typically occurs in the first two or three welds on the charging water line off the accumulators on the HCU skid. This is not a safety issue because automatic or manual scram can be achieved during normal operation without accumulator pressure by using reactor pressure. Moreover, during startup, the ability to scram is assured by the commitment at RBS to rework or replace all known indications in charging water pipe welds prior to plant startups.

Typical HCU Charging Water Piping Arrangement

1. PT examinations of the welds at location #1 have been and will continue to be performed following every full core plant scram from power for 100% of the HCUs. All indications documented during these inspections shall be reworked/replaced prior to restart of the plant from each scram.

4. The fracture mechanics analysis performed by General Electric demonstrates that at least 4 additional full core scrams from power can be tolerated without the development of a through wall crack even when a crack of 0.5" long x 0.0825" deep is assumed to exist (pipe wall thickness is 0.147"). Since the HCUs are subject to general visual inspections on a daily basis by Operations personnel, it is likely that leaks would be discovered and isolated before the pipe had the opportunity to break. Therefore, pipe break can be eliminated as a potential consequence. This conclusion is further strengthened by GSU's commitment to rework/replace all welds with known indications prior to restart of the plant from future scrams.
