UNITED STATES
NUCLEAR REGULATORY COMMISSION
WASHINGTON, D. C. 20555

SAFETY EVALUATION BY THE OFFICE OF NUCLEAR REACTOR REGULATION
RELATING TO THE RESTART OF THE
FORT CALHOUN STATION, UNIT NO. 1
FACILITY OPERATING LICENSE NO. DPR-40
OMAHA PUBLIC POWER DISTRICT
DOCKET NO. 50-285

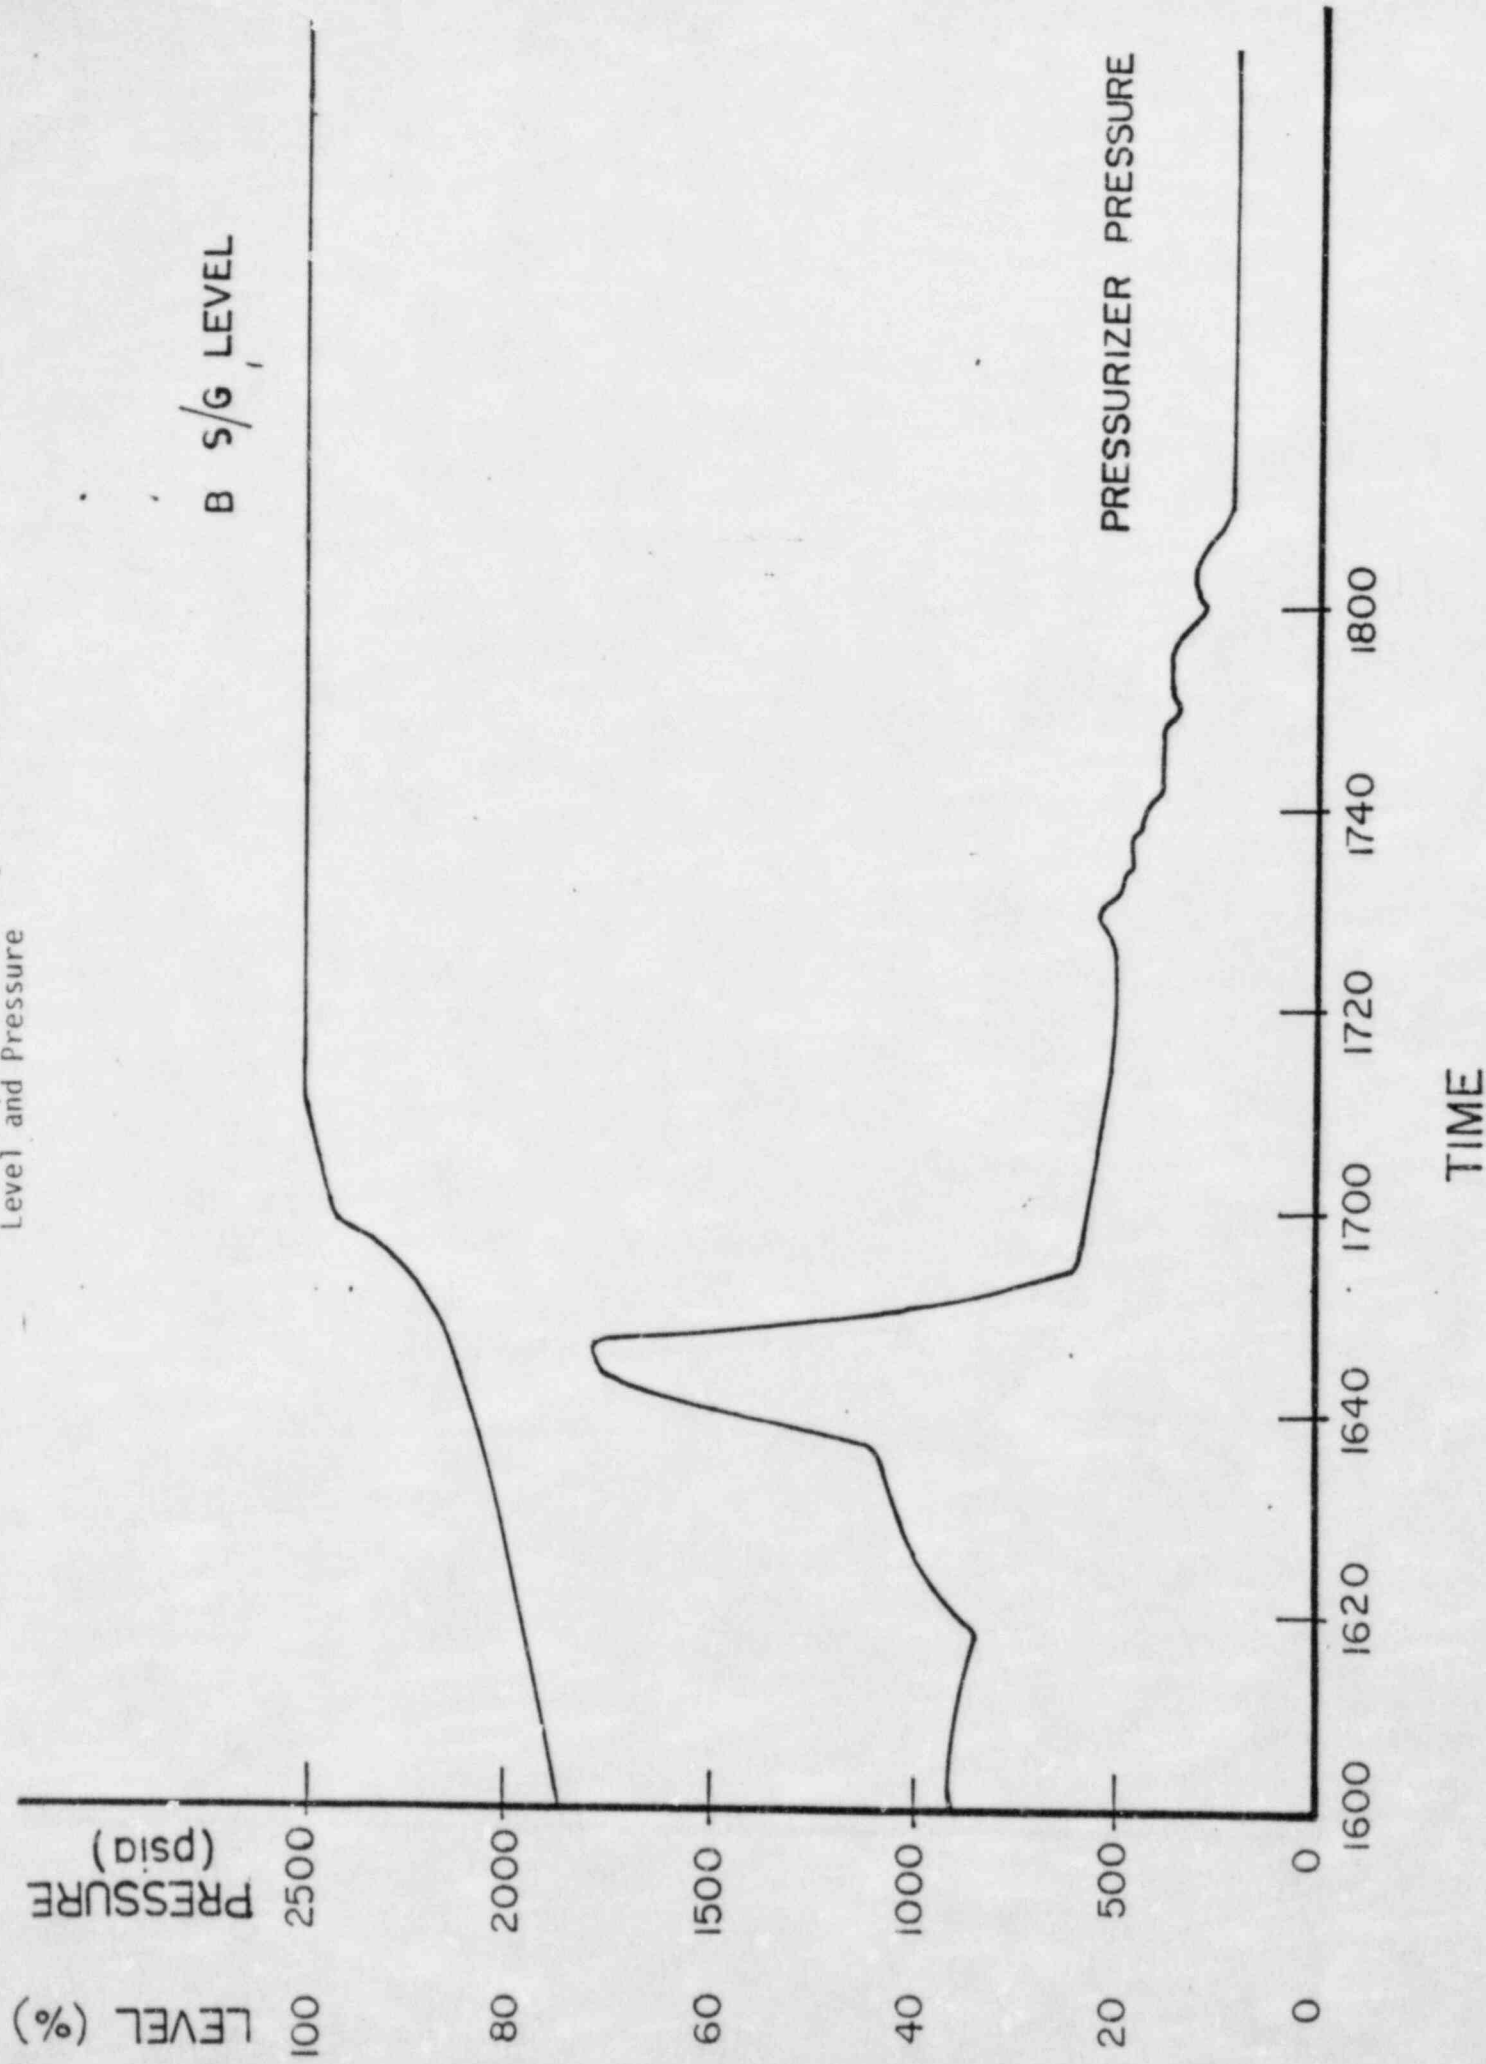
Figure 1: Time Sequence Relating to Steam Generator Level and Pressure

The reactor coolant system was depressurized in a few minutes; it was cooled down in a few hours using the A steam generator and the atmosphere steam dump valve. Figure 1 illustrates the reactor coolant system pressure and the B steam generator water level as a function of time during the event. Table 1 contains a more detailed time history of the event, including initial conditions.
