Hope Creek Generating Station

HOPE CREEK GENERATING STATION
DOCKET NO. 50-354
UNIT NO. 1
LICENSEE EVENT REPORT 92-001

TITLE (4): Engineered Safety Feature Activation - Trip of Reactor Protection System Electrical Protection Assembly resulted in half scram and initiation of A & C Channels of Nuclear Steam Supply Shutoff System due to personnel error.

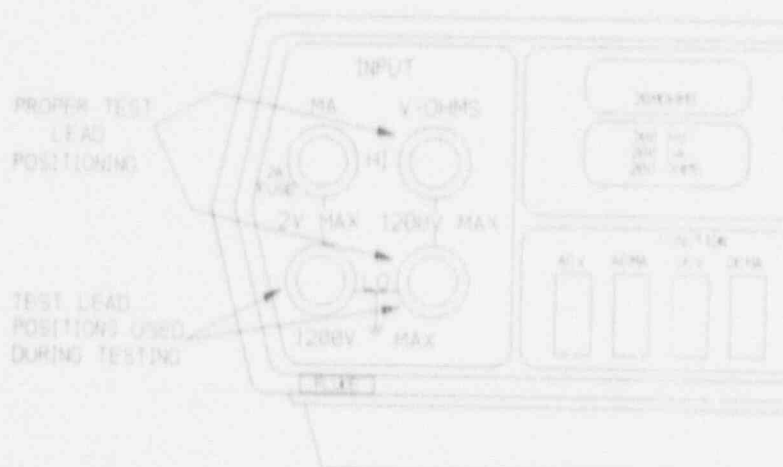
Technicians had been scheduled to collect voltage output readings of the RPS MG sets IAW the performance trending program. The data acquisition is performed quarterly IAW an approved functional test which designates specific locations for data acquisition. The technicians performing the test obtained a meter (Fluke model 8600A) from the calibration room and set it up for the test verifying that the Fluke was on the proper range and function setting for the required readings. When the leads of the meter arced the Technicians suspected that the meter was faulty and immediately sent it to the calibration lab to determine the cause of the failure. The calibration lab could not determine the cause of the failure and in turn forwarded the Fluke to the vendor for root cause determination. A report from Fluke determined that the meter failed due to a short circuit created by the test leads being plugged into the wrong terminals of the meter. The incorrect lead placement resulted in a short circuit path through the meter.

The direct cause of this event was concluded to be personnel error on the part of the technicians who set up and used the meter without adequate self checking. The leads were installed by one of the technicians before the second technician used the meter to obtain the voltage readings. Failure to correctly place the leads in the meter by the first technician and failure to verify proper lead placement by the second technician prior to its use are considered to be the primary causes of this event.

1. The technicians involved in this test have been counseled on the need for self checking and attention to detail when performing routine activities during testing.
2. This incident will be reviewed with all technicians to reinforce the importance of proper self check procedures when performing routine tasks.
3. A Performance Enhancement Panel will review this event with the technicians involved to determine adequacy of corrective actions.
