NORTHEAST UTILITIES

Docket No. 50-423
Re: 10CFR50.36
February 18, 1992
MP-92-179

Millstone Nuclear Power Station, Unit No. 3 Steam Generator Tube Inservice Inspection Report

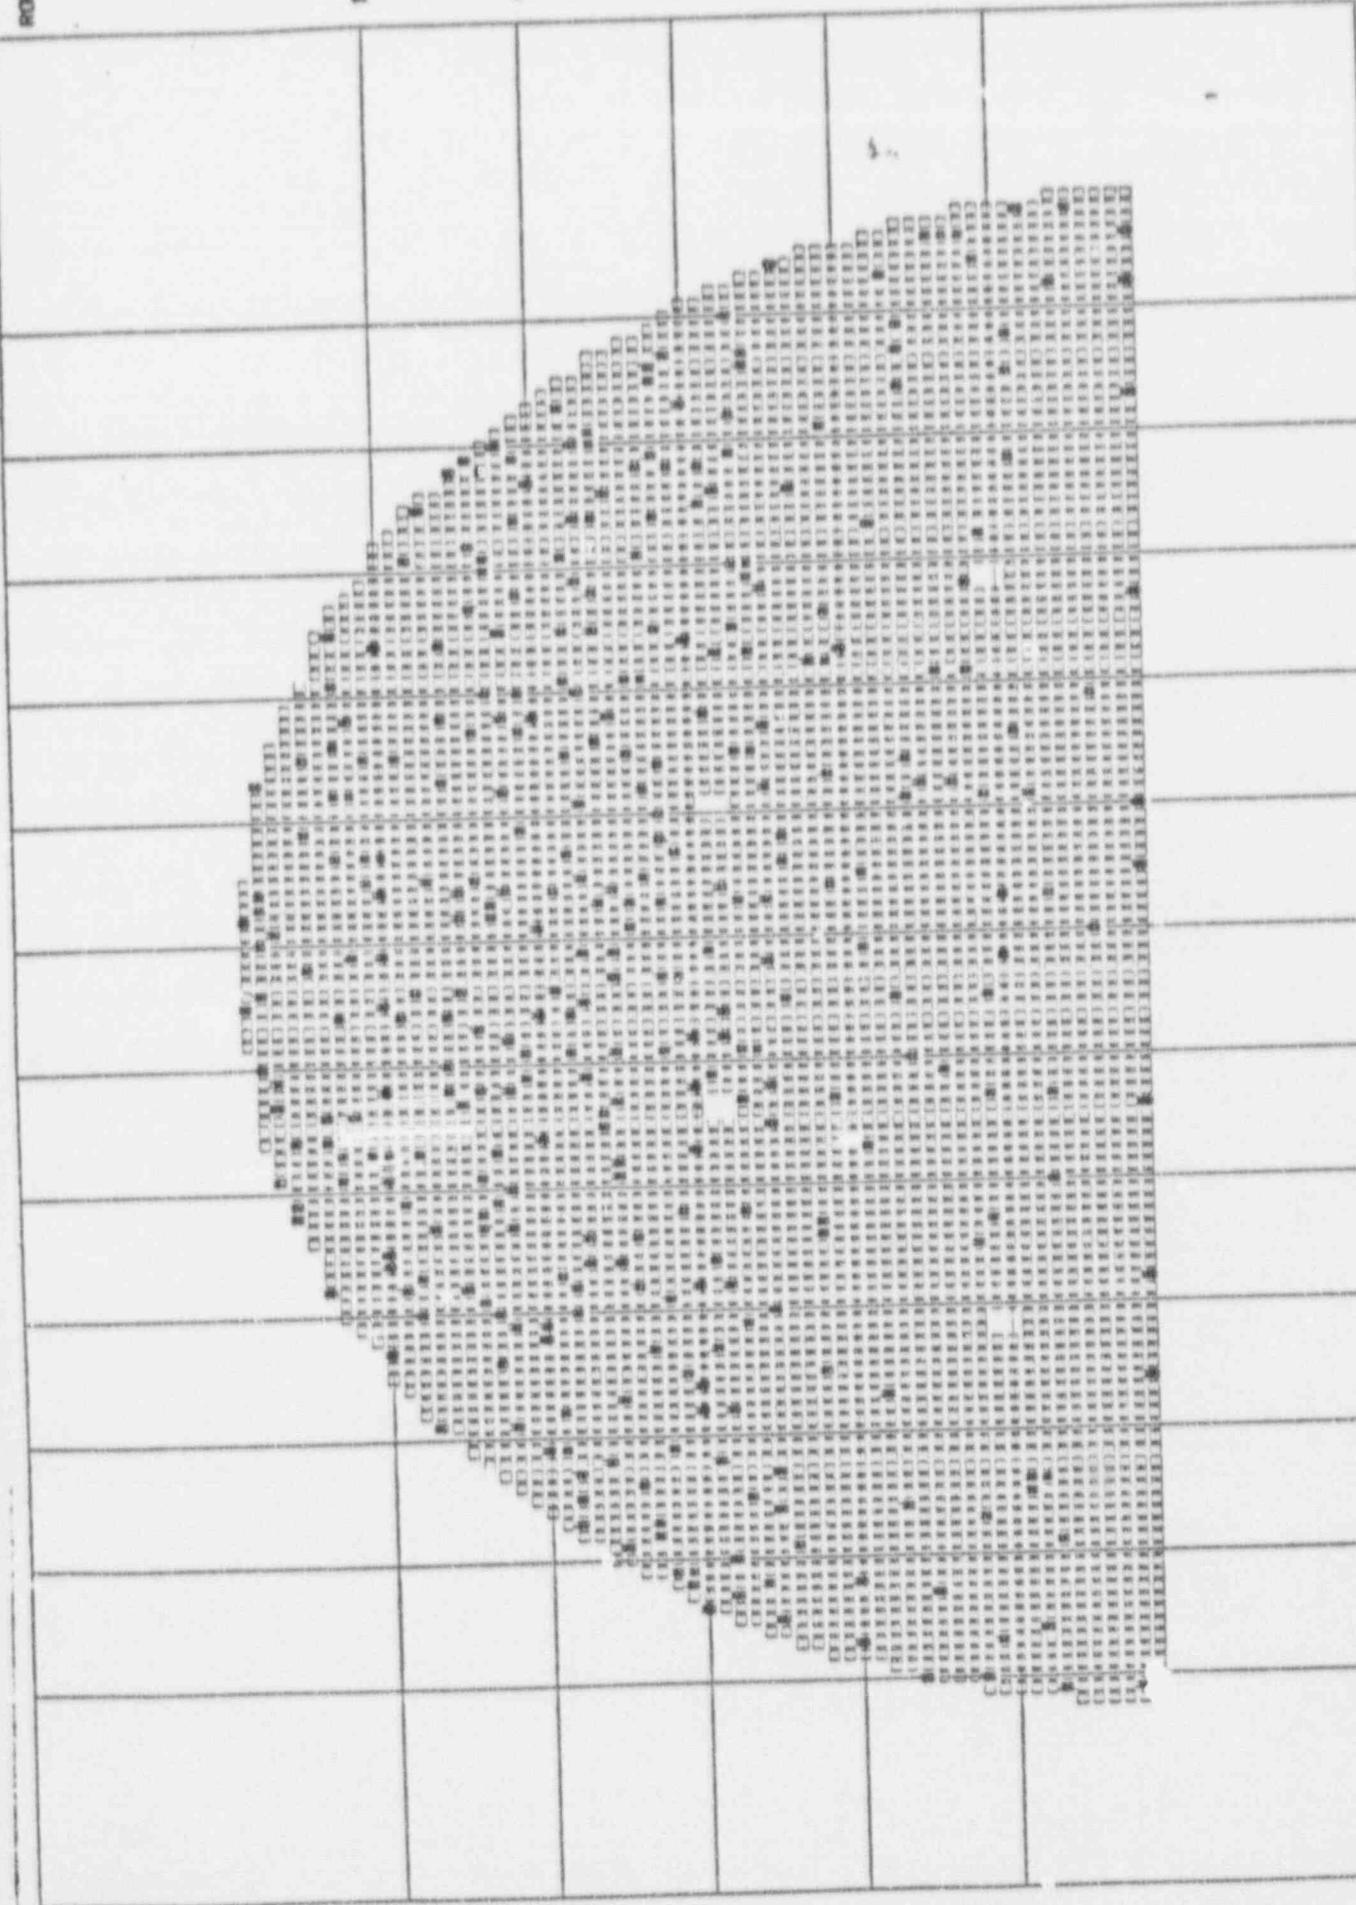
FIGURE 1 -- Technical
Specification Sample

The End of Cycle 3 SG tube inspection was completed on February 21, 1991. In accordance with Technical Specification 4.4.5.2, an initial sample of steam generator tubes (shown on Figures 1 and 2) was selected and inspected. The results of this sample classified the steam generators in the C-1 category (Less than 5% of the total tubes inspected are degraded tubes and none of the inspected tubes are defective). An additional sample of 6392 tubes was inspected. Included within this sample was 100 percent Eddy Current Testing of all the tubes associated with the anti-vibration bar (AVB) wear regions in both the "B" and "D" steam generators. The intent of this augmented sample was to ensure the Unit 3 Eddy Current Program detects and monitors steam generator tube wall degradation and damage precursors. The complete results of the inspections are provided in Tables 1 through 3.

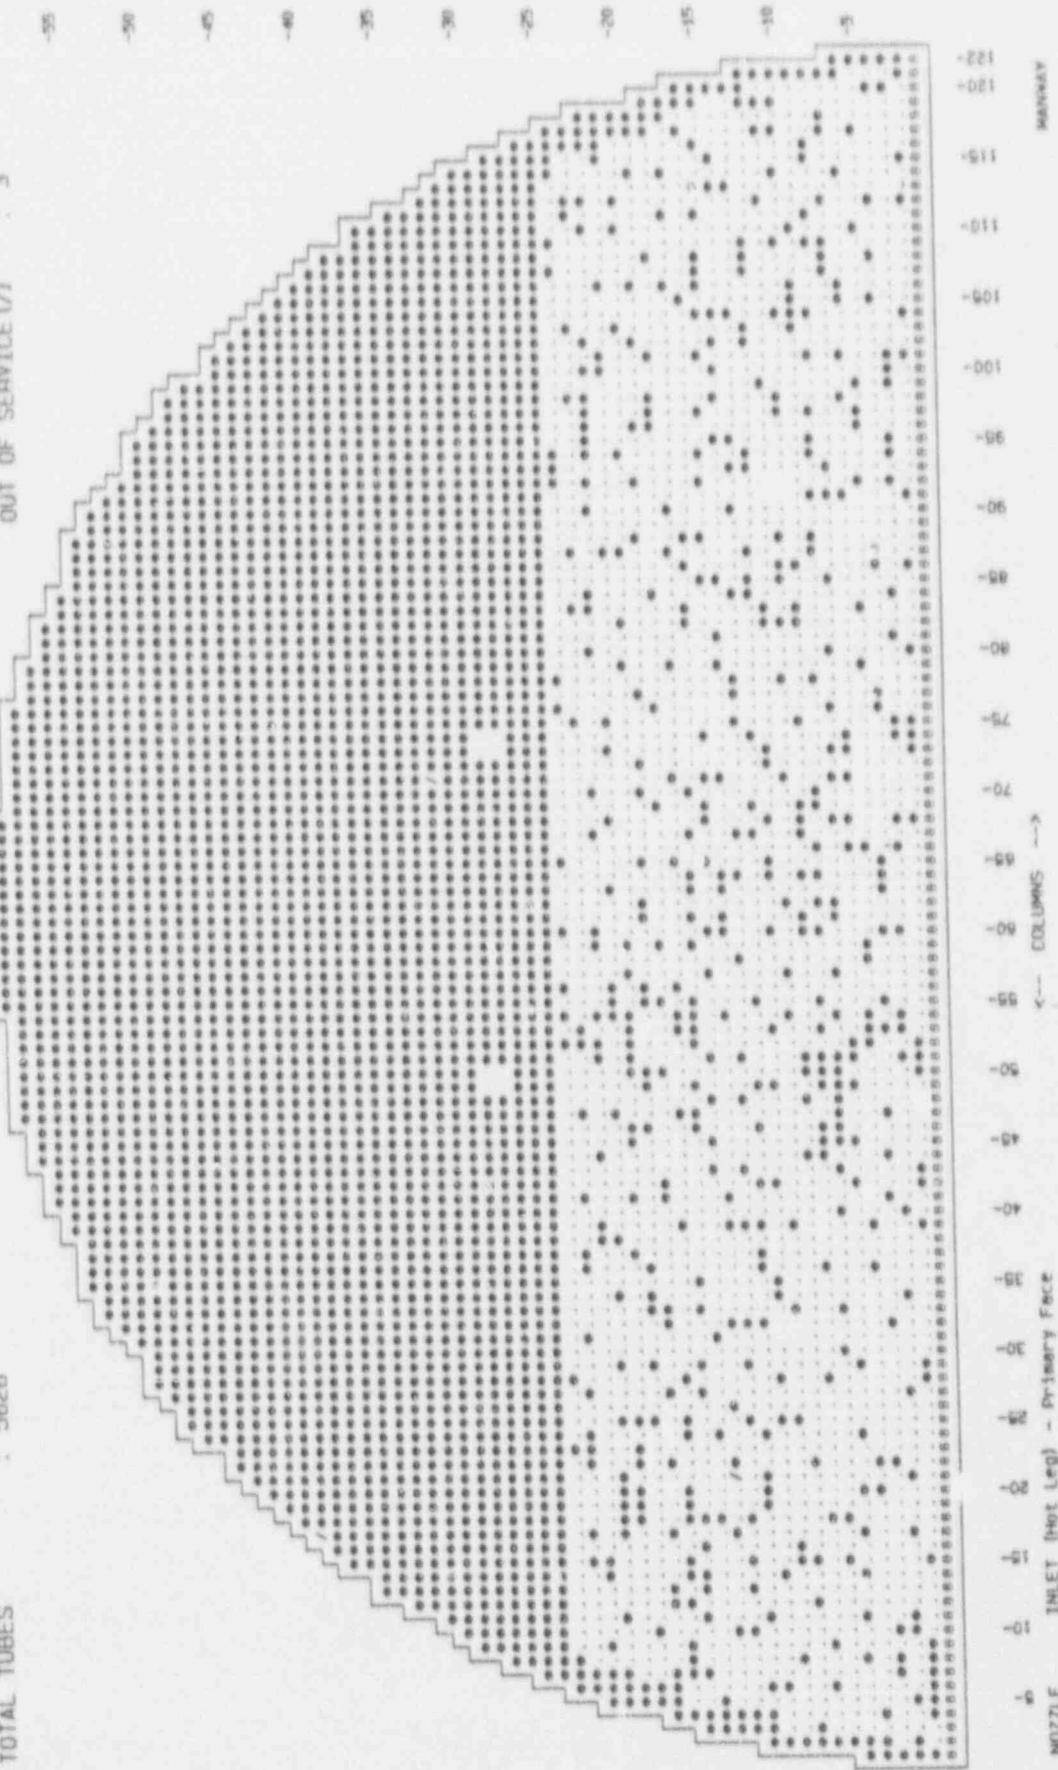
Figure 1

The complete inspection totaled 7101 bobbin probe tests (31% of the tubes in all 4 SGs) including 3555 tubes in steam generator "B" (63.2% of the tubes in "B", shown on Figure 3) and 3546 tubes in "D" (63% of the tubes in "D", shown on Figure 5). All tubes except row 1 were run full length, tube end to tube end. The row one tubes were run from the hot leg tube end to the eighth tube support plate on the cold leg. The following are the summary results of the Eddy Current Inspections for each steam generator:

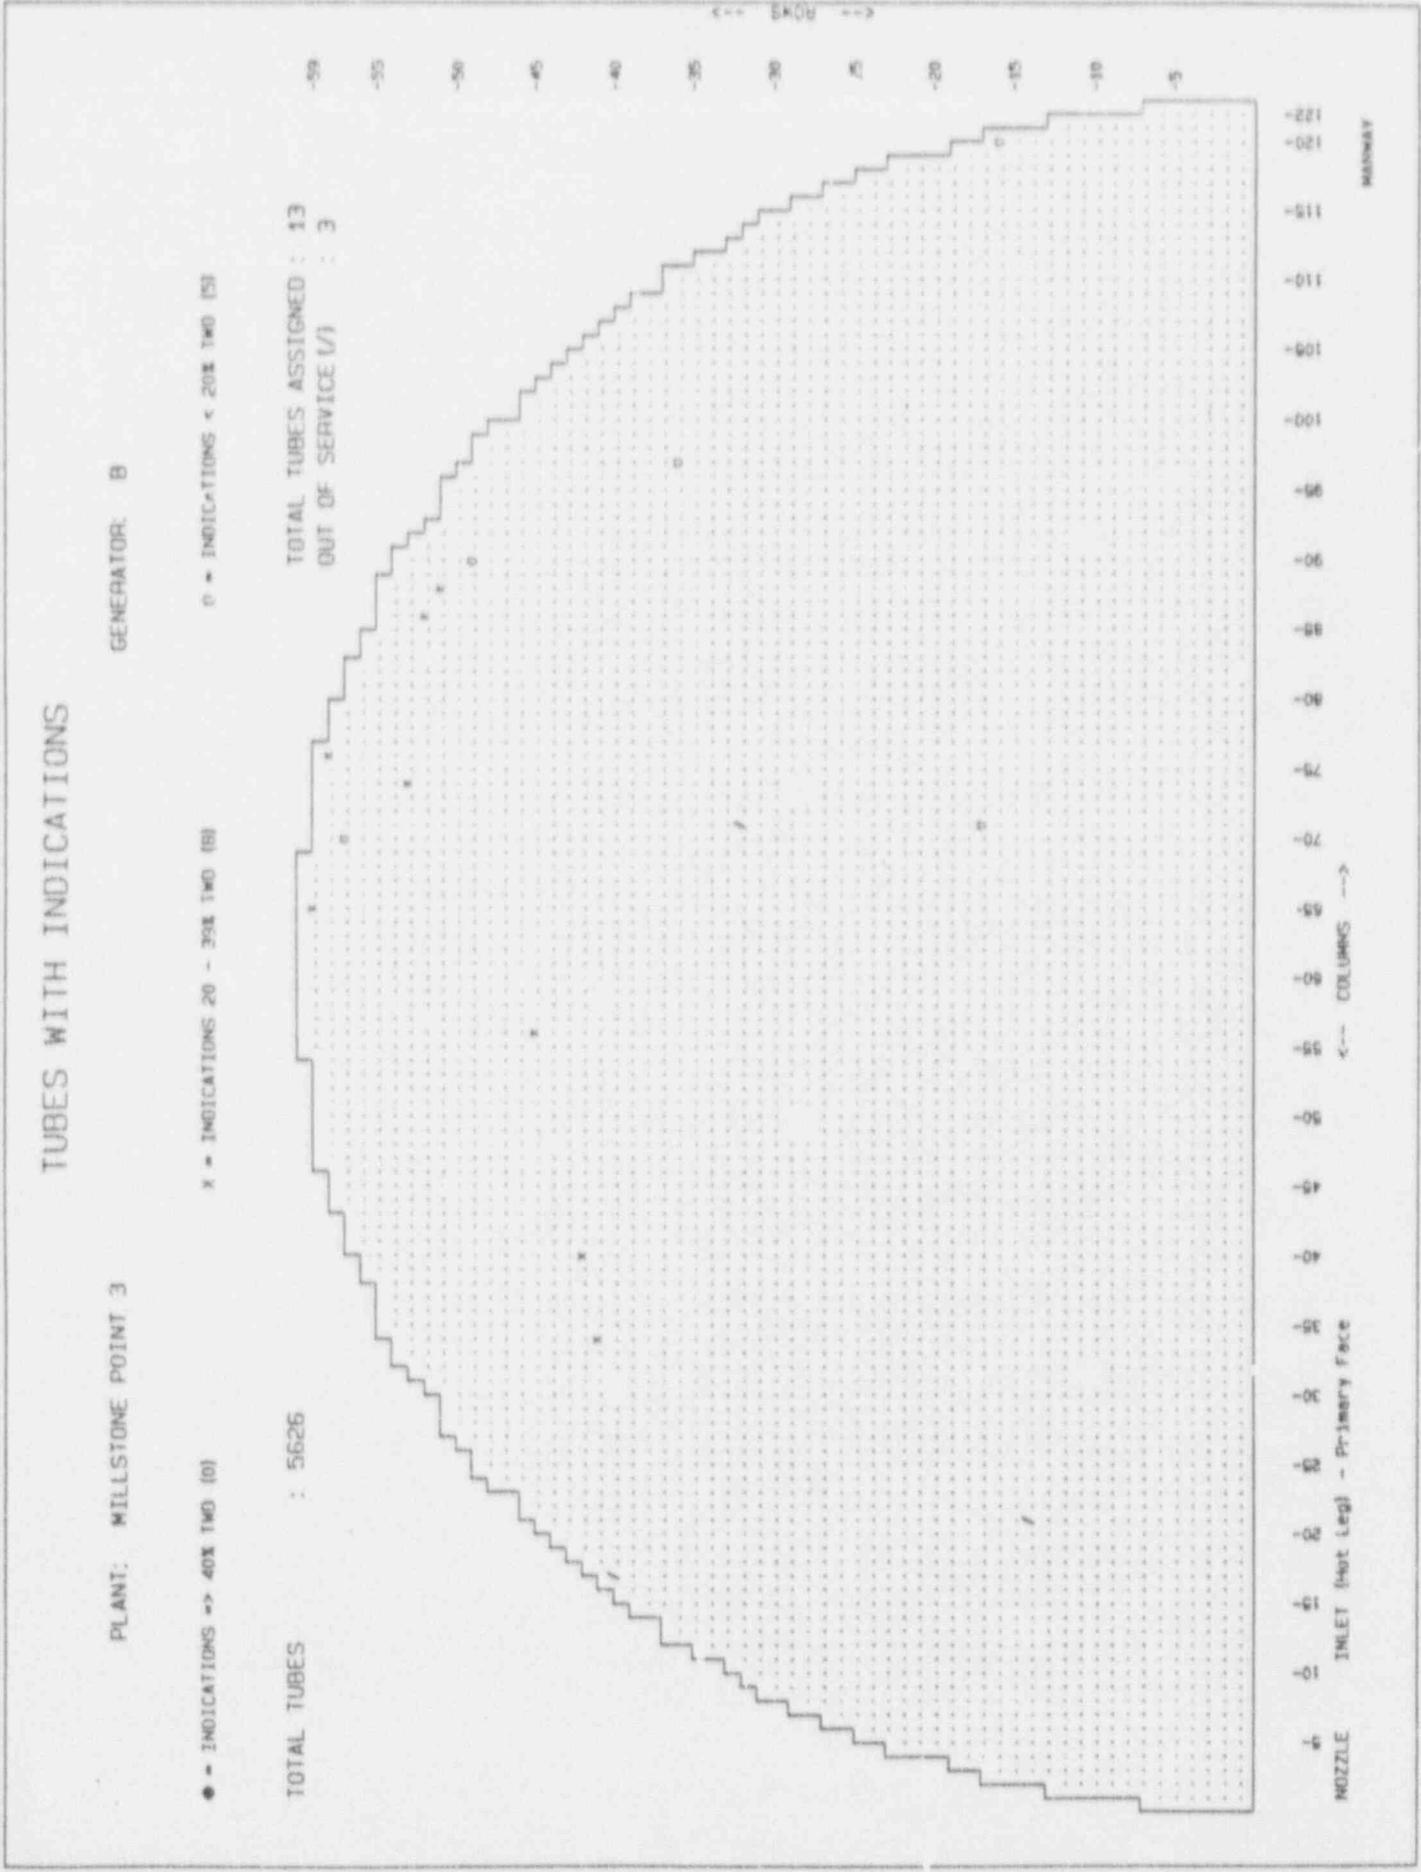
The most significant tube degradation was outside diameter flow induced vibrational wear, located at the SG AVBs. A total of five tubes examined (or 0.14% of the tubes inspected) in the "B" SG were degraded, (i.e., exhibiting wear greater than 20 percent).

A small number of outer diameter indications not originating at an AVB were identified by this examination. Three tubes (0.08% of the tubes inspected in "B" SG) were identified by bobbin probe as having greater than 20% wall loss. They were low amplitude signals, which generally measure less than 30% through wall.

The data for all tubes degraded by 20% or more is provided in Table 2. Figure 4 shows the location of all indications and plugged tubes within the "B" steam generator.

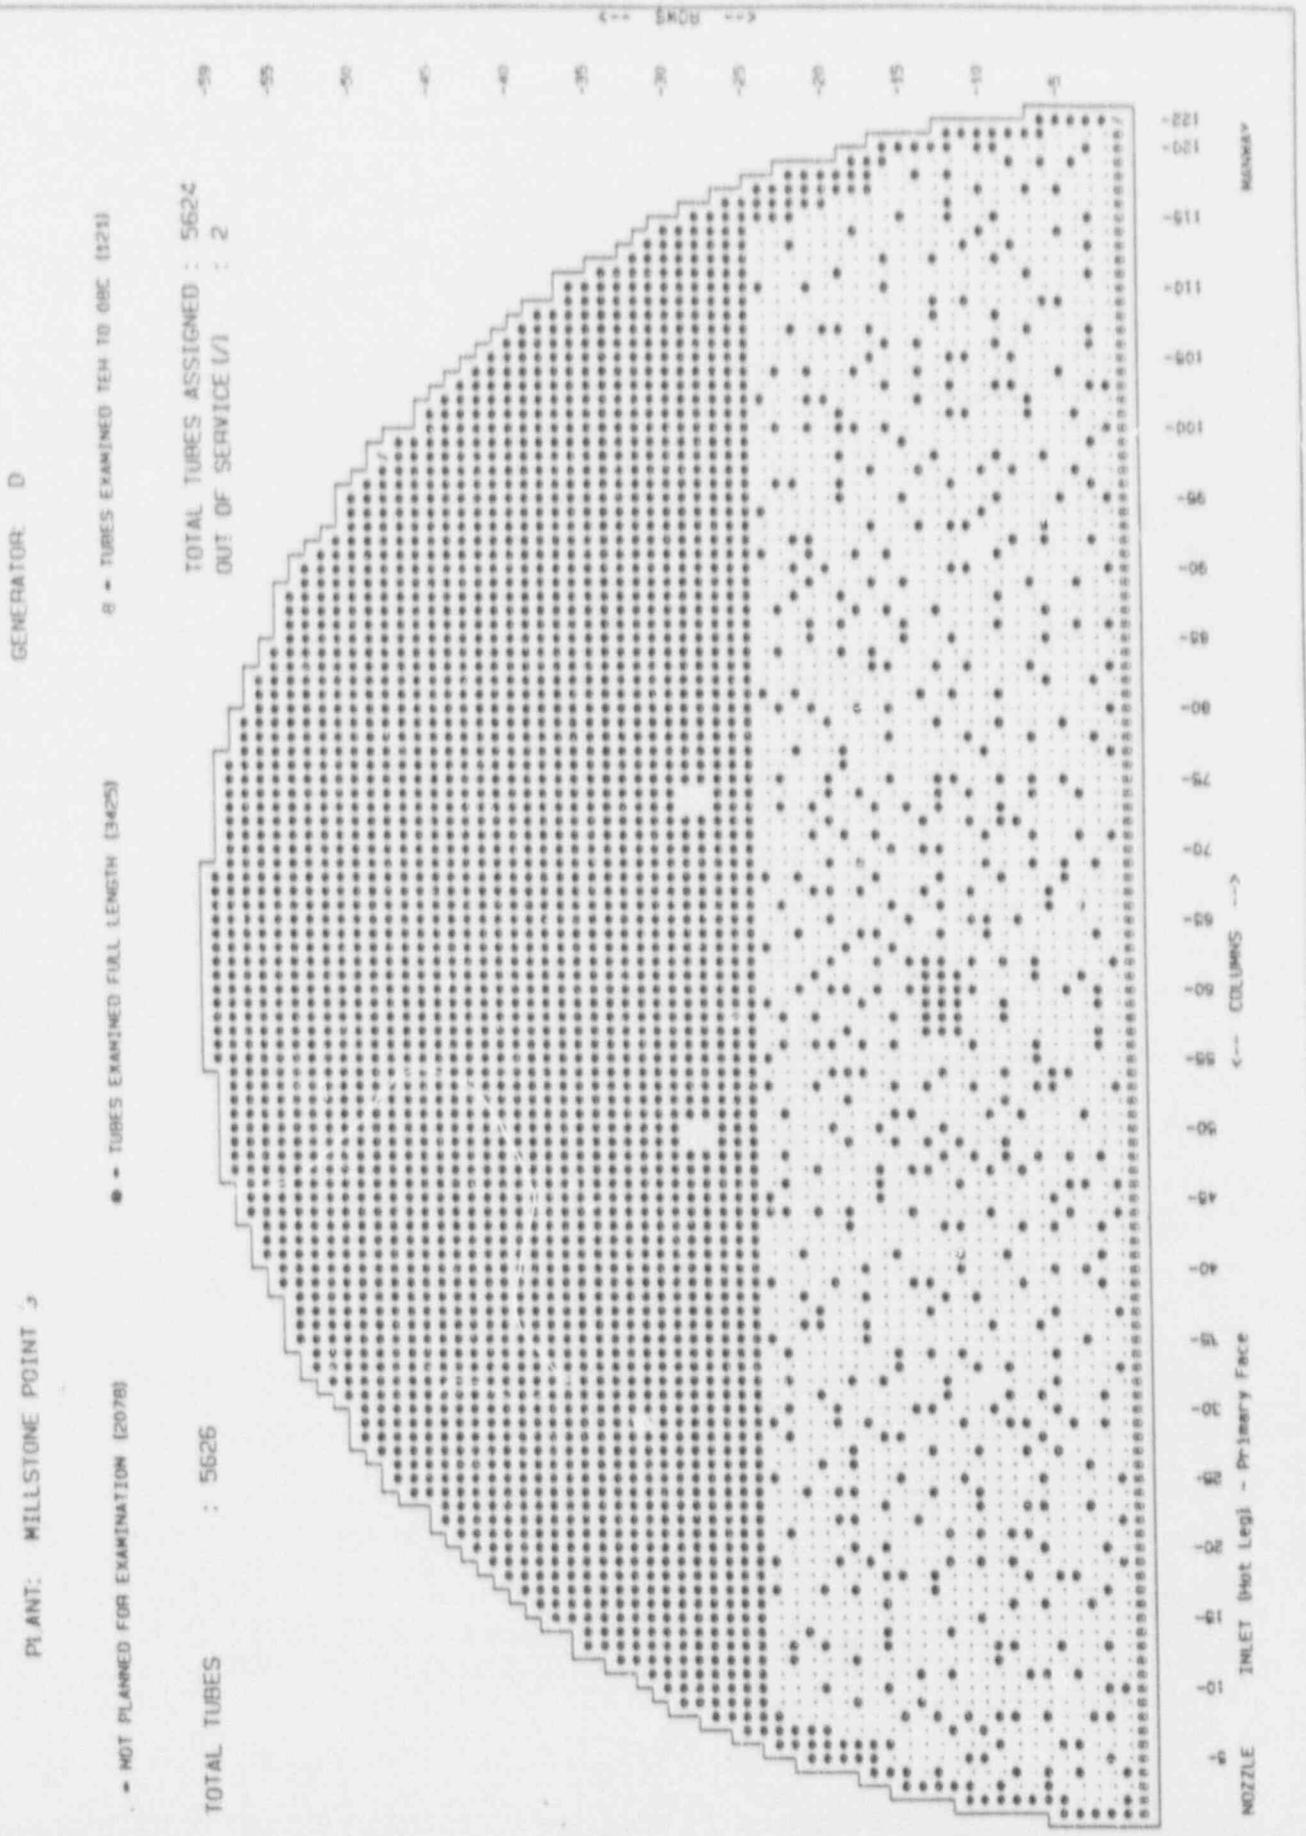
Figure 6

Again, most of the degradation was vibrational wear, which occurred at the AVB region. Of the 3546 tubes examined, 39 tubes were identified as degraded (experiencing damage 20% throughwall or greater). Of these 39 tubes, five (5) tubes (or 0.14% of the tubes inspected in "D" SG) had sufficient damage to be considered defective in accordance with the definitions stated in Technical Specification 4.4.5.4. These tubes, at locations R42-C42, R43-C103, R53-C86, R53-C88 and R53-C90 all contained wear type indications exceeding the plugging limit of 40% throughwall. In accordance with Technical Specifications these tubes were removed from service.

Two (2) additional tubes were identified with OD wall loss greater than 20% throughwall, not attributed to anti-vibration bar wear. One tube, R5-C1, which was identified with 30% through wall damage, had not changed since the preservice baseline examination. This indication was determined to be the result of either the installation or manufacturing process. Both tubes are identified in Table 3.

The total tubes examined in "D" steam Generator exhibiting degradation was 1.16%. All tubes having greater than 20% degradation are identified on Table 3 and Figure 6.

TUBES WITH INDICATIONS
