UNITED STATES OF AMERICA
NUCLEAR REGULATORY COMMISSION

In the Matter of)	Docket Nos. STN 50-454 OL
)	STN 50-455 OL
COMMONWEALTH EDISON COMPANY)	
)	
(Byron Nuclear Power Station,)	
Units 1 and 2))

DIRECT TESTIMONY OF
BOBBY G. TREECE
ON ISSUES 5 AND 6
(CABLE OVERTENSIONING),
AS LIMITED BY THE LICENSING BOARD'S
ORDER OF JUNE 8, 1984

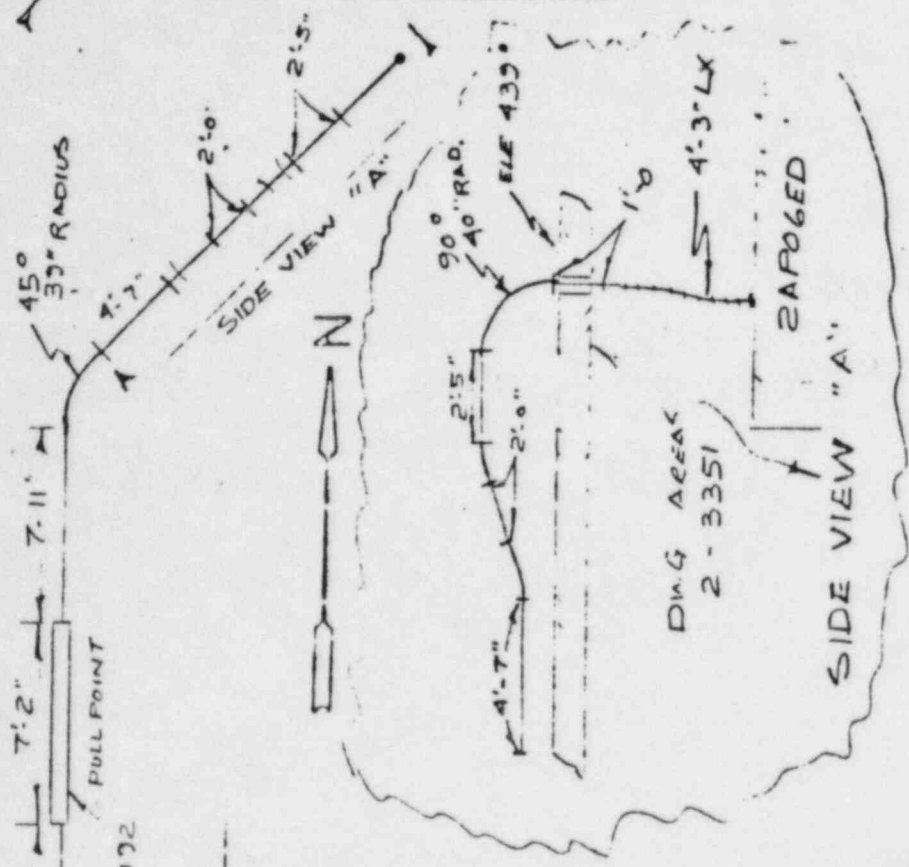
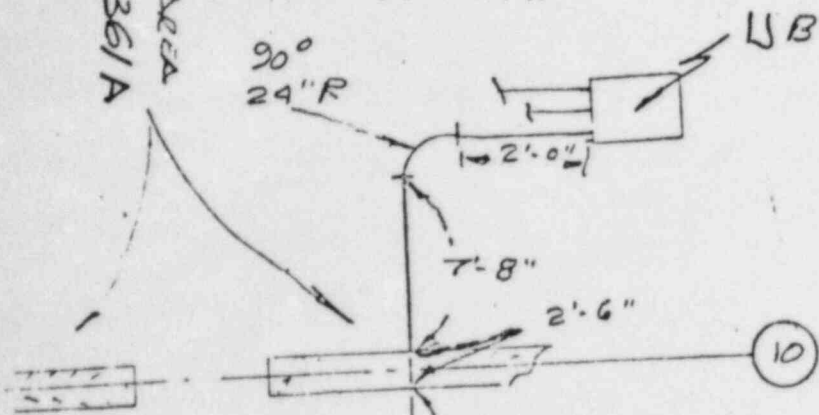
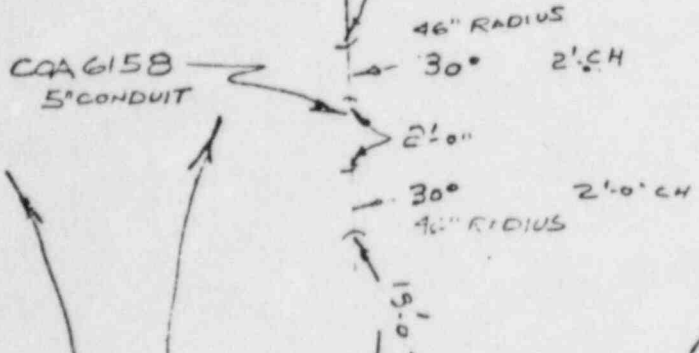
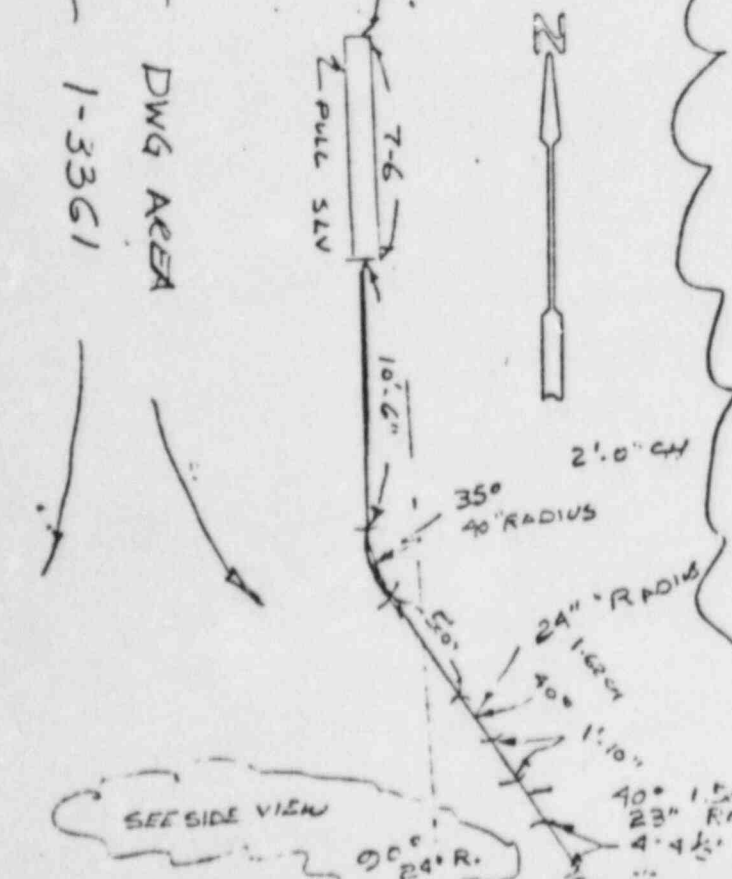
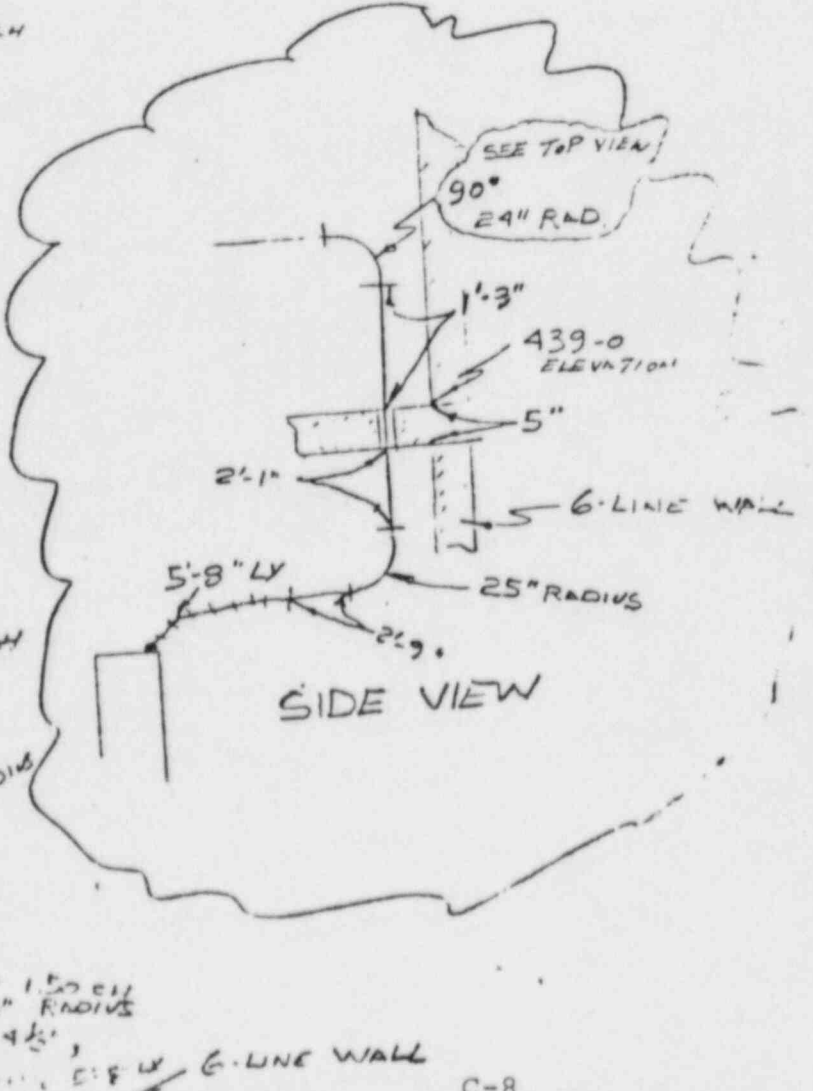
Attached are calculations for the cable pulls for the drawings submitted by you. Pulling from LJB261A to Gear in one continuous length provides excessively high pulling tension and sidewall pressures. This is caused by the excessive number of offsets located in this run. The total tension calculates out to 52,000 lbs. in this direction. The coefficient of friction actual was probably lower than 0.35 but in any case the allowable tension and sidewall pressures were exceeded by the wide margin. These calculations appear on pages 1 and 2 of the attached sheets.

DIRECTION OF PULL: GEAR TO 1-3361
INSTALLED CABLES: 3-1/2 750KVA, 5V
PULLING FIT USED: ONE CONTINUOUS PULL
PULL STRAP NOT UTILIZED

If the cable was pulled from LJB261A to gear it should be replaced because of the very high pulling tension and sidewall pressure that would have been experienced.
