CATAWBA NUCLEAR STATION
DIESEL ENGINE 1A COMPONENT REVALIDATION INSPECTION
FINAL REPORT

PREPARED BY
DUKE POWER COMPANY

June 29, 1984

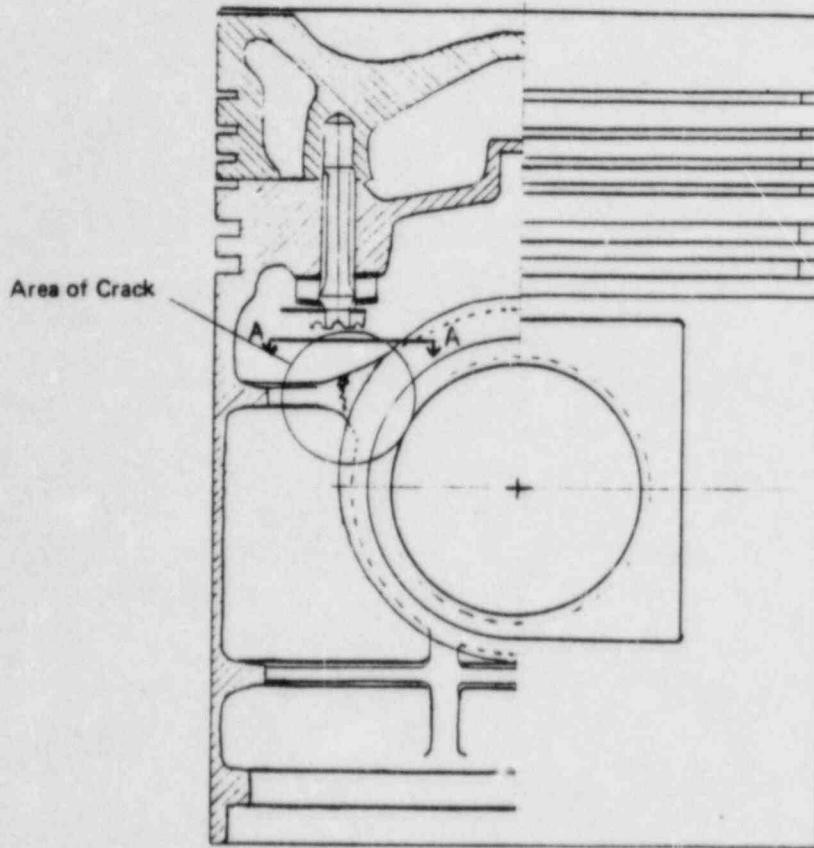
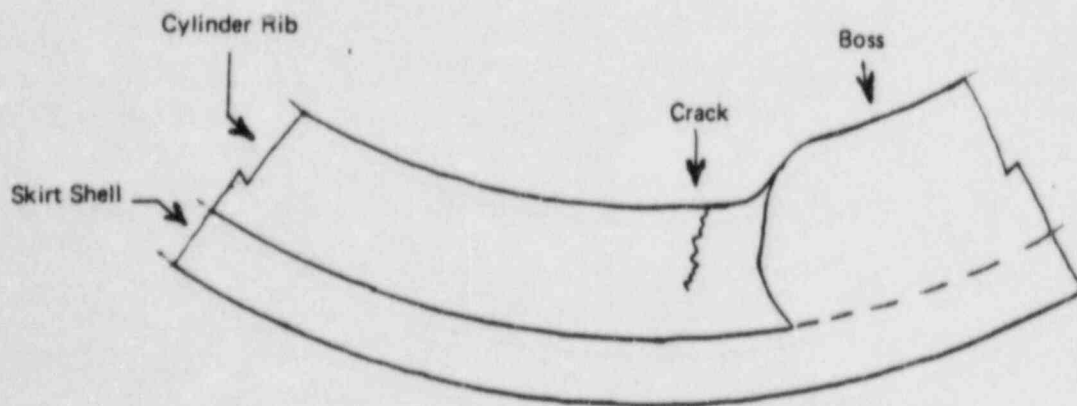
FIGURE 2-1
CRACKED TYPE AN PISTON SKIRT

- One major problem was noted on the 1A diesel. Four of the type AN piston skirts used in the 1A diesel were found to have one or more cracks in the region where an internal circumferential reinforcing rib intersects the piston pin boss (Figure 2-1). This problem is discussed further in Section 2.2.

Four type AN skirts were found to have cracks adjacent to piston pin bosses. (Figure 2-1) These cracks run approximately vertically, and appear to initiate on the inside of the skirt where a circumferential reinforcing rib intersects the piston pin boss. The largest crack, on skirt 3L, was through wall and was about 3 to 4 inches long on the outside.

Elevation view of skirt

View A-A
Detail of crack initiation

The most significant condition noted was the presence of cracks in four piston skirts adjacent to piston pin bosses. The largest crack was 3 or 4 inches long and was through the wall. The cracks appear to originate at the skirt ID, on the fillets where a reinforcing rib intersects the piston pin bosses, and to run in an approximately axial direction. The cause of the cracking is unknown at this time but is believed to be due to cyclic fatigue. Skirts have been sent to FaAA for failure analysis.

The cracked AN type piston skirts in the Catawba 1A diesel did not cause any operational problems, and 12 of the 16 skirts were free of cracks. Nevertheless, all the piston skirts will be replaced with improved design AE skirts. The AE skirts have been stress relieved and include improved design features such as a thicker reinforcing rib and better rib-piston boss intersection details. These improvements are expected to adequately reduce the stresses and propensity for cracking in the area which experienced cracking at Catawba. The FaAA/Owners Group program will quantify the benefits achieved by use of AE piston skirts. It is anticipated that this will show that no cracking is expected during the life of the Catawba diesels. The AE piston skirts also incorporate the latest improvements in the stud boss region, which has been a problem area in earlier piston designs at the skirt to head transition.

Cracks were found to be present in piston skirts near piston pin bosses. As a result, all of the piston skirts will be replaced with type AE pistons. In addition, a detailed failure analysis has been initiated, as part of the TDI Owners Group program.

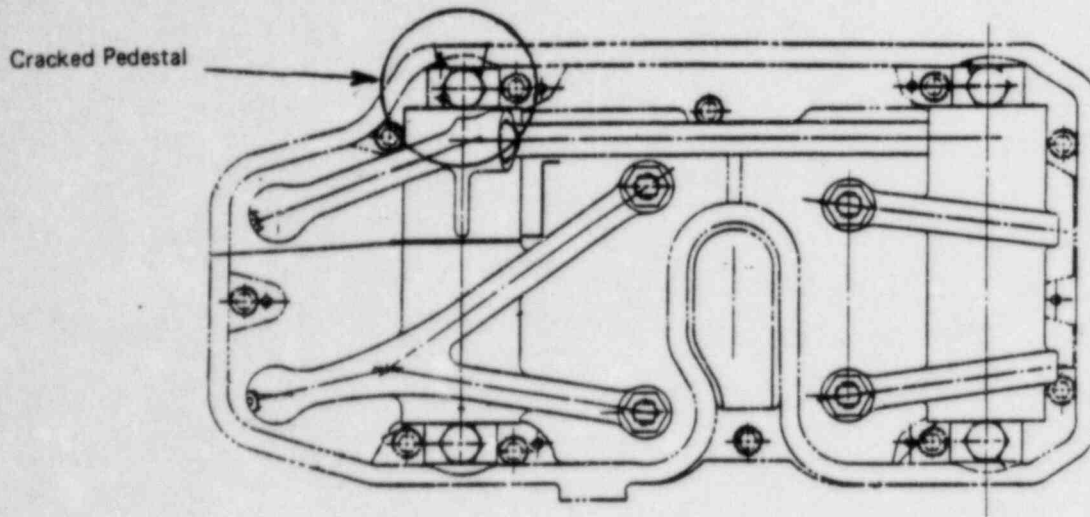
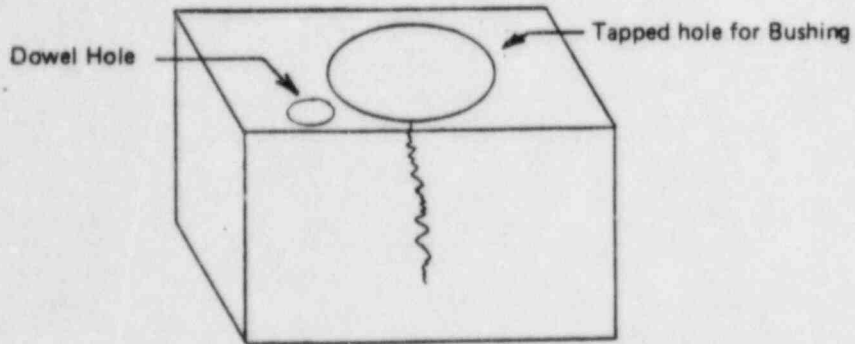
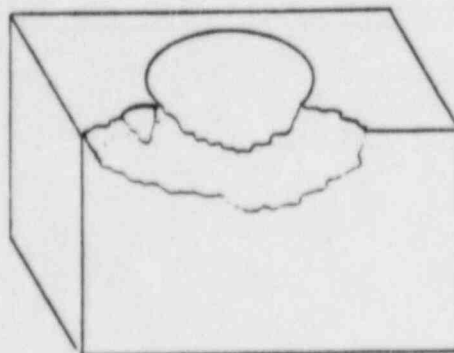
FIGURE 2-2
CRACKED SUBCOVER CASTINGS

- Two subcover castings were found to have cracks in an intake rocker arm pedestal (Figure 2-2). These cracks are discussed in Section 2.3.
- Two Catawba cylinder heads (one on diesel 1A and one on 1B) experienced small jacket water leaks into the fuel injector cavity. Metallographic examinations of the head removed from the 1A diesel indicates that the leak was due to a fatigue crack (Figure 2-3). This problem is discussed in Section 2.4.

Two cast iron subcovers were found to have cracks in a pedestal where the intake rocker arm shaft is bolted to the subcover (Figure 2-2B). Prior to the extended operation test, another subcover was found to have a piece of this pedestal missing (Figure 2-2C). None of these cracks have affected diesel operability. However, since similar problems have been reported with other diesels, FaAA has initiated a failure analysis of a Catawba subcover as part of the Owners Group program. Preliminary studies indicate that the cracks are due to installation tolerances between dowels, bushings and the pedestal leading to excessive interference and possibly fatigue cracking.

A. Plan view of subcover

B. Crack in web between bolt hole and surface

C. Cracked off Edge of Pedestal

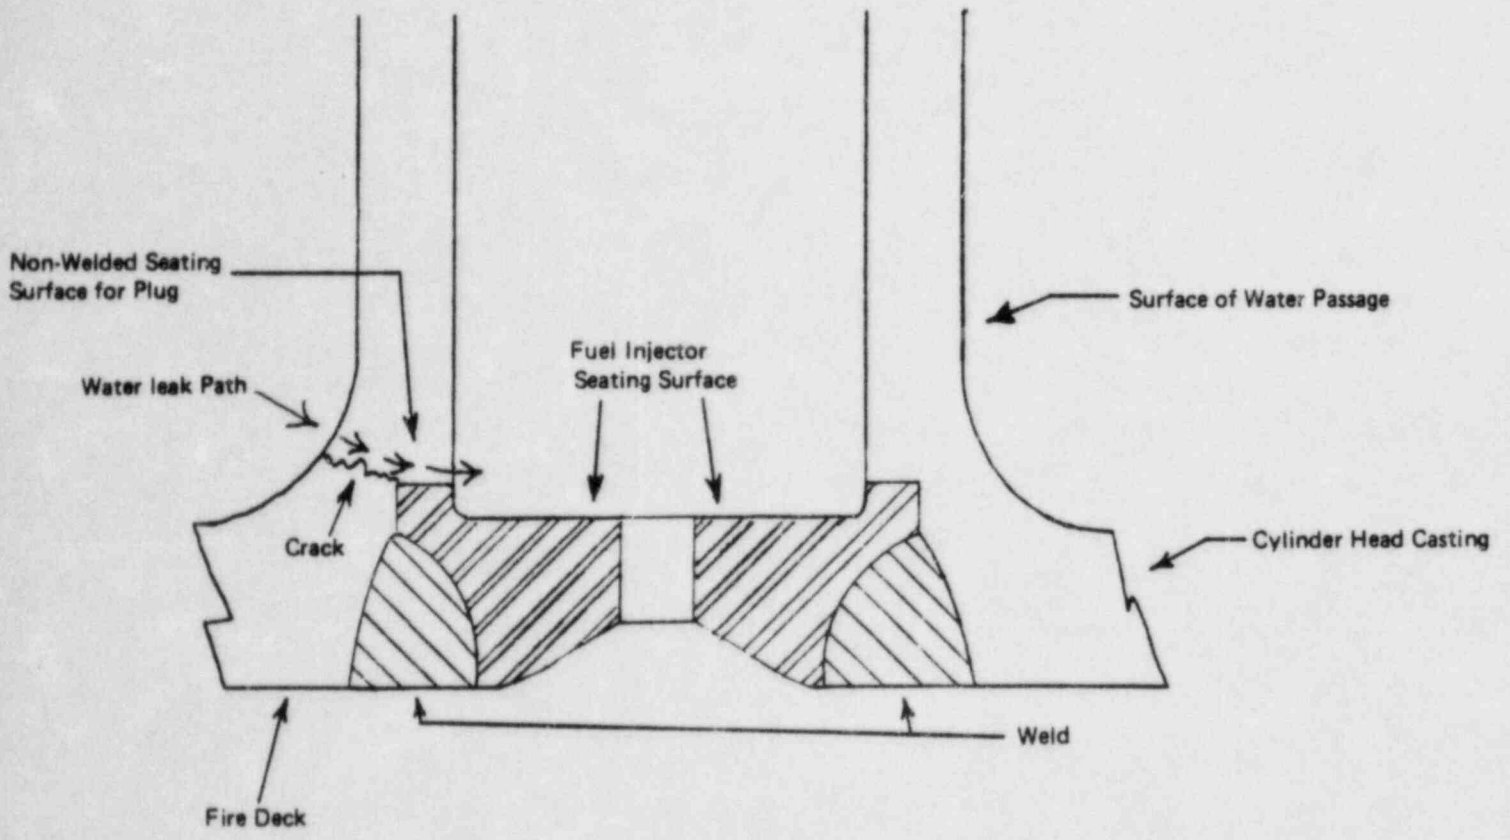
FIGURE 2-3
CRACK IN CYLINDER HEAD

engine was of similar magnitude to that of 1A. The 1A cylinder head has recently been examined by FaAA. This investigation (reference 20) revealed that the leak was caused by a crack initiating from the corner of a welded-in plug where it was seated in the cylinder head (Figure 2-3). This welded-in plug is reported by TDI to have been used to repair the casting around the fuel injector hole. Evaluation of all heads installed on Engine 1A (reference 22) indicates that one other head (6 left) has been repair welded with a plug.

Two small jacket water leaks have been experienced at Catawba resulting in water leaking into the fuel injector nozzle cavity. Failure analysis of one of the leaking heads has been completed (reference 20). The leak was due to cracks propagating from a corner where a welded plug was installed in the fuel injector nozzle seating area. This welded plug was used to repair the injector bore during manufacture. (Figure 2-3)

The leaks caused by the cracks have not affected diesel operability since they result in small amounts of water leaking into the fuel injector cavity and then off of the diesel. As all of the heads now on diesel 1A have experienced no cracking and were not leaking after the extended operation test, the heads are considered acceptable for continued operation. However, the repaired head (6 left) will be replaced as a matter of conservative judgement.

The currently installed heads in the 1A diesel engine are considered to be satisfactory since they were not leaking when last used and exhibit no cracks in inspectable areas. Further, the type of leaks caused by cracks due to plug welding do not affect diesel operation and are not significant. However, the repaired head (6 left) will be replaced.
