UNITED STATES
 NUCLEAR REGULATORY COMMISSION
 REGION II
 101 MARIETTA STREET, N.W.
 ATLANTA, GEORGIA 30303

Report No.: 50-416/84-17

Facility Name: Grand Gulf 1

Inspection Date: May 2 - 4, 1984

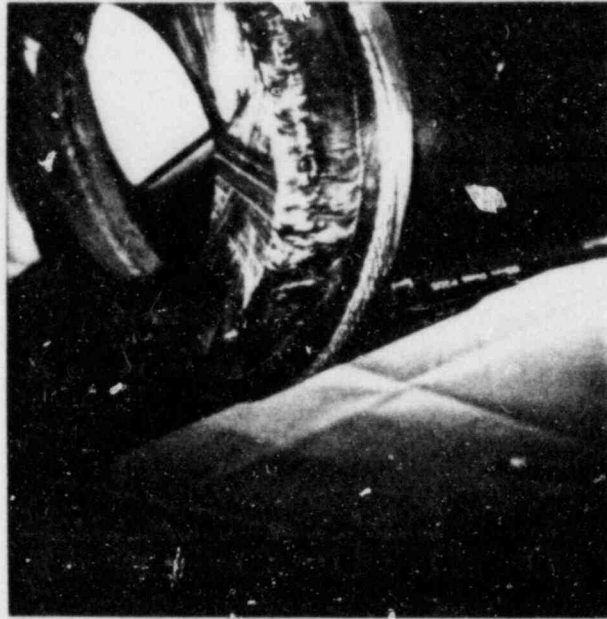
FIGURE 1

As stated earlier in this report, the failed pipe section exhibited two cracks. The first was located near the attachment weld joining the 3" diam. weld-o-let to the 18" diam. RHR outlet line No. 18"-GBB-81 and the second was in the 90° elbow of the 3" diam. line, No. 3"-GBB-90 just upstream from valve F065B or about two feet from the 18" diam. RHR outlet line. A close visual examination disclosed that the crack at the weld-o-let was located at the toe of the weld on the OD surface and propagated through to the ID surface of the 18" diam. pipe in a location which was approximately 1mm away from the edge of the weld-o-let penetration. The path of the crack on both sides of the joint appeared to be circumferential and singular e.g., without branching. The second crack which was located on the inside/short radius of the 3" diam. elbow followed a path that was transverse to the axis of this line with a slight positive slope from about 5 to 8 o'clock, see figures 1 and 2. The crack was located outside of the pipe to elbow weld heat affected zone (HAZ). The elbow appeared to be bent approximately 1° and 2° off the y axis of the pipe. At the time of this inspection, the licensee had not performed a failure analysis, therefore it was impossible to determine at this point the cause of failure. However, taking into account the fact that (1) this line experienced extended periods of

vibration, believed to be associated with low flow conditions, and that (2) unlike loop "A" this line did not have a vertical support at or near the elbow to resist this type of motion would suggest the failure resulted from material fatigue assisted by forces generated from a water hammer. The inspectors requested and the licensee has agreed to provide the staff with a copy of the failure analysis report for review.

Three inch weld-o-let and 18" diam. RHR pipe weldment depicting circumferential crack at the toe of the weld.

At the outlet of RHR heat exchanger No. B002B, the inspectors noted that the affected 3" pipe section and the weld-o-let attachment had been removed. The new weld-o-let had been welded to the 18" outlet line and preparations were underway to weld a 6" cap on the new weld-o-let, thereby isolating the 3" condensate line from service. At this time the inspectors witnessed the ultrasonic examination of weld FW-60 on RHR Loop A line 18"-GBB-21. This examination was performed on welds in high stress locations i.e., structural discontinuities, near the cracked line to determine whether the apparent vibration had compromised weld integrity. In addition, the inspectors observed the three pipe restraints that sustained some anchor plate damage as a result of this event. These were on the suction side of RHR pumps A and B. The restraints were identified as follows:

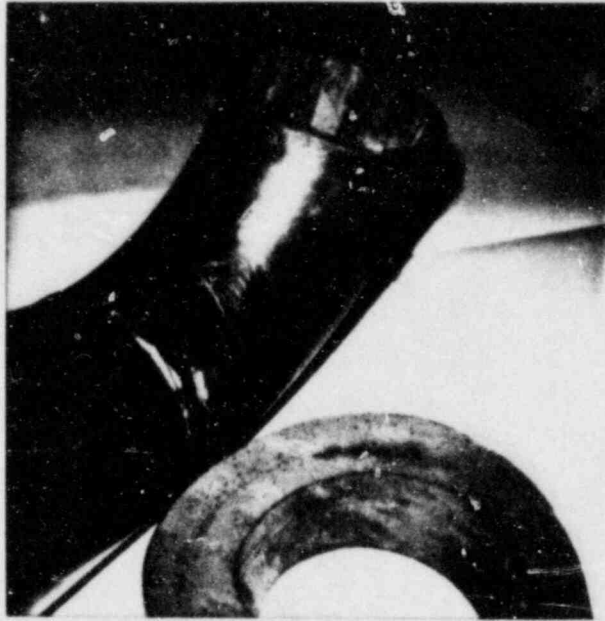
FIGURE 2

Section of 3" diam. RHR pipe and weld-o-let removed because of leakage depicting cracking condition on the inside diameter of the 3" elbow and on the ID of the 18" RHR pipe surface near the weld-o-let penetration.
