### LICENSEE EVENT REPORT (LER)

FACILITY NAME (1) Susquehanna Steam Electric Station-Unit 2	DOCKET NUMBER (2) 0 5 0 0 0 3 8 8	PAGE (3) 1 OF 015
--	--------------------------------------	----------------------

TITLE (4)  
Reactor Shutdown due to inoperability of the 'B' Loop of Low Pressure Core Injection.

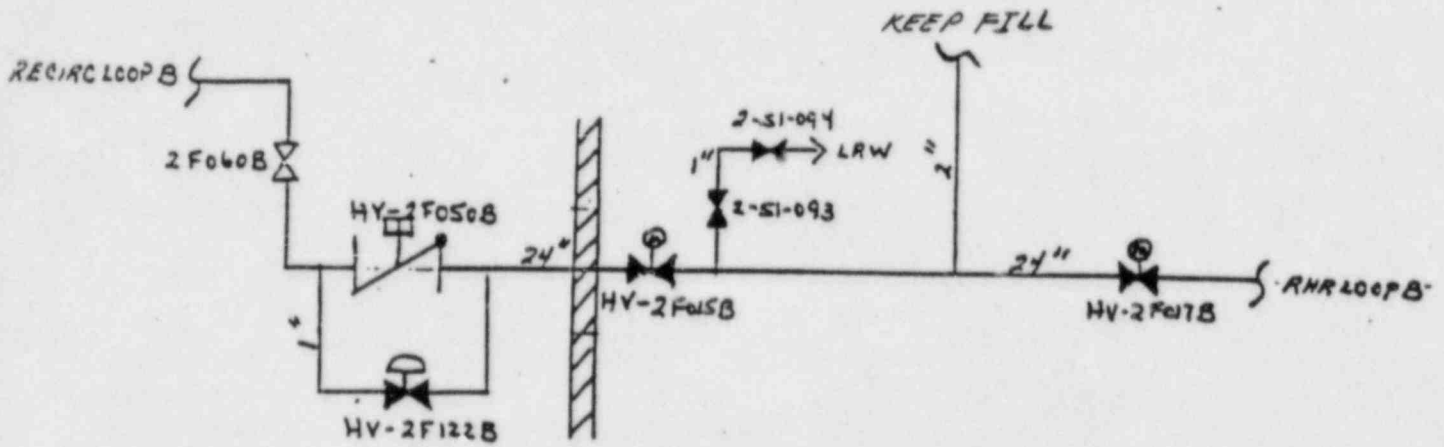
The LCO was incurred at 0615 hours on 5/21/84 when the LPCI Injection Valve HV-2F015B was closed and de-energized in compliance with T.S. 3.6.3 following the occurrence of dual indication on the Testable Check Valve HV-2F050B and its Bypass Valve HV-2F122B (Also refer to Time Line and Figure 1 attached to this report). Later that day, the RHR Throttle Valve HV-2F017B was closed and HV-2F015B was cycled in an attempt to seat HV-2F050B; when HV-2F017B was reopened the 'B' RHR primary side heat exchanger pressure was observed increasing. Valve HV-2F017B was closed.

At 0530 hours on 5/28/84, shutdown of the Unit 2 reactor commenced from low power testing at a power level of 2% in accordance with Action Statement (b)(3) of T.S. 3.5.1.b.2 due to the inoperability of the 'B' Loop of LPCI (Also refer to LER 84-008-00). The LCO was incurred at 0615 hours on 5/21/84 when the LPCI Injection Valve HV-2F015B was closed and de-energized in compliance with T.S. 3.6.3 following the occurrence of dual indication on Testable Check Valve HV-2F050 and its Bypass Valve HV-2F122B. Later that day, the RHR Throttle Valve HV-2F017B was closed and HV-2F015B was cycled in an attempt to seat HV-2F050B; when HV-2F017B was reopened, the 'B' RHR primary side heat exchanger pressure was observed increasing (Also refer to Time Line and Figure 1 attached to this report). Valve HV-2F017B was closed.

The HV-2F015B is a horizontally mounted gate valve. Upon disassembly and inspection of LPCI Injection Valve HV-2F015B it was found that the valve's disc would not center on its seat due to the dimensions of the disc guide bearing surface and this resulted in the valve's disc sitting "low" in the valve's body. Due to machining tolerances during manufacturing, the disc would not seat in the same location each time it was stroked. To stop leakage thru the valve, its seat was lapped and upon the vendor's recommendation, its lower disc guide bearing surface was built up one-quarter (1/4) inch. The valve was reassembled and an LLRT and a hydro were satisfactorily completed on 6/7/84 and 6/8/84, respectively.

The reason for dual indication on Testable Check Valve's Bypass, HV-2F122B was attributed to a loose diaphragm plate connector that resulted in improper contact with the limit switches on the bypass valve. The plate connector and its set screws were tightened, and its operator reconnected. Proper stroking and indication was observed during the performance of a subsequent LLRT.

Valve 2F015B disassembled and inspected; valve's disc would not center on its seat due to improper dimensions of the disc guide bearing surface; the valve's seat was lapped and the lower disc guide bearing surface was built up  $\frac{1}{4}$  inch with the valve vendors recommendation; the valve was then reassembled.
