#### SNUPPS

SLNRC 84-0014 Fire Protection Review SUBJ:

### RESPONSES TO NRC FIRE PROTECTION

# AUDIT CONCERNS

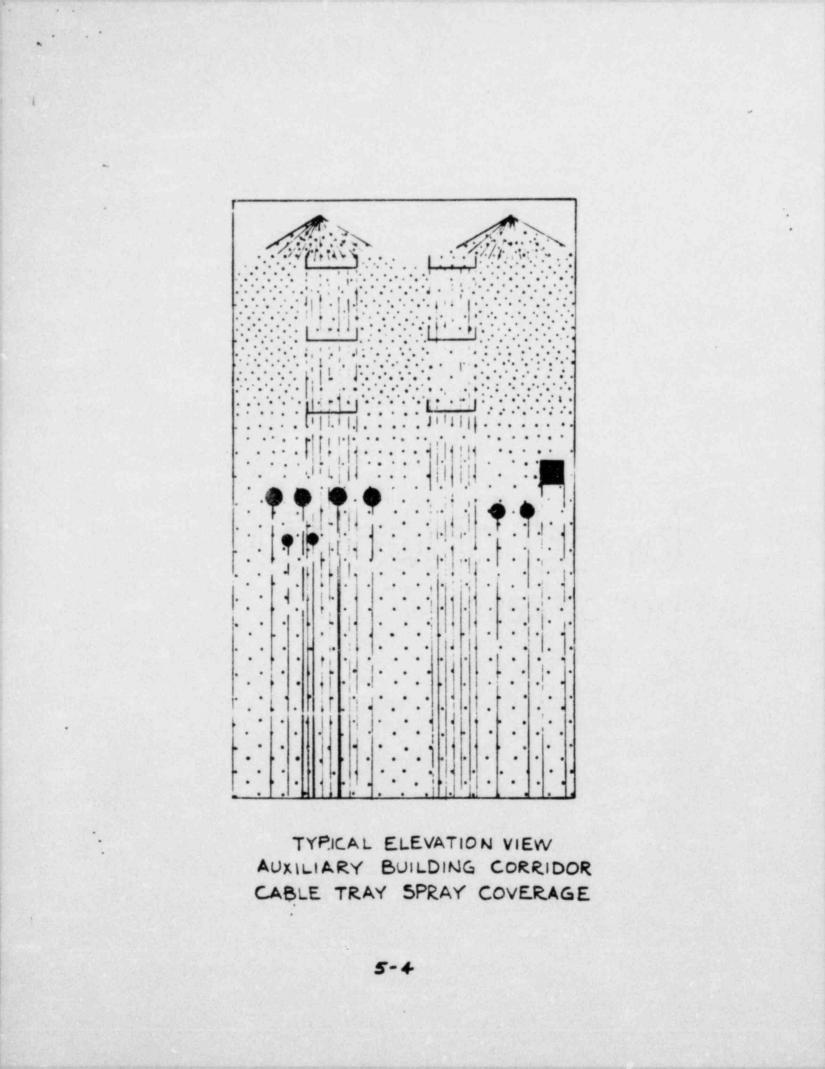
The NRC fire protection auditors indicated a general concern that certain auxiliary building corridors were too congested to allow the sprinklers located above cable trays to provide adequate coverage of the general floor area. Thus the cable trays were potentially lacking adequate protection from transient fires. The auditors suggested that additional sprinklers may be required below the lowest obstruction.

DESCRIPTION OF PHYSICAL LAYOUT/OBSTRUCTIONS: The layout of the contents of each auxiliary building corridor is similar. The corridor is generally 12 to 15 feet wide with cable trays suspended from overhead steel. The trays are a maximum of 2 feet wide with a minimum of 3 feet horizontal separation between stacks. No other components are routed at the elevation of the cable trays (except fire headers and sprinklers).

Below the trays the obstructions, if any, consist of piping runs. The pipes are generally small diameter and widely spaced. They do not constitute a significant blockage. There are very limited quantities of horizontal HVAC ducting. In the few places where it does exist, it is generally not wider than 2'-0". In summary, significant blockages do not exist in the auxiliary building corridors. None of the blockages are wider than 2'-0" and the cable trays are well separated (3'-0") and not wider than 2'-0". NFPA 13 requires sprinklers to be installed beneath ouccs, gratings etc. over 4 ft. wide.

The attached figure provides an elevation view of a typical corridor with two stacks of trays and a pictorial presentation of the head locations and sprinkler coverage. As shown the heads are located within inches of the ceiling and the 120° discharge cone of fine mist sized droplets pervades the calle tray area. The concentration of spray below the trays will be influenced by spray impingement on the walls, cable trays and any pipes which are present below the trays; however, due to the spray flow rate, the size of the droplets and turbulence due to the fire, a sufficient density of spray droplets will exist below the trays to control postulated transient fires until the fire brigade arrives.

The concerns raises have been reviewed along with each auxiliary building corridor. Based on this review, it has been determined that no additional sprinklers are necessary. The following descriptions provide the bases for this determination.

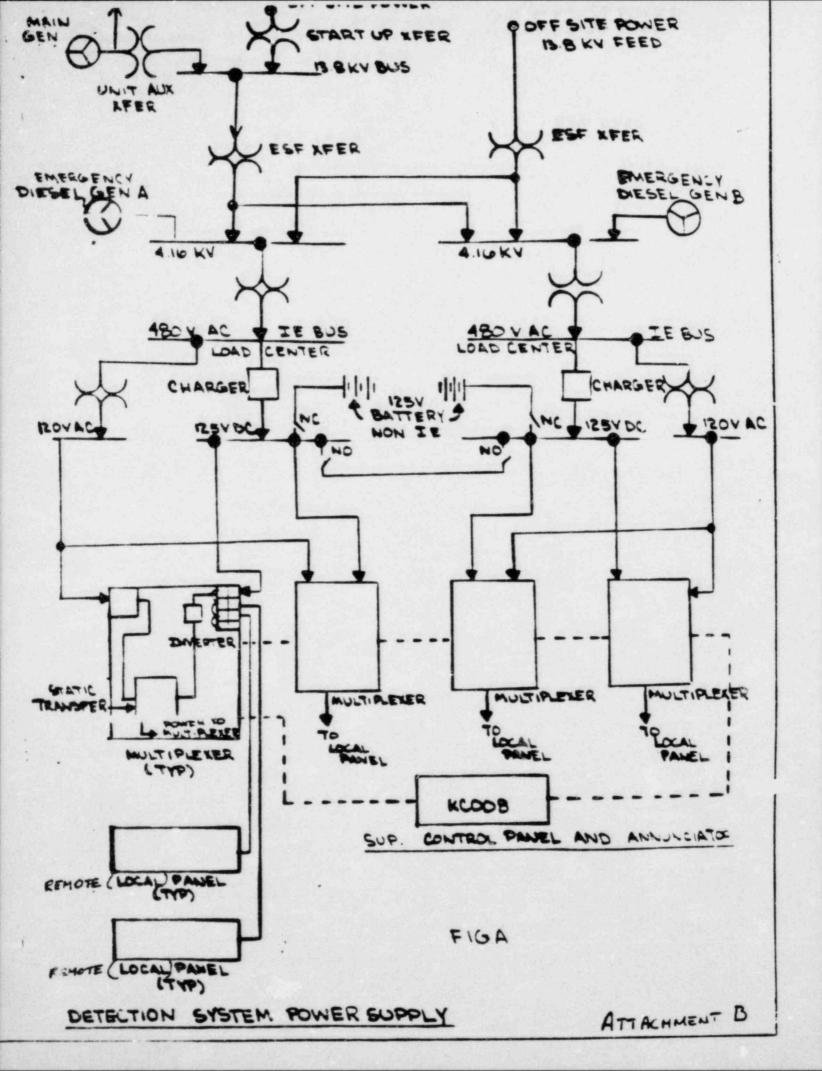
ATTACHMENT A

Question: Based on Figure A. per paragraph 2225C. NFPA 72D 1975 are batteries with 4 hour capacity required at location A?
