6-19-84

In Reply Refer To:
Dockets: 50-445
50-446

The attached enclosures are matters relating to alleged improper construction practices involving the Comanche Peak Steam Electric Station main condensers (Units 1 and 2) expressed by an alleger during an interview conducted on August 24, 1983 by members of the NRC Office of Investigation Field Office, Region IV. Although the condenser units are components within the BOP classification, the allegations expressed raise concern as to the quality of workmanship that could impact on reactor safety.

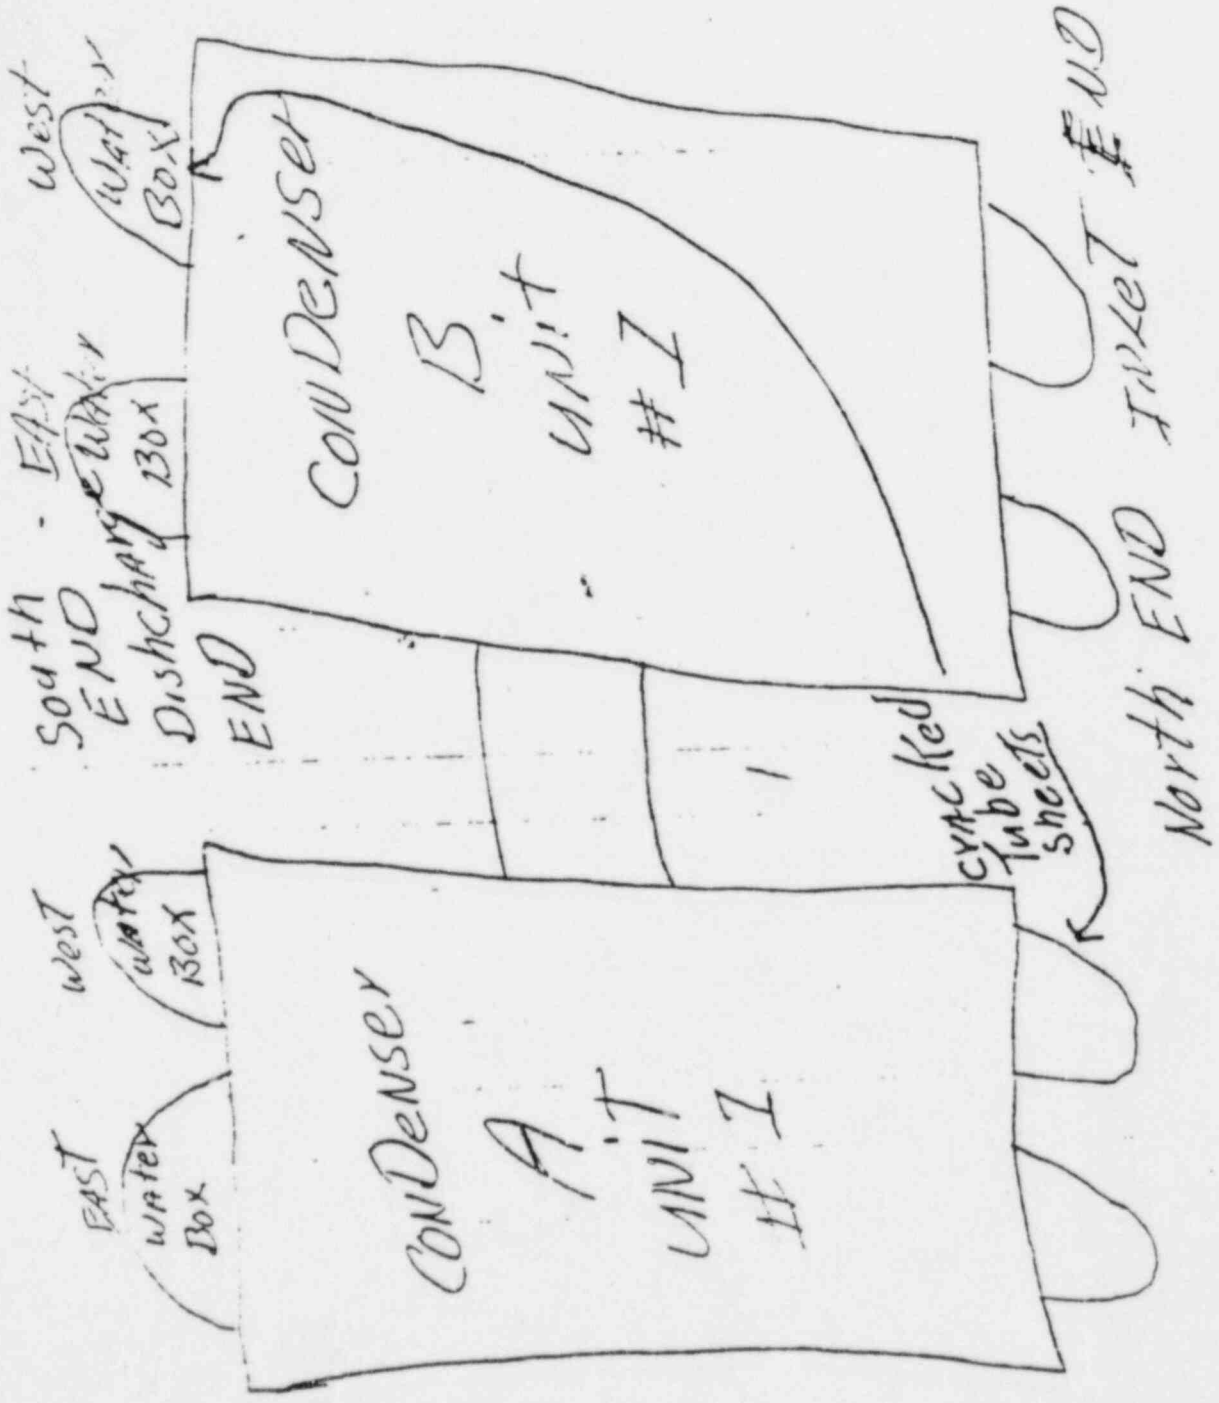
9 ██████████ Exhibit 1 just referred to
10 follows.)

15 Here is your water boxes right here and your
16 condensers. All right, in condenser A on the inlet end on
17 the west box and it is in three sections. You have got
18 some cracked tube sheets in here. Back there you have got
19 some cracked tube sheets. You have got overrolled tubes or
20 barely overrolled. They are supposed to be rolled 069
21 thousand is a perfect roll inside reading. They allow us
22 to go to 071 thousand. We went up 90-some thousands.

12 [REDACTED] Okay. Condenser B, Unit 1,
13 west discharge water box and you have got a cracked tube
14 sheet. Also, the tubes are overrolled severely.

15 On the east water box, condenser B, discharge
16 end, you are heavily overrolled and you undoubtedly have
17 got quite a few cracks in it. I can swear to that. I know
18 you do because it swelled up so big.

19 Overroll on the west box, condenser A, Unit 1,
20 discharge end.

21 East water box, discharge end, condenser A,
22 you are still leaking, and overrolled.

2 Condenser A, Unit 1, intake box, the west box,
3 you have got cracked tube sheets.

13 [REDACTED]: They are still there, yes. All
14 you got to do is go in there. It is really terrible. What
15 I would suggest doing is on the big ones like 90-some
16 thousand is cutting the tube out and look at your sheet.
17 There is a spider web crack. I showed the people the
18 crack, and that is when I first starting getting the
19 pressure, this is about three years ago, after I reported
20 this stuff. I kept on insisting on this crack, and then
21 everybody would go oop, and [REDACTED], he would go, you
22 know, [REDACTED], I am not for sure they are cracked. I would
23 go I am not. You know, you can throw a cat through it, and
24 he goes no, no, no.

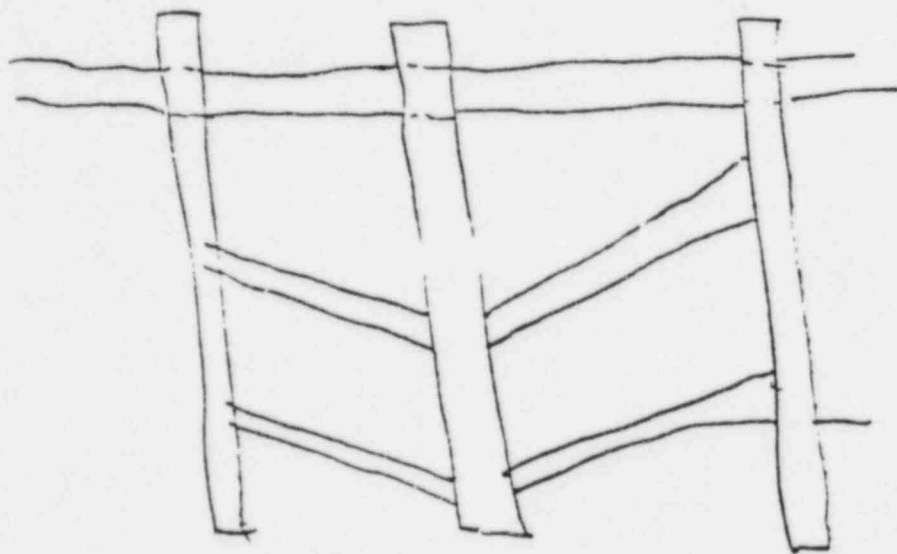
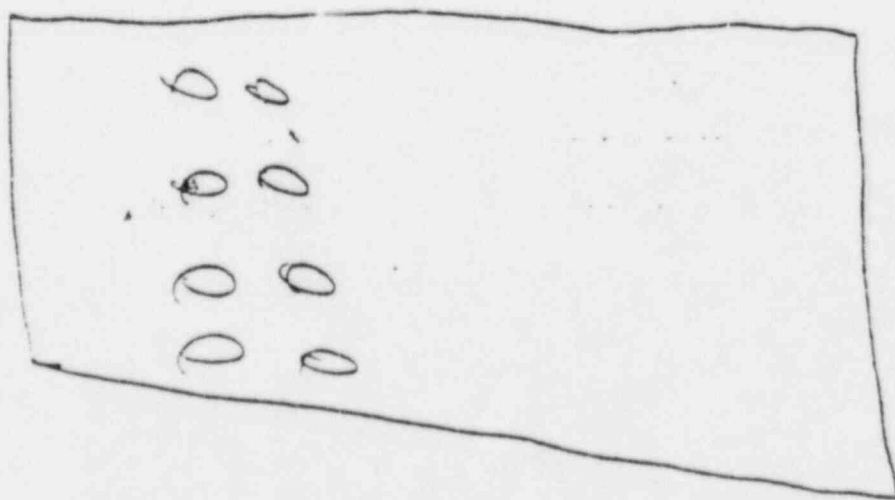
12 ([REDACTED] Exhibit 2, the document just
13 referred to, follows:)

This is a real good example. These tube
support sheets came in. We laid them on top of each other
and we put dowel pins in them. Some of the holes was
three-eighths of an inch off from the others, you know.

So I called [REDACTED] and I told him, I said we
are going to have a problem here. These holes are way off.
Well, he calls Westinghouse, and Westinghouse says oh,
there is nothing to it. [REDACTED] says, [REDACTED], they are just
three-eighths of an inch off. I said well, you have got
three foot from the center of one sheet to the other, and
when you start off with three-eighths of an inch off you
are off quite a ways when you get to the other end, you
know, the three foot.

If you go three-eighths of an inch off, over
here you might be an inch and a half off, and by the time
you turn it back in then automatically you are going to
head the other way. So you are binding every sheet. You
are cutting into the tubes.

1 certain amount of clearance so that tube can roll in and
2 without binding. They are cut in two here.

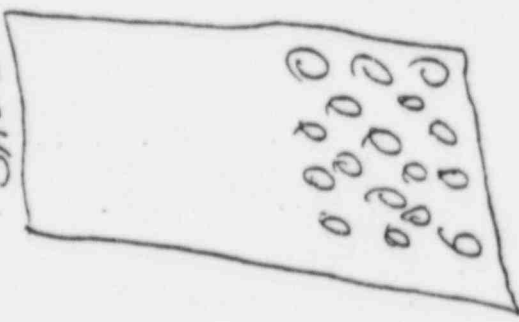
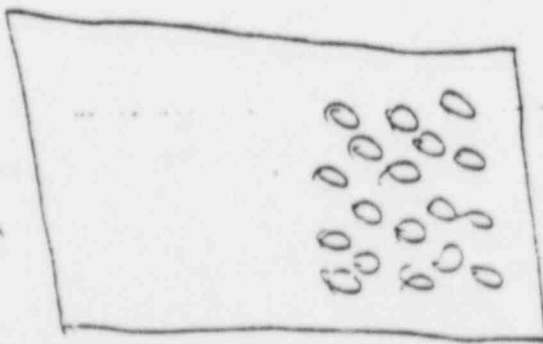
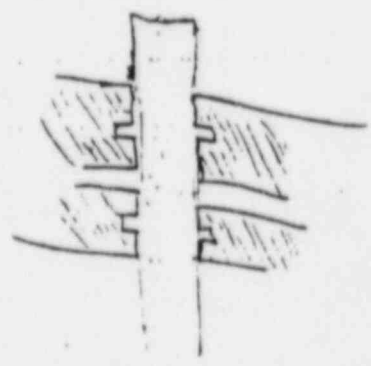
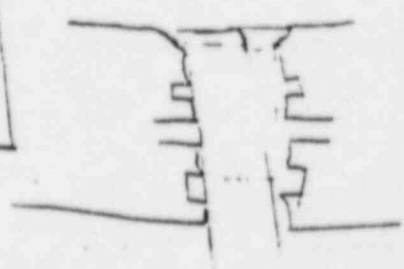
([REDACTED] Exhibit 3, the document just
referred to, follows:)

5 [REDACTED]: On your inlet tube sheets.
6 They are 1/32nd flush, the tubes, and they are flared. If
7 they are sticking out, you get a build-up between your
8 tubes. So when we flared these we busted a lot of tubes,
9 or quite a few of them as a matter of fact.

10 Now this chart, and it sticks out, but we cut
11 them down like a half inch so it would look half way
12 decent. But when we was flaring these tubes they was
13 busting pretty bad, and the reason they was busted so bad
14 in this one area is because the counterbore in your tube
15 sheet where it allows the flare to flare out was way
16 overboard. So in order for us to flare it tight enough we
17 busted a tube, and the ones that didn't bust we hadn't
18 flared it tight enough. When you don't flare them tight
19 enough you get a build-up between your sheet and your
20 tubes and it eats the tube off.

[REDACTED]: We have got cracks here on these flares.

[REDACTED]: Yes, Glen Rose, Texas at Comanche Peak. Most of them is in condenser A on the inlet end east water box middle way of the sheet.

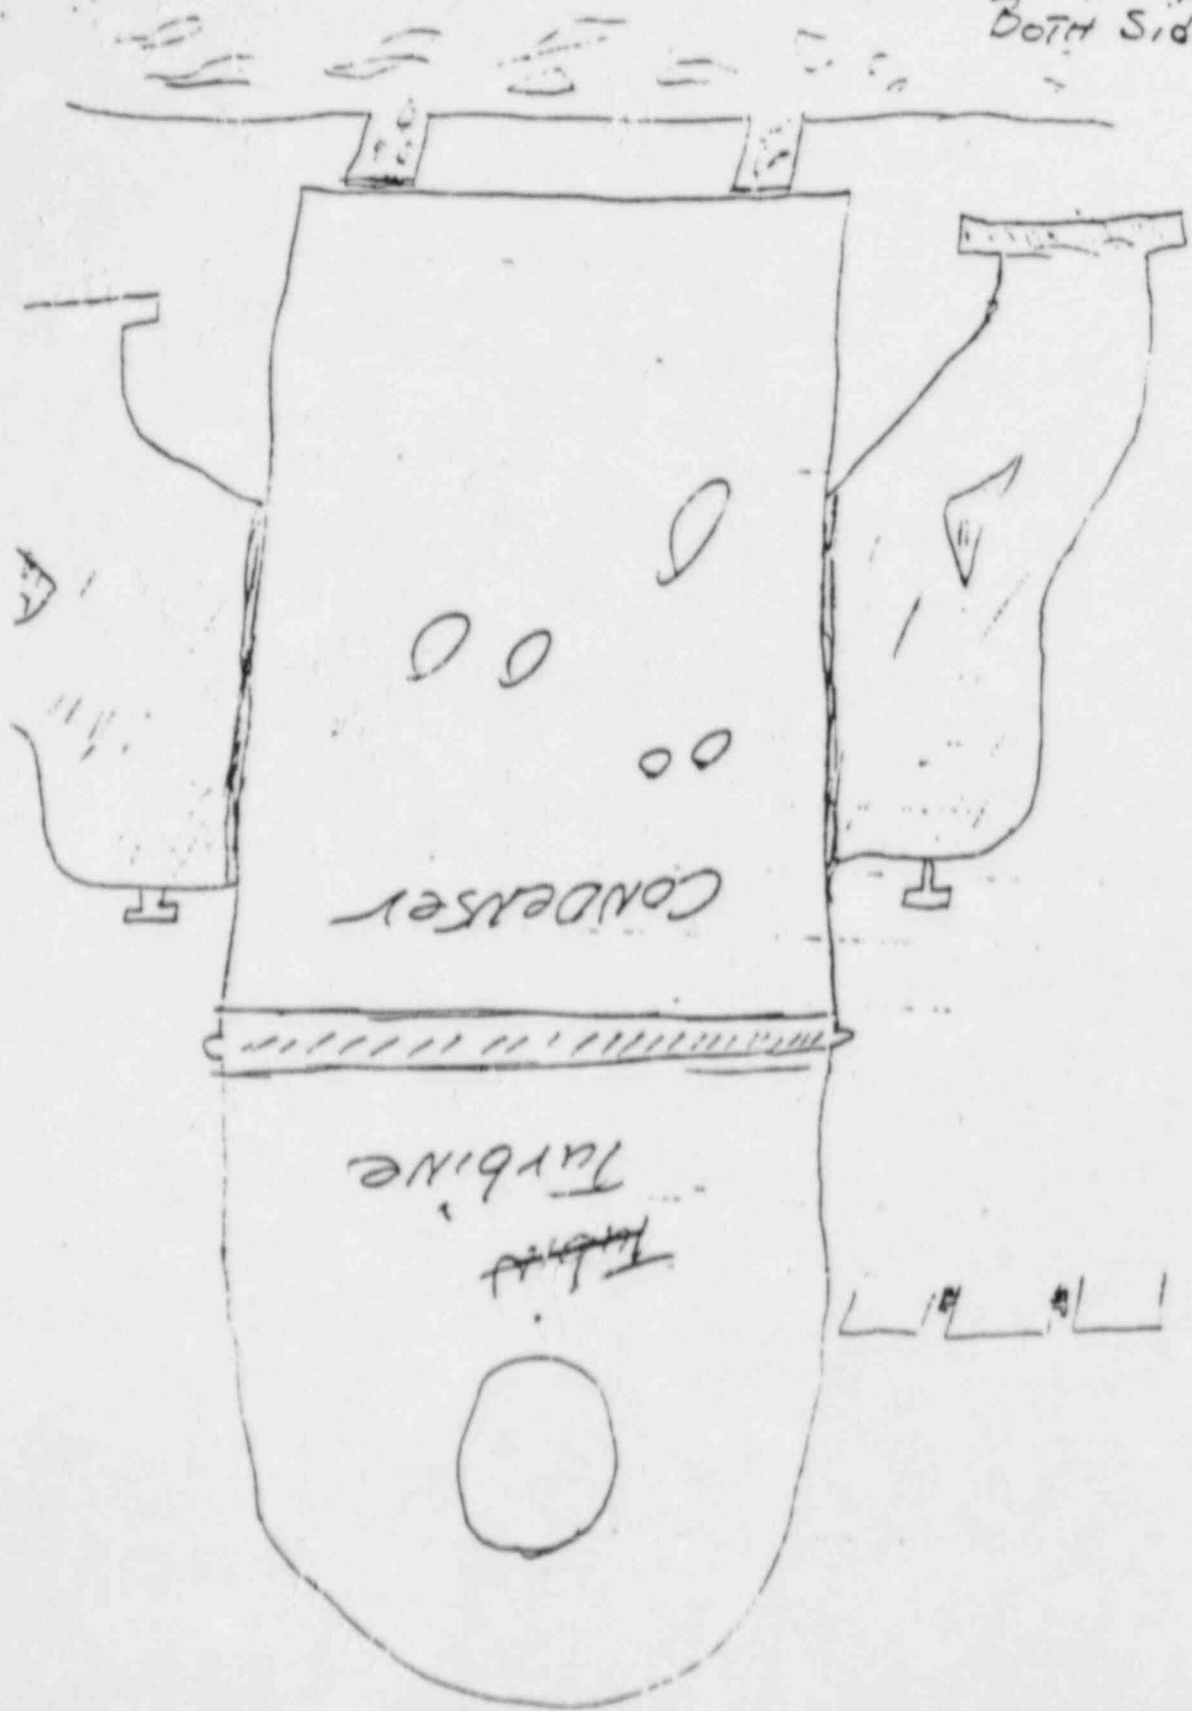
([REDACTED] Exhibit 5A and 5B follows:)

They took a reading and they was three-eighths of an inch off alignment. So they went up here and they took jacks and they started jacking and, boy, jacked it all the way over to where they want it and they release it, that little old expansion joint, and pulled it back. The little expansion joint was a one loop and it was an eighth of an inch thick and it had one little fillet weld on each side of it, real weak. They put several, several tons on it. I will show you what it looked like.

4 [REDACTED]: (Referring to Exhibit 5B) Oh,
5 this is the expansion joint I was talking about with the
6 fillet welds. It is a real small stainless steel 1/8th
7 expansion joint and it has got two small, little fillet
8 welds there.

11 [REDACTED]: We put several, several, I
12 think two or three hundred tons against it.
