LICENSEE EVENT REPORT (LER)

FACILITY NAME (1) Fort St. Vrain, Unit No. 1	DOCKET NUMBER (2) 0 5 0 0 0 2 6 1 7	PAGE (3) 1 OF 0 5
---	--	----------------------

TITLE (4)
Loss Of 480V Bus 1 - Loop 1 Shutdown

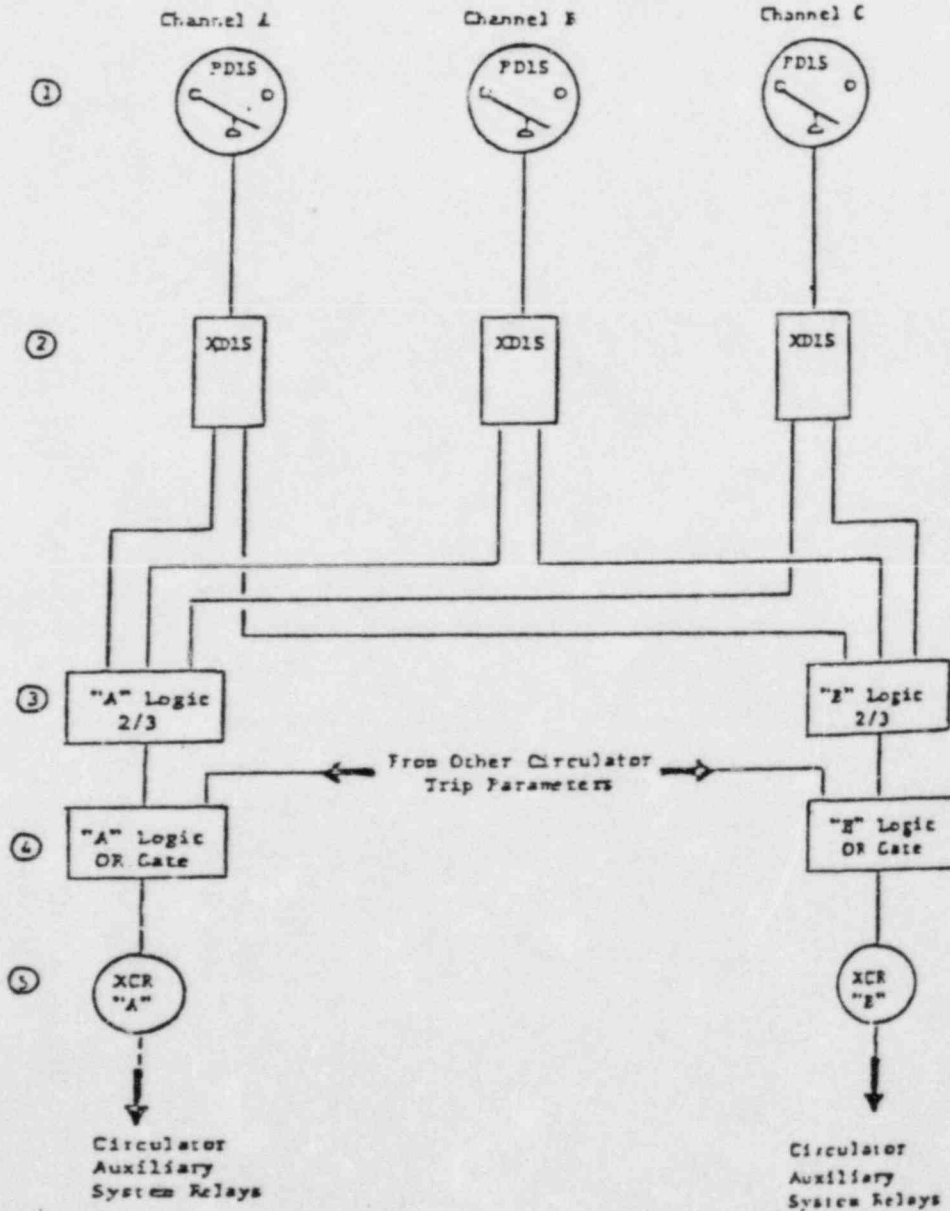
FIGURE 1

Referring to Figure 1, as the pressure differential between the water supply cavity and the main drain decreases, the pressure differential switches (PDIS) [1] will individually close at their respective setpoints. This applies a voltage to the switch input modules (XDIS) [2], tripping them. Each tripped XDIS module transmits a signal to both "A" and "B" logic channels [3]. When either "A" or "B" logic receives inputs from any two of the three XDIS modules, they will transmit a signal to the "A" or "B" logic OR gate [4] respectively. The OR gates transmit any input signal to the respective special control relay (XCR) [5] to energize auxiliary relays which trip the helium circulator and initiate the following helium circulator protective actions:

1. Isolation of the steam and water turbine supply and return lines.
2. Fire the bearing water accumulator system, which initiates a surge of bearing water, to allow coastdown of the circulator.
3. Apply the brake when speed has decreased below 700 RPM.
4. Apply the mechanical shutdown seal.
5. Isolate the remaining circulator auxiliaries.

TYPICAL FOR EACH CIRCULATOR
