SAFETY EVALUATION BY THE NUCLEAR REGULATORY COMMISSION

FORT CALHOUN STATION, UNIT NO. 1

OMAHA PUBLIC POWER DISTRICT

DOCKET NO. 50-285

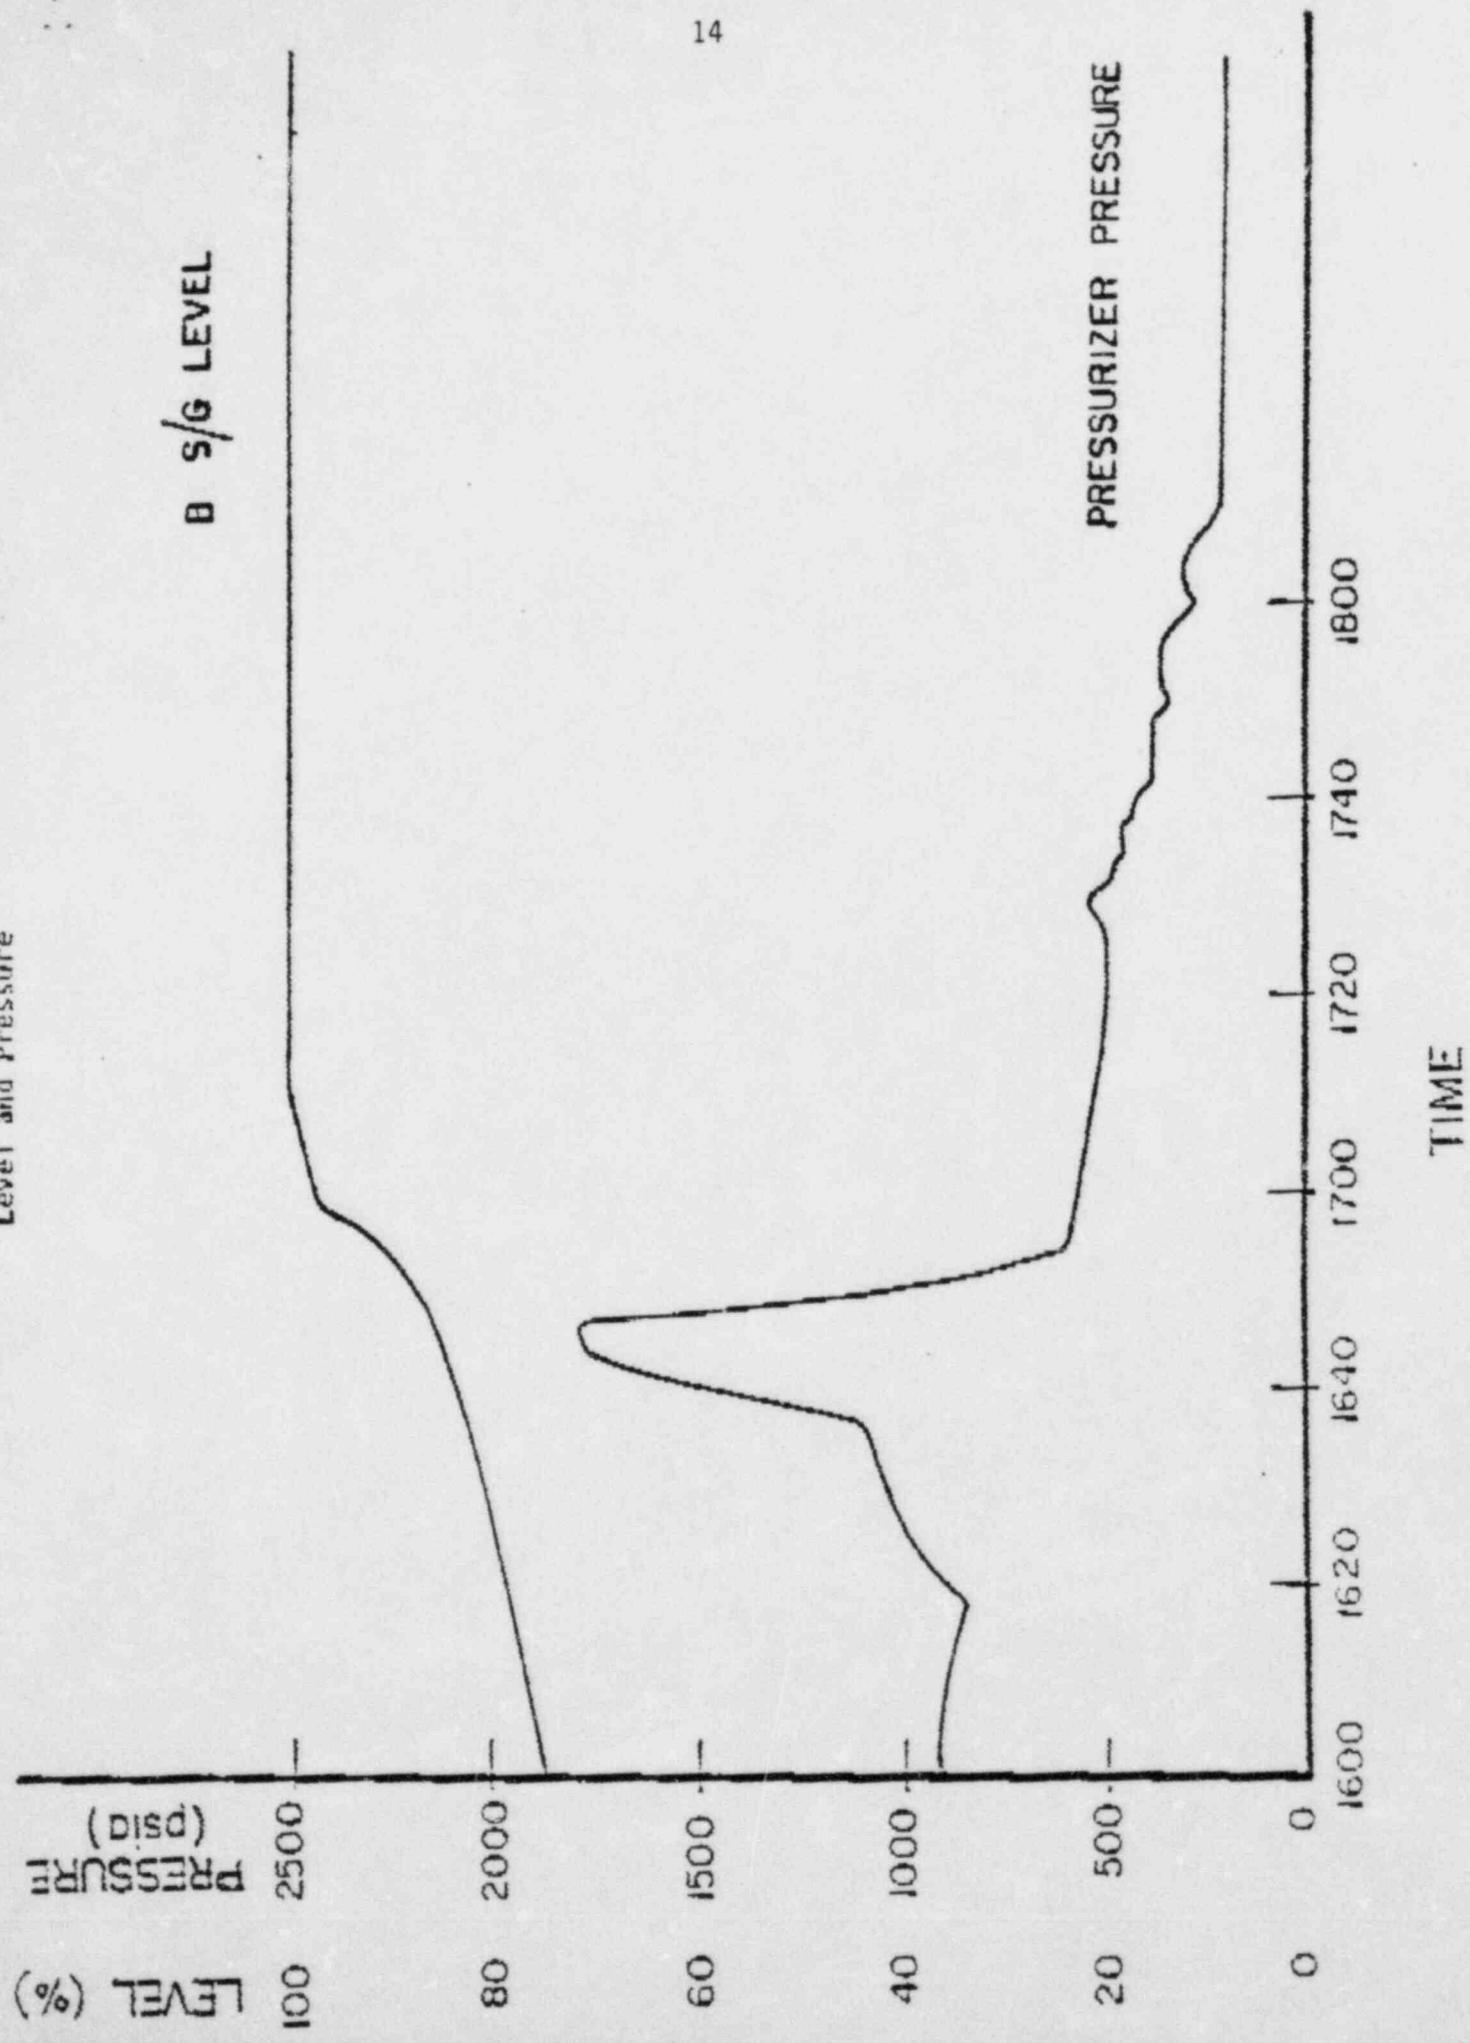
Figure 1: Time Sequence Relating to Steam Generator Level and Pressure

The reactor coolant system was depressurized in a few minutes; it was cooled down in a few hours using the A steam generator and the atmosphere steam dump valve. Figure 1 illustrates the reactor coolant system pressure and the B steam generator water level as a function of time during the event. Table 1 contains a more detailed time history of the event, including initial conditions.
