SUBJECT: NRC INSPECTION REPORT 40-1162/98-01

Report No. 40-1162/98-01

Facility: Site of former Split Rock Mill

Dates: May 11-14, 1998

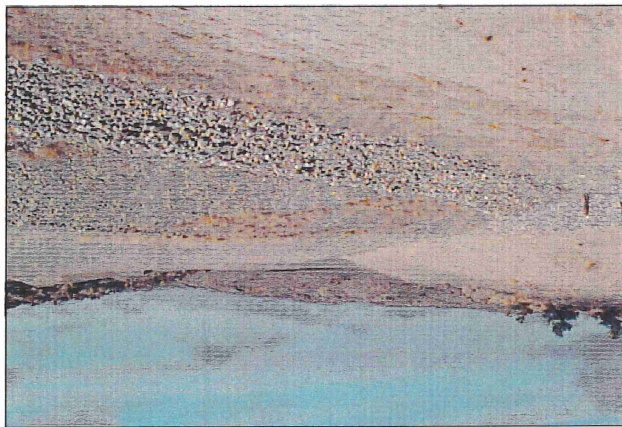
Northwest section of tailings impoundment and north-central diversion ditch.

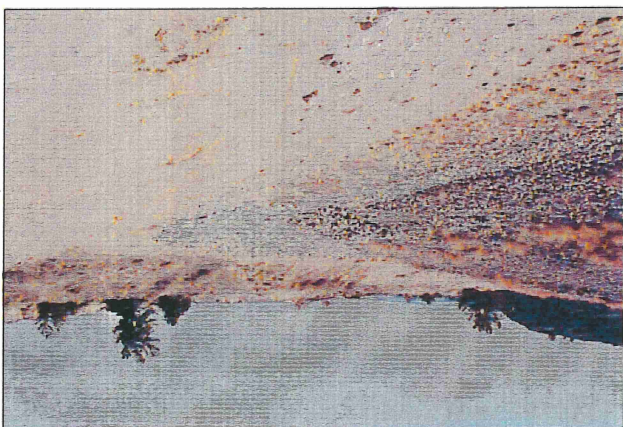
North-central diversion ditch with rip-rap.

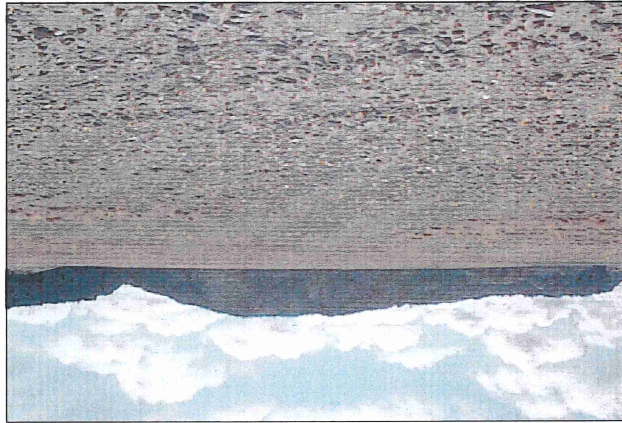
Top of tailings impoundment area reclaimed during 1994-1996.

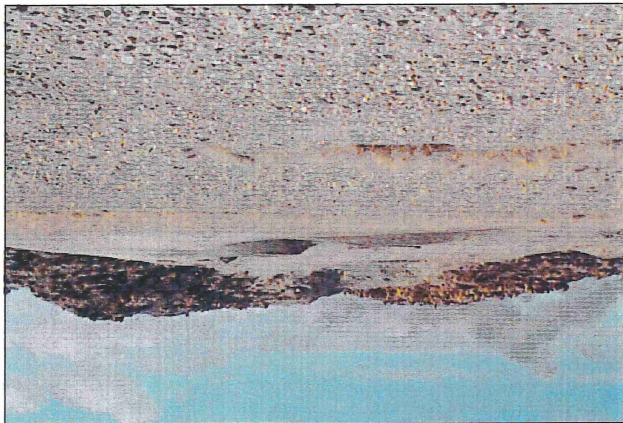
Rock stockpile area exempted from radiological cleanup.

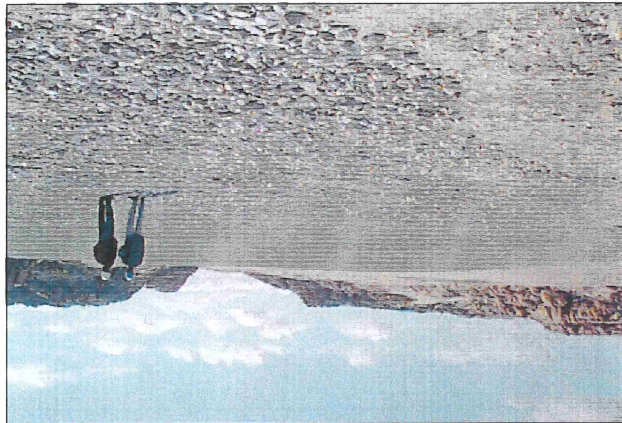
Top of tailings impoundment area reclaimed during 1997.

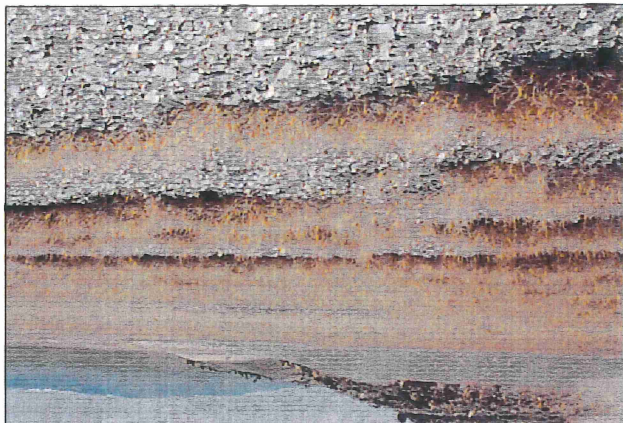
Vegetation on top of tailings impoundment area reclaimed during 1996.

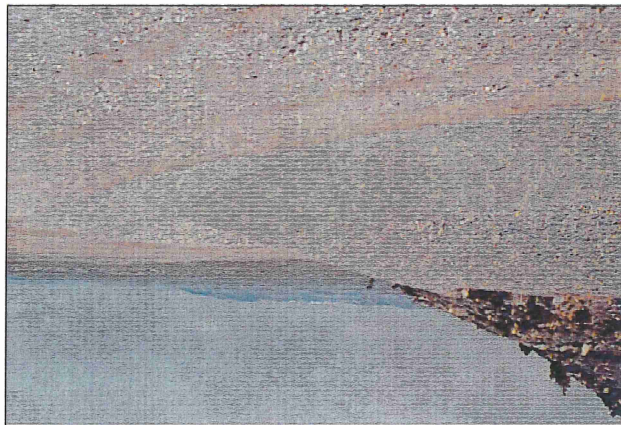
South diversion ditch with varying rip-rap gradations.

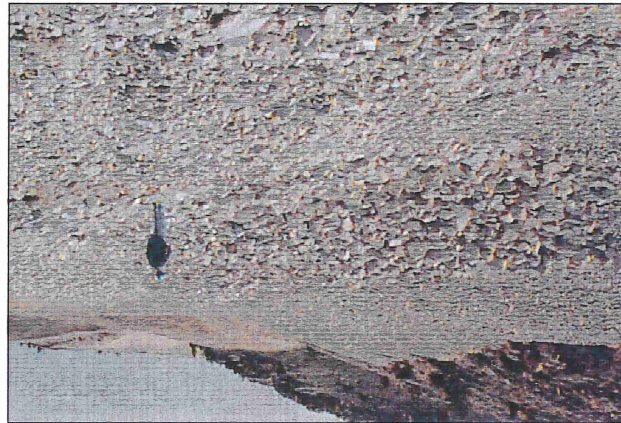
Southwest section of tailings impoundment and south diversion ditch with 18-inch rip-rap.

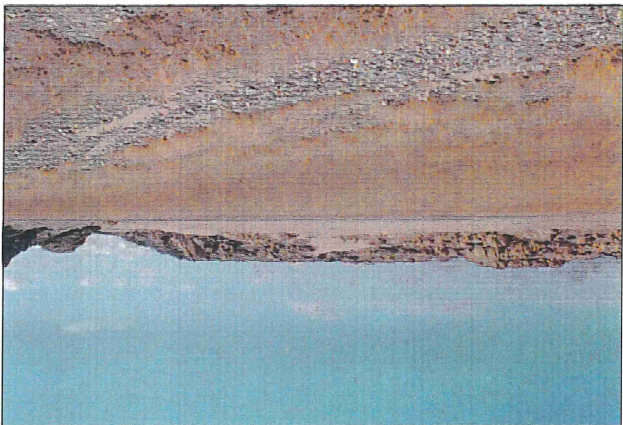
Northeast section of tailings impoundment.

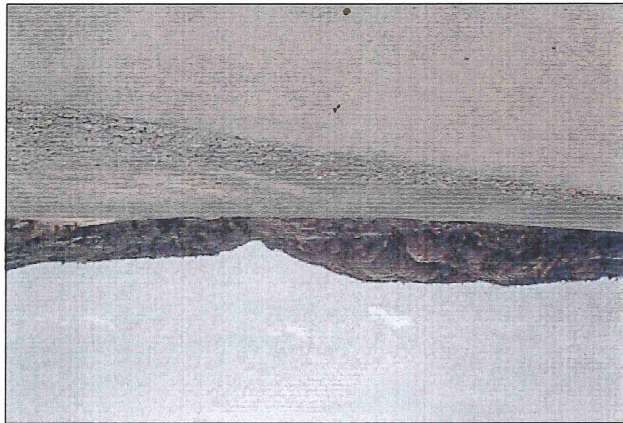
Confluence of north diversion ditch and drainage swale on top of tailings impoundment.

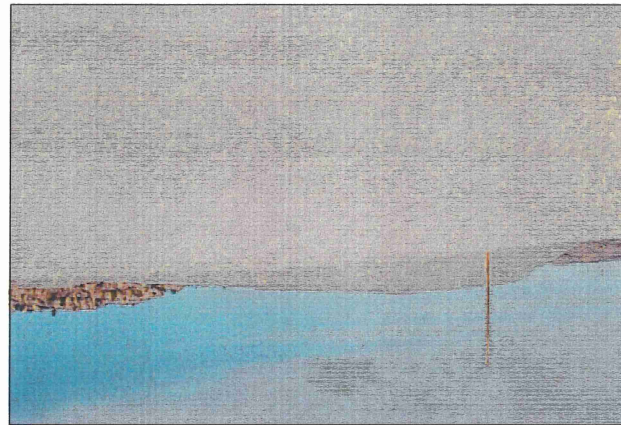
Area of windblown cleanup (foreground) and rock exempted from cleanup (background).

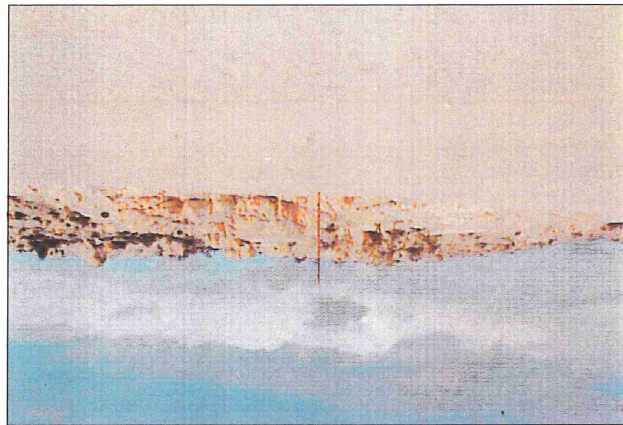
Area of windblown cleanup near northeast environmental monitoring station.

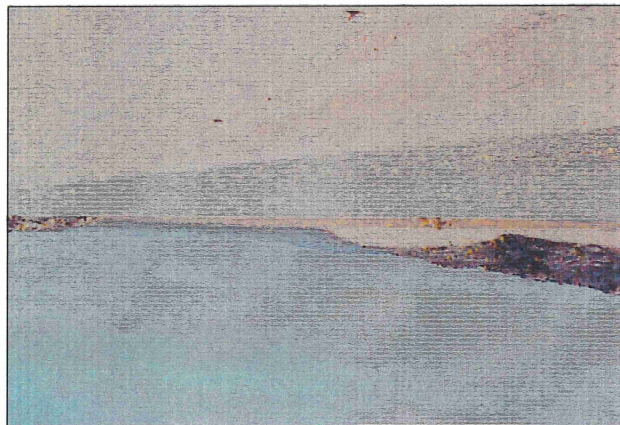
Tailings impoundment areas reclaimed during 1997 (foreground) and 1996 (background).

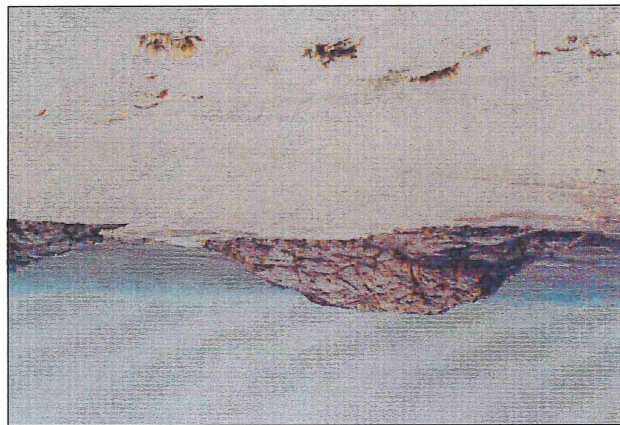
Windblown cleanup performed in Northeast Valley area.

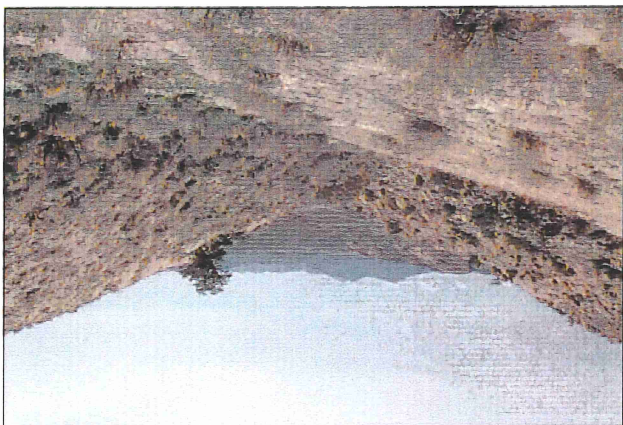
Front side of North Dune area exempted from radiological cleanup.

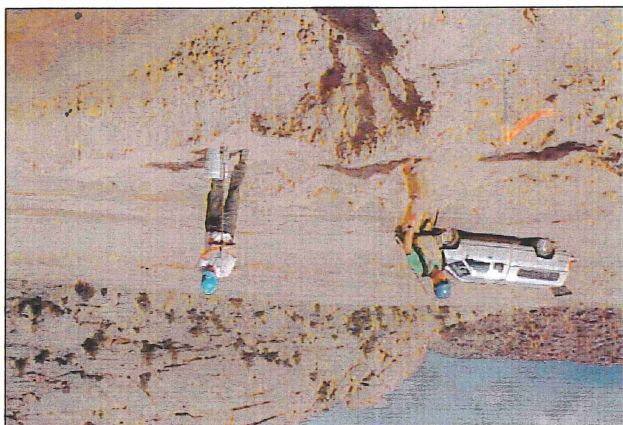
Licensee personnel performing gamma survey and soil sampling in NRC-selected grid.

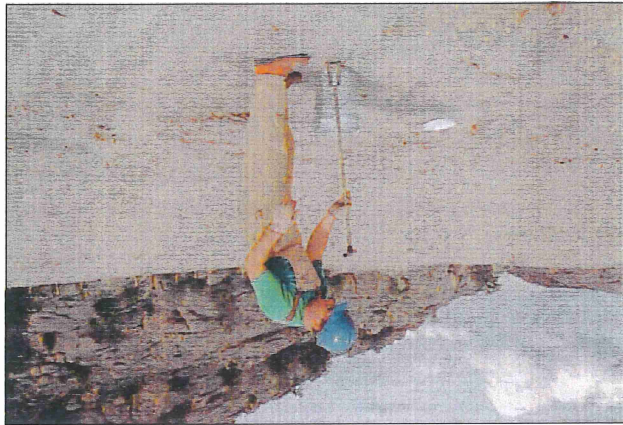
Soil sampling in progress by licensee personnel.

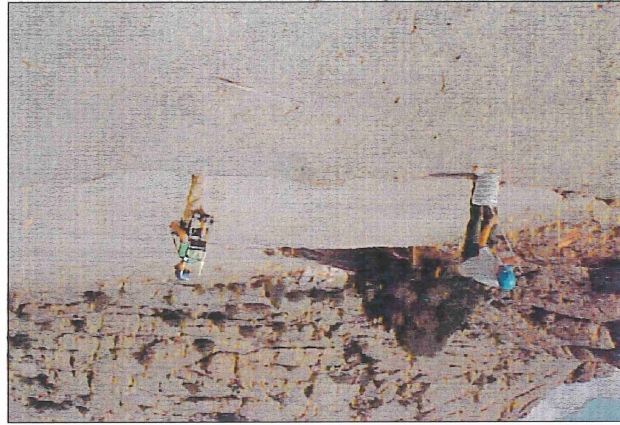
Gamma scanning and soil sampling by licensee personnel.
