SUBJECT: NRC INSPECTION REPORT 40-1162/98-01

Report No. 40-1162/98-01

Facility: Site of former Split Rock Mill

Site of Former Western Nuclear Split Rock Mill NRC Inspection Report 40-1162/98-01

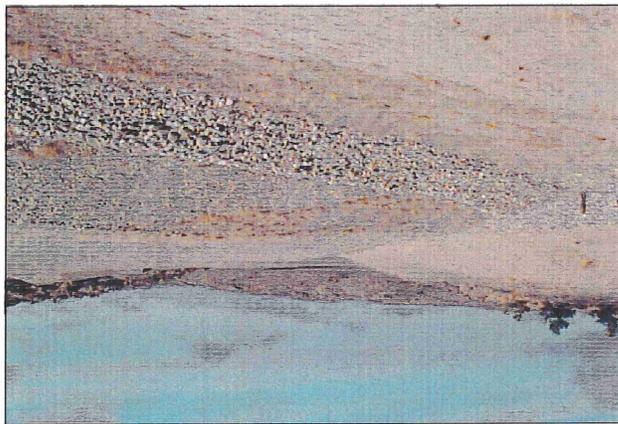
Northwest section of tailings impoundment and north-central diversion ditch.

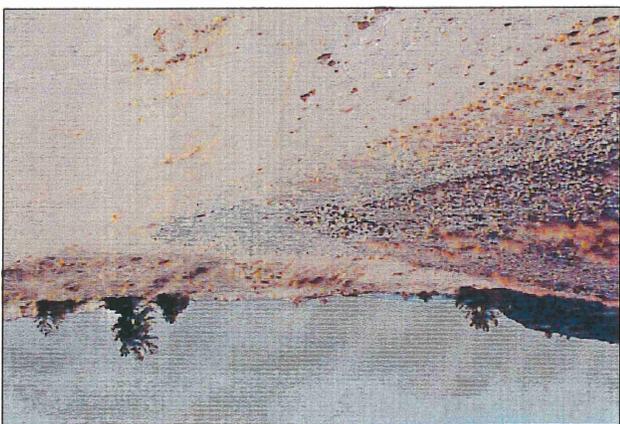
North-central diversion ditch with rip-rap.

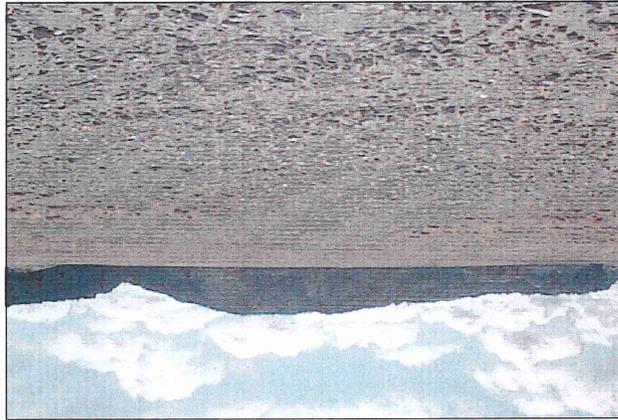
Top of tailings impoundment area reclaimed during 1994-1996.

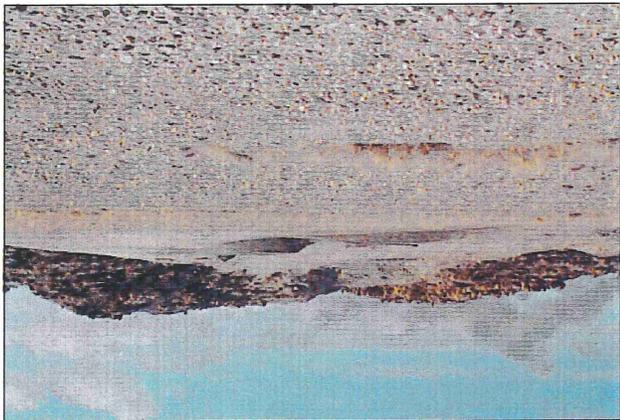
Rock stockpile area exempted from radiological cleanup.

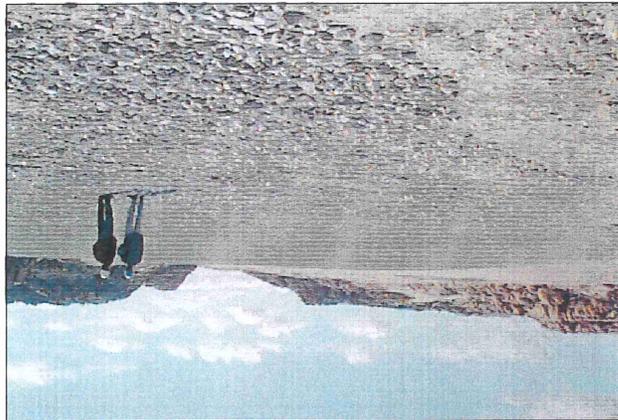
Top of tailings impoundment area reclaimed during 1997.

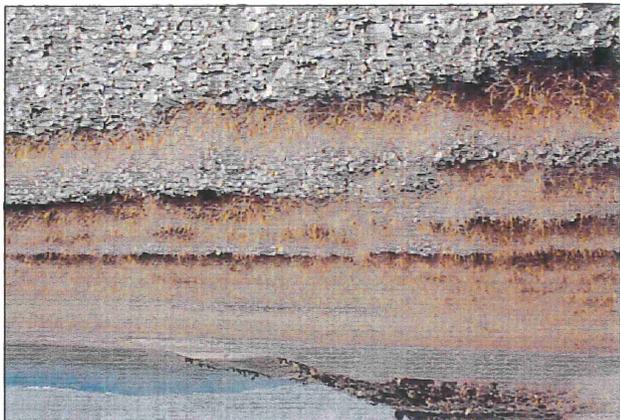
Vegetation on top of tailings impoundment area reclaimed during 1996.

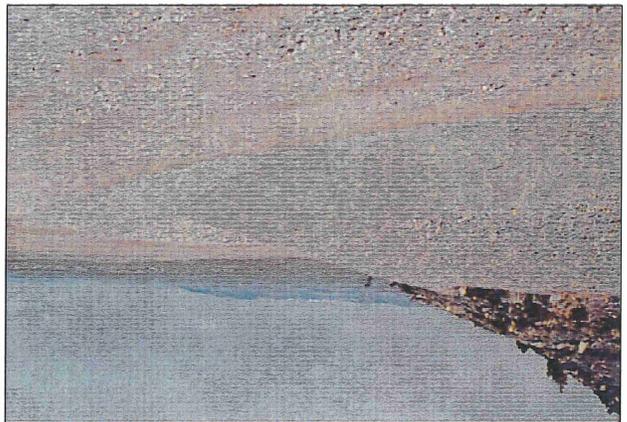
South diversion ditch with varying rip-rap gradations.

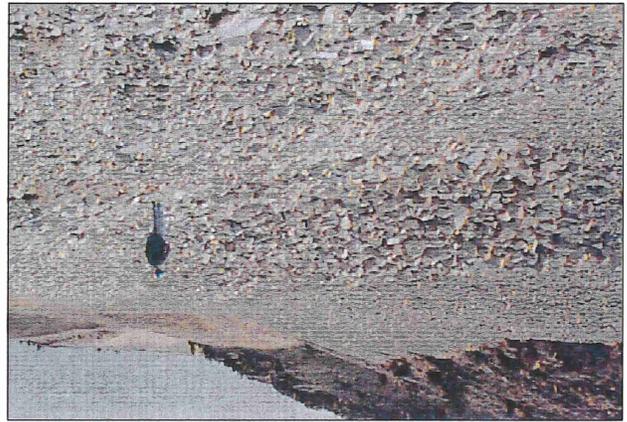
Southwest section of tailings impoundment and south diversion ditch with 18-inch rip-rap.

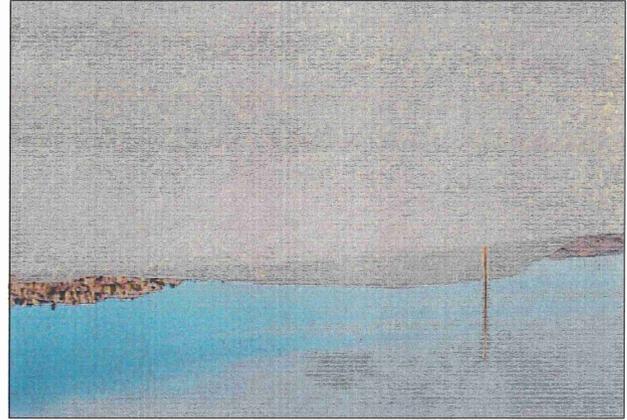
Area of windblown cleanup (foreground) and rock exempted from cleanup (background).

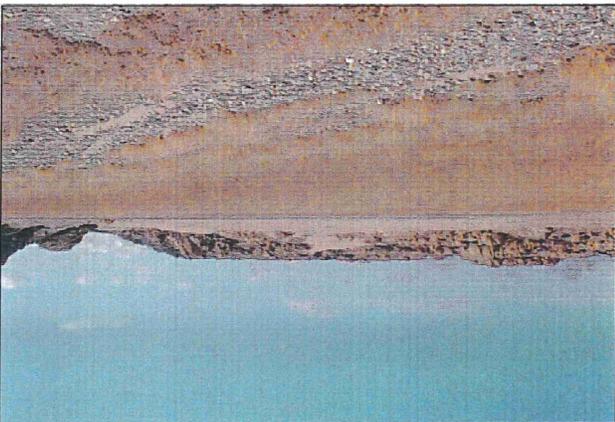
Northeast section of tailings impoundment.

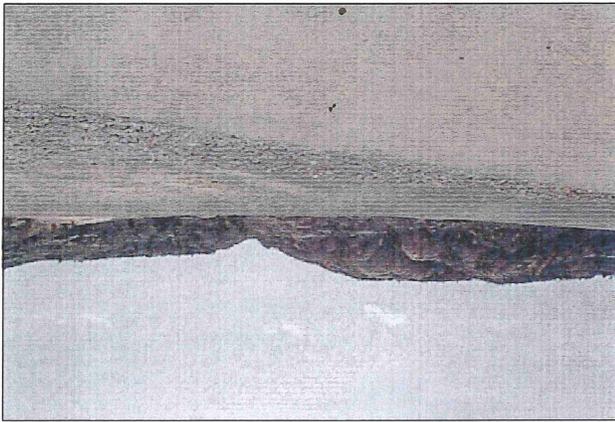
Confluence of north diversion ditch and drainage swale on top of tailings impoundment.

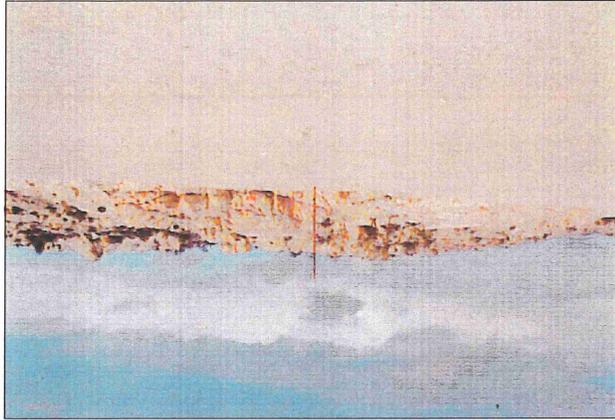
Area of windblown cleanup near northeast environmental monitoring station.

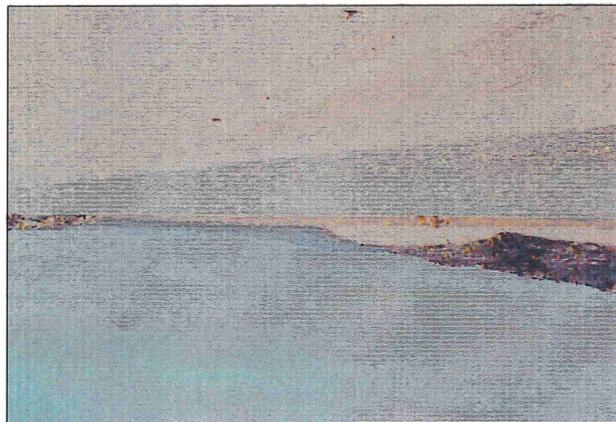
Tailings impoundment areas reclaimed during 1997 (foreground) and 1996 (background).

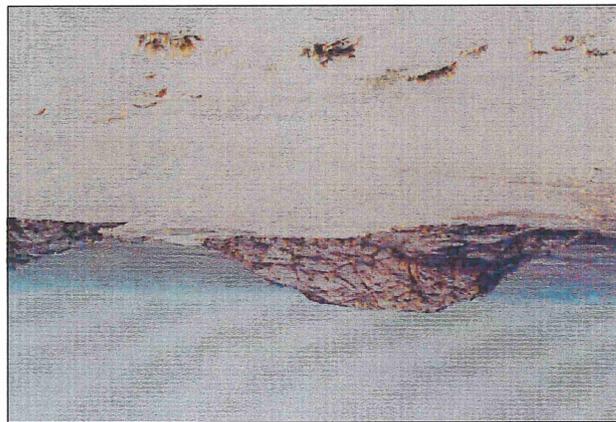
Windblown cleanup performed in Northeast Valley area.

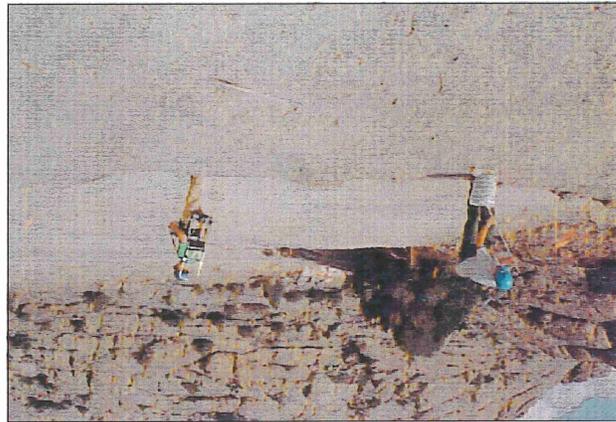
Gamma scanning and soil sampling by licensee personnel.

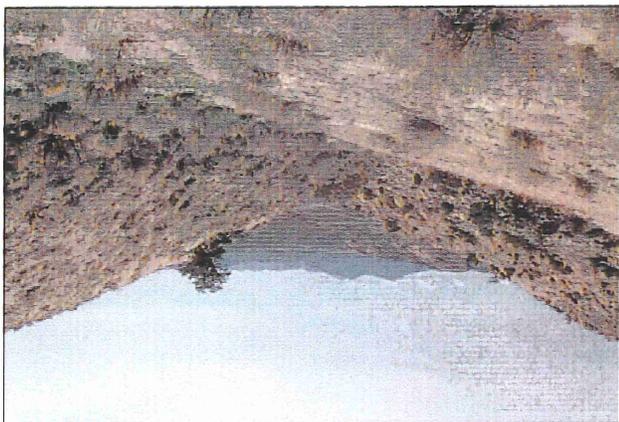
Front side of North Dune area exempted from radiological cleanup.

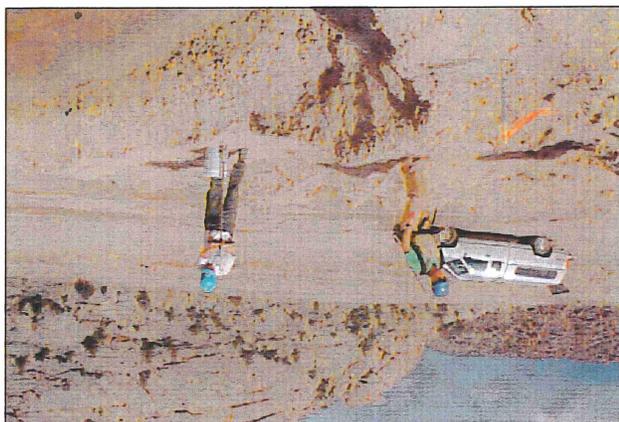
Licensee personnel performing gamma survey and soil sampling in NRC-selected grid.

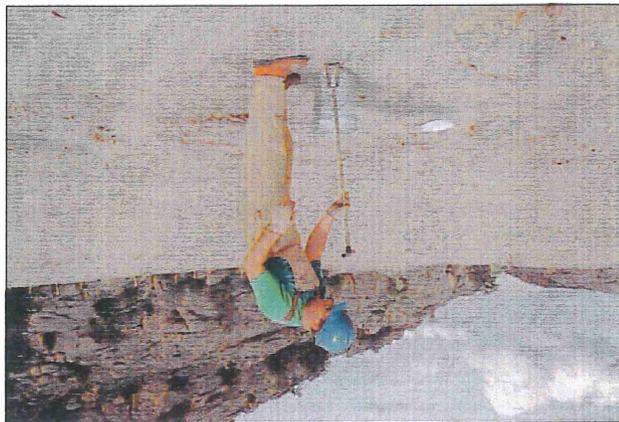
Soil sampling in progress by licensee personnel.
