U.S. NUCLEAR REGULATORY COMMISSION
REGION IV

Inspection Report: 50-361/95-14
50-362/95-14

Facility Name: San Onofre Nuclear Generating Station, Units 2 and 3

Inspection Conducted: July 10 through August 8, 1995, onsite and in-office
review through August 30, 1995

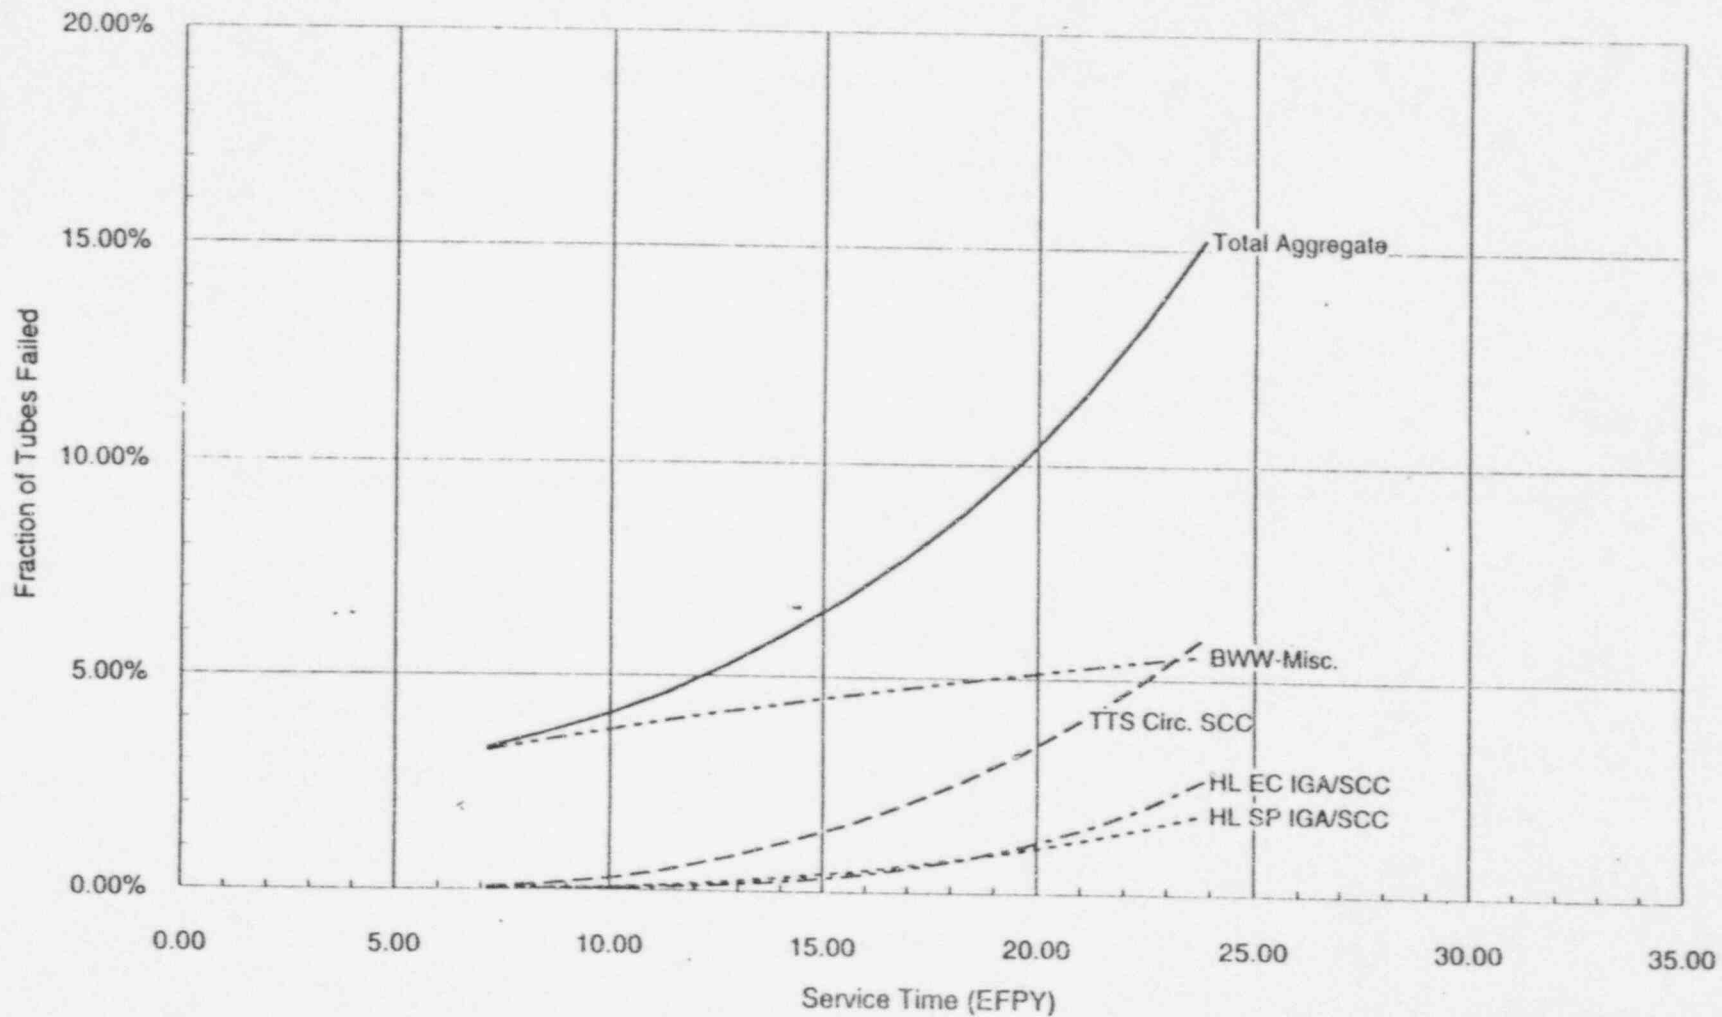
Figure 1

**San Onofre Nuclear Generating Station, Unit 2
Steam Generator Tube Degradation Predictions
($T_{hot} = 609\text{ }^{\circ}\text{F}$)**

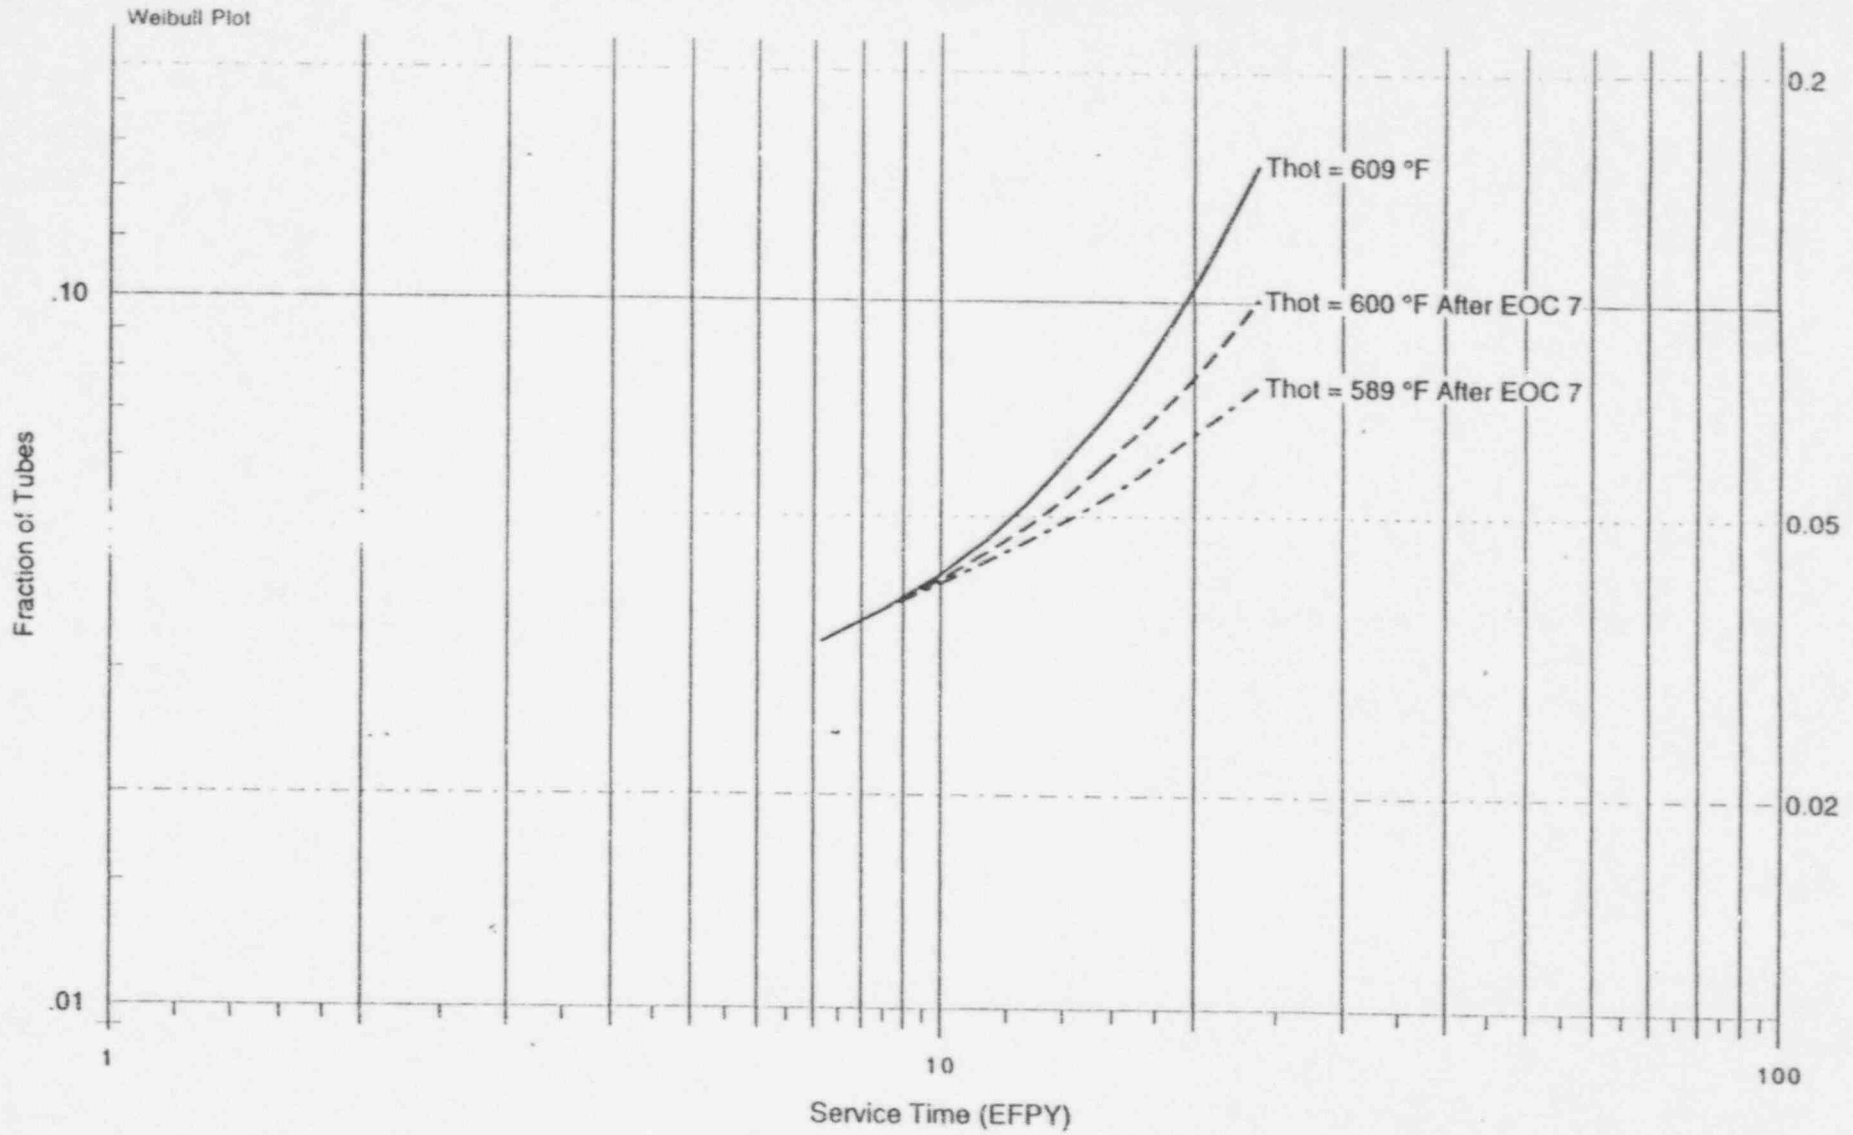
Figure 3

**San Onofre Nuclear Generating Station, Unit 2
Aggregate Steam Generator Tube Degradation Prediction**

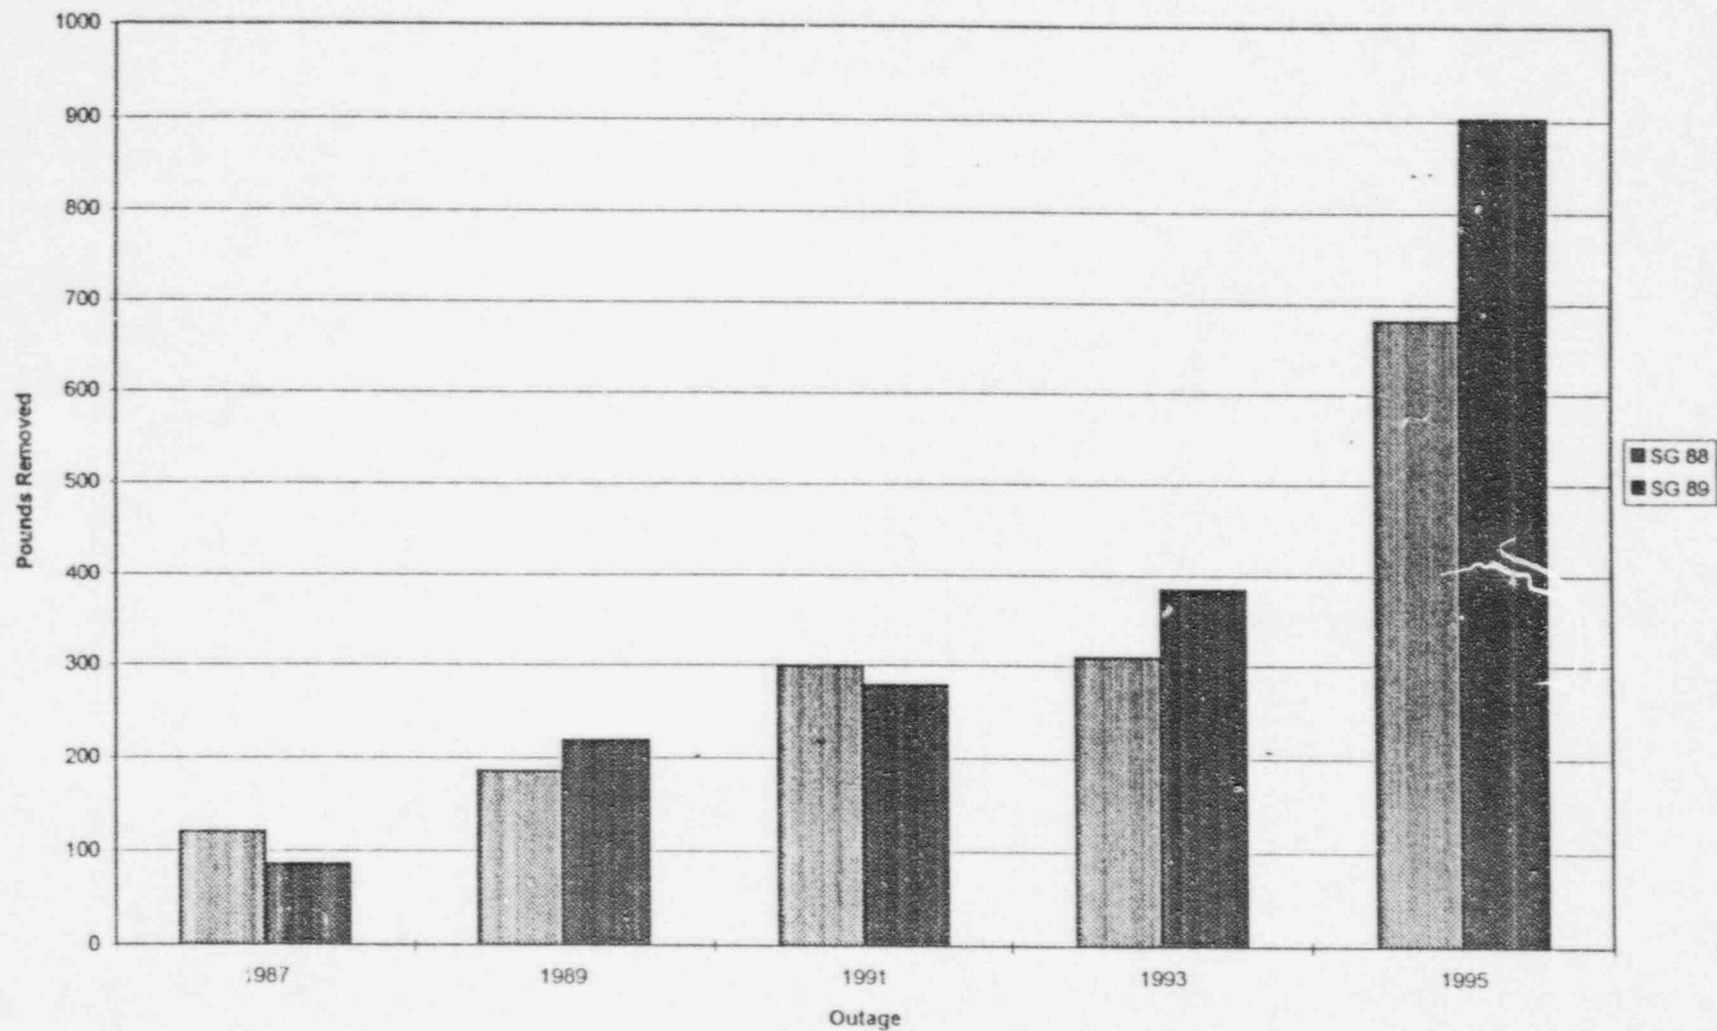
- Overall, the historical Units 2 and 3 data were considered by the inspectors to reflect progression to excellent current secondary water chemistry performance. However, an increasing trend in sludge removal amounts was also noted. Feedwater iron content (i.e., corrosion product transport to the steam generators) was, thus, considered to currently be the only secondary chemistry issue requiring continued management attention (Section 7.2).

SO2 SG Sludge Removal

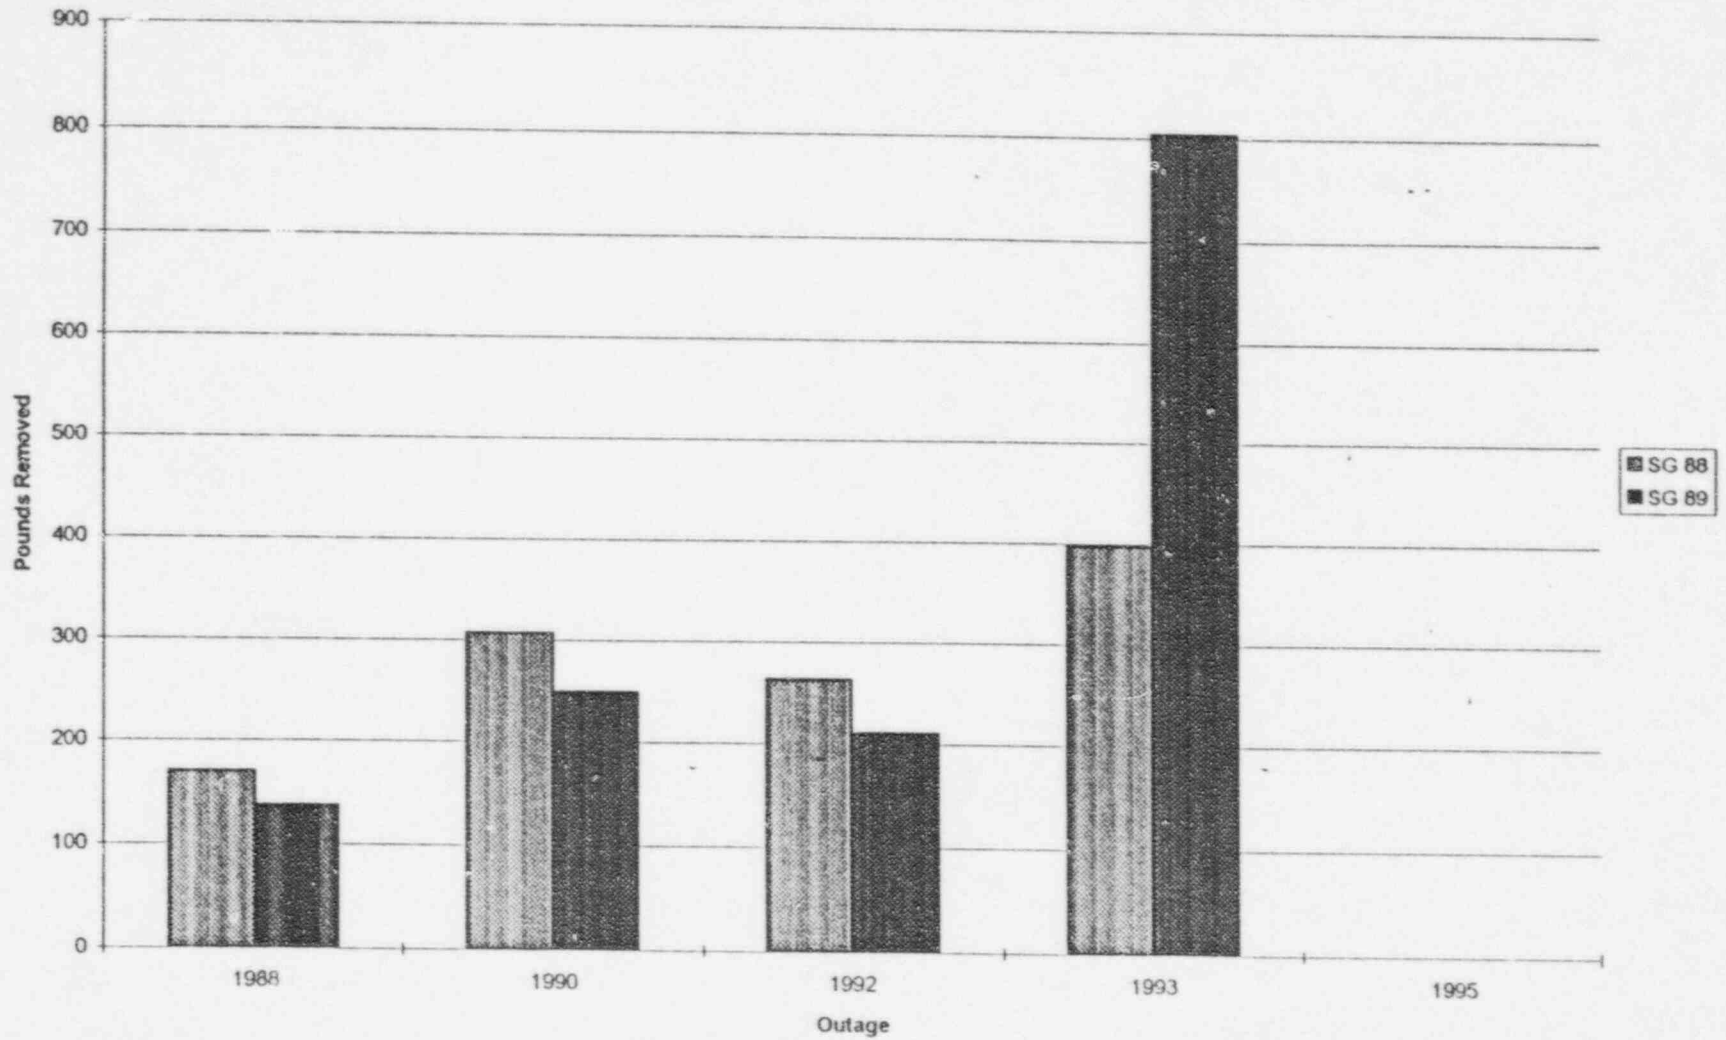
SO3 SG Sludge Removal
