Northeast
Nuclear Energy

Reference: Facility Operating License No. DPR-65
Docket No. 50-336
Licensee Event Report 95-035-00

LICENSEE EVENT REPORT (LER)

TITLE (4)
Misinterpretation of Technical Specification Surveillance Requirements for A.C. Systems

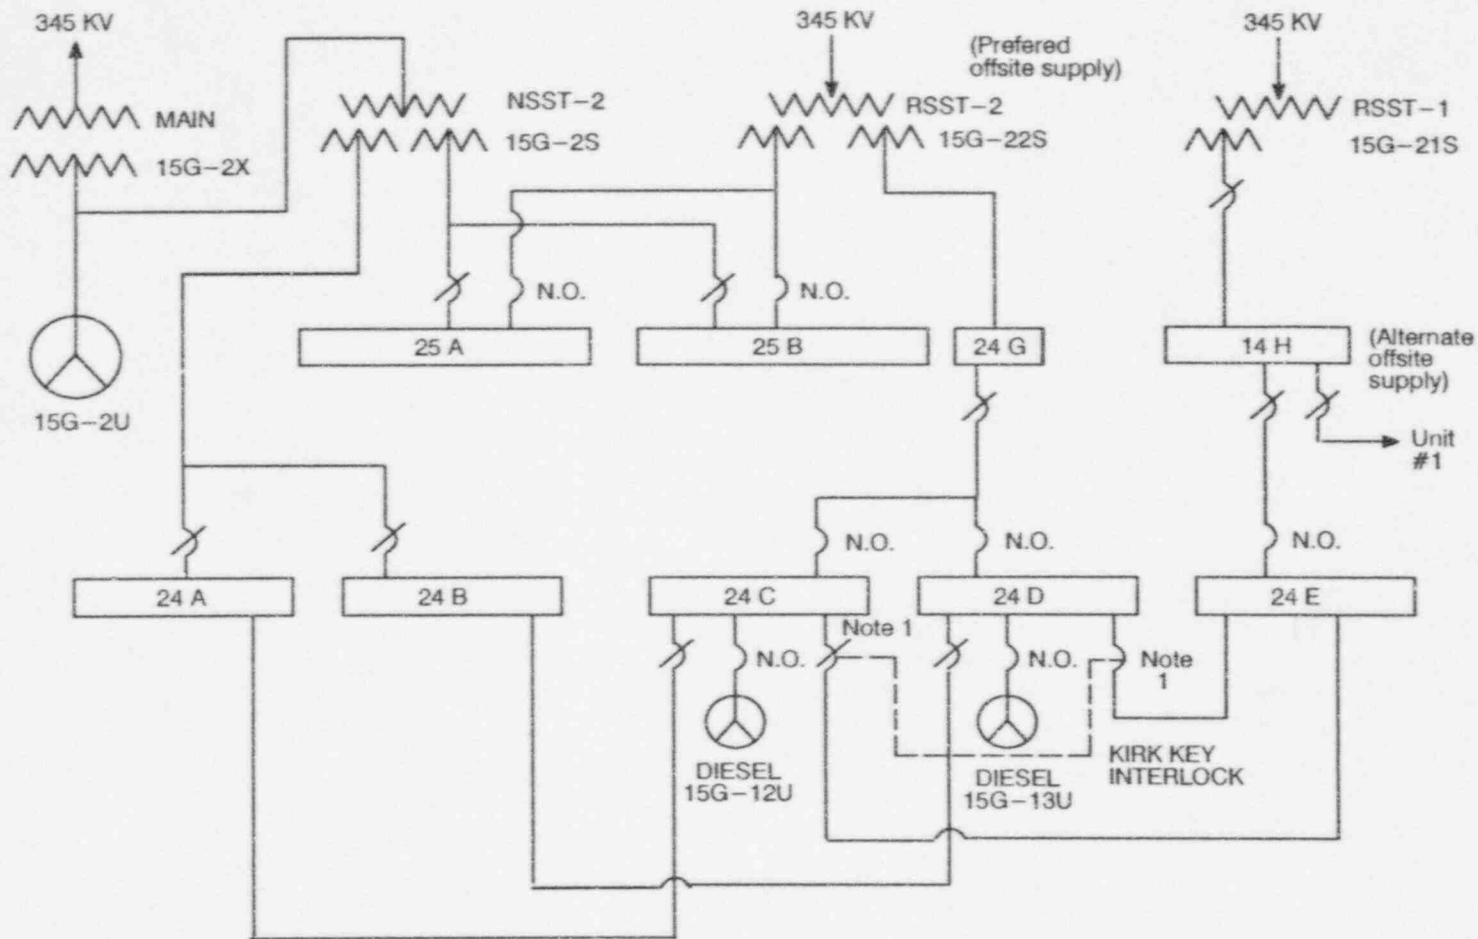
SIMPLIFIED MILLSTONE UNIT 2 SINGLE LINE DIAGRAM

For the preferred offsite power supply, the existing surveillance procedure for Technical Specification 3.8.1.1 did not provide the circuit breaker and voltage verifications necessary to adequately demonstrate the operability of the preferred supply from the switchyard to the onsite electrical distribution system. However, control room indication and alarms have provided the operator with information on the availability of the preferred offsite supply. A control room annunciator will alarm when the normally closed feeder circuit breaker is open.

For the alternate offsite power supply, the existing surveillance procedure did not provide the circuit breaker and voltage verifications necessary to adequately demonstrate its operability. However, control room indication and a Unit 1 operating procedure have provided the operator with information on the availability of the alternate offsite supply. A note in the Unit 1 operating procedure states that "Unit 2 should not require power from bus 14H prior to proceeding" when de-energizing the 14H bus.

1. Operability status of power transfer from Unit 2 RSST to buses 24C and 24D (preferred offsite supply).
2. Operability status of power transfer from bus 14H to bus 24E (alternate offsite supply).
