MIDLAND - D. Gillen's Status Report

SUBJECT: MIDLAND UNITS 1 & 2 - GEOTECHNICAL ENGINEERING
PROBLEMS RELATED TO PLANT FILL

Midland Units 1 & 2

History of Geotechnical Engineering Problems Related to Plant Fill

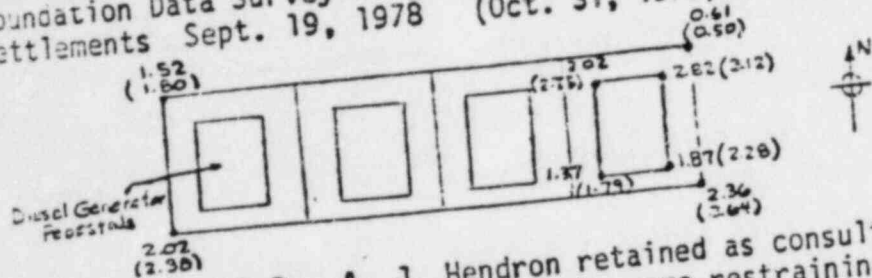
- B. Diesel Generator Building (Cat. I Structure)
1. Settlement data first recorded July 10, 1978. (larger than expected)
 2. Settlement approaching maximum value in FGAR Fig. 2.C-40 August 21, 1978
 3. Exploratory Program begun August 25, 1978 (Dutch cone)
 4. Oral report to NRC (I&E) Sept. 7, 1978
 5. Foundation Data Survey Program expanded Goldberg, Zoino & Dunicliff
 6. Settlements Sept. 19, 1978 (Oct. 31, 1978) (in inches)

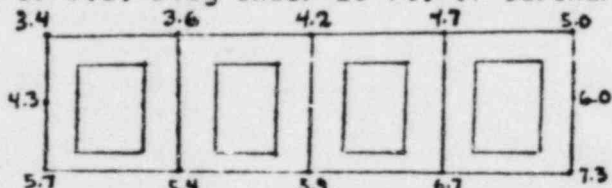
- c. Recent change to permanent dewatering system to replace chemical grouting (see Page 3.)
16. Settlement of D.G. Bldg under 20 ft. of surcharge (6-29-79) (in inches)

17. Present plans call for removal of preload in September, 1979.
18. Preload (full scale load test) data will provide relationship between settlement and load \Rightarrow used to predict residual settlements of structure

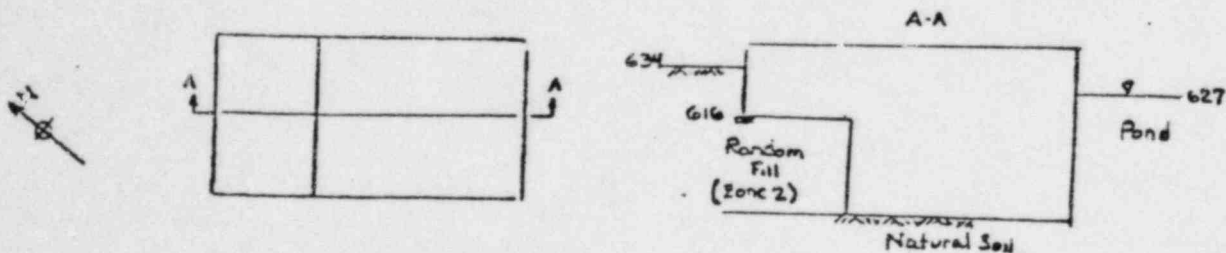
2. Plan and Cross Section:

5. Supporting soil conditions: soft to very stiff clay and loose to very dense sand backfill over medium to very dense sand over glacial till.
6. Investigative conclusions

- a. Some areas of support fill have not been sufficiently compacted
 - b. No settlement evident because existing dead loads are being supported by cantilever action

- c. Analysis indicates total design load cannot be supported by cantilever action.
7. Proposed corrective action
 - a. Predrilled bearing piles to be placed under the north wall of the structure → concrete filled steel pipe piles penetrate into bearing stratum at Elev. 587 ft; Design capacity - 100 tons

- b. Horizontal loads will be carried by deeper part of structure
 - c. Detail drawings on Fig. 83. (Beurtel)

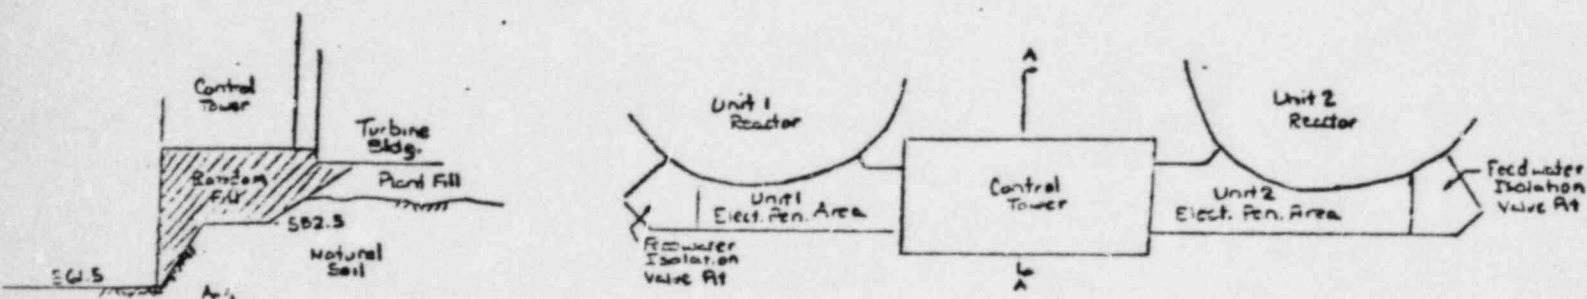
2. Plan and Cross Section

3. Soil Exploration
 - a. Twelve borings made in area
 - b. Control Tower (3 borings)
 - Medium to very dense sand backfill over glacial till
 - local void under mudmat Elev. 590-589 (boring Ax-9)
 - c. Unit 1 Electrical Penetration Area (2 borings)
 - dense to very dense sand backfill with occasional layers of loose sand and soft clay over glacial till - layer of concrete Elev. 583.5 to 580.

- d. Unit 2 Electrical Penetration Area (2 borings)
 - Generally same as C.
- e. Units 1 and 2 Feedwater Isolation Valve Pits (5 borings)
 - Loose to dense sand and medium to very stiff clay backfill with occasional soft zones over dense glacial till - concrete used as backfill in spots

- a. Void under concrete mudmat in control tower area
- b. Backfill material under electrical penetration areas and valve pits has not been sufficiently compacted

- a. Pressure grouting to fill the void under the mudmat.
- b. Unsuitable backfill under elect. pen. areas and valve pits removed and replaced by lean concrete \geq 2000 psi comp. strength

- Temporary support for valve pits \Rightarrow supported externally from turbine bldg. and buttress access shaft
 - If external support of Elect. Pen. areas is necessary, steel girder resting on containment ring girder and turbine building crane column will be provided.

- When dewatering has lowered GWT to Elevation 600 ft., access shafts will be dug from 634' to 603' and tunnels made under valve pits
 - Temporary support system installed under the ends of the electrical penetration areas jacked piles, caissons or concrete piers.

- Excavation and removal of unsuitable fill will be done by manual or mechanical means
 - Upon completion of excavation, the excavated area will be backfilled with lean concrete; 5 ft maximum lift thickness (first lift 2 ft); successive lifts doweled into preceding lift.

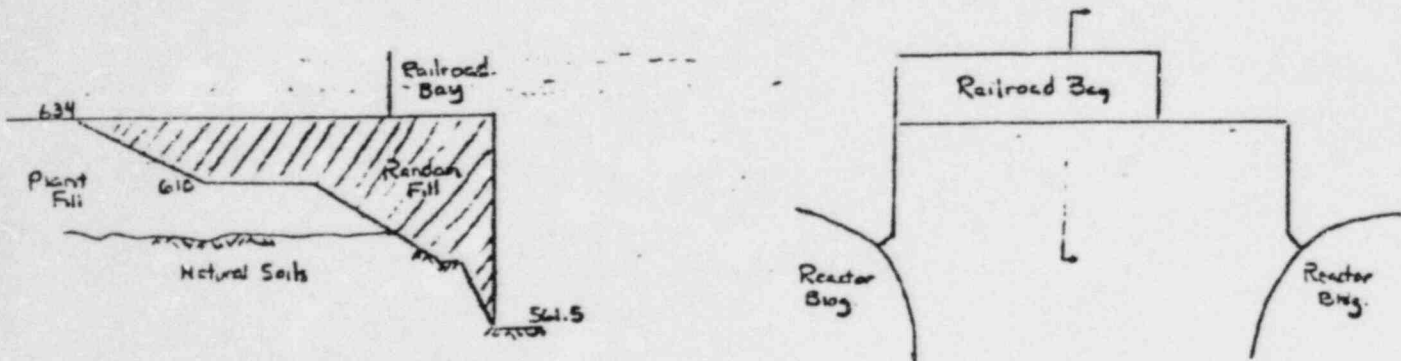
1. Plan and Cross Section

2. Soil Exploration
 - a. Three borings in area
 - b. Medium to very dense sand backfill over dense glacial till
 - c. Some concrete also used as fill
 - d. Analysis indicates that the fill can safely withstand the imposed loading
3. Deficiency
 - a. The upper 18 ft of sand may be susceptible to liquefaction
 - b. Plan to stabilize sand by chemical grouting since changed to permanent dewatering system
