LICENSEE EVENT REPORT (LER)

FACILITY NAME (1) North Anna Unit 1	DOCKET NUMBER (2) 0 5 0 0 0 3 3 8	PAGE (3) 1 OF 0 4
----------------------------------------	--------------------------------------	----------------------

TITLE (4)
Recirculation Spray Cooler Lap Ring Cracking

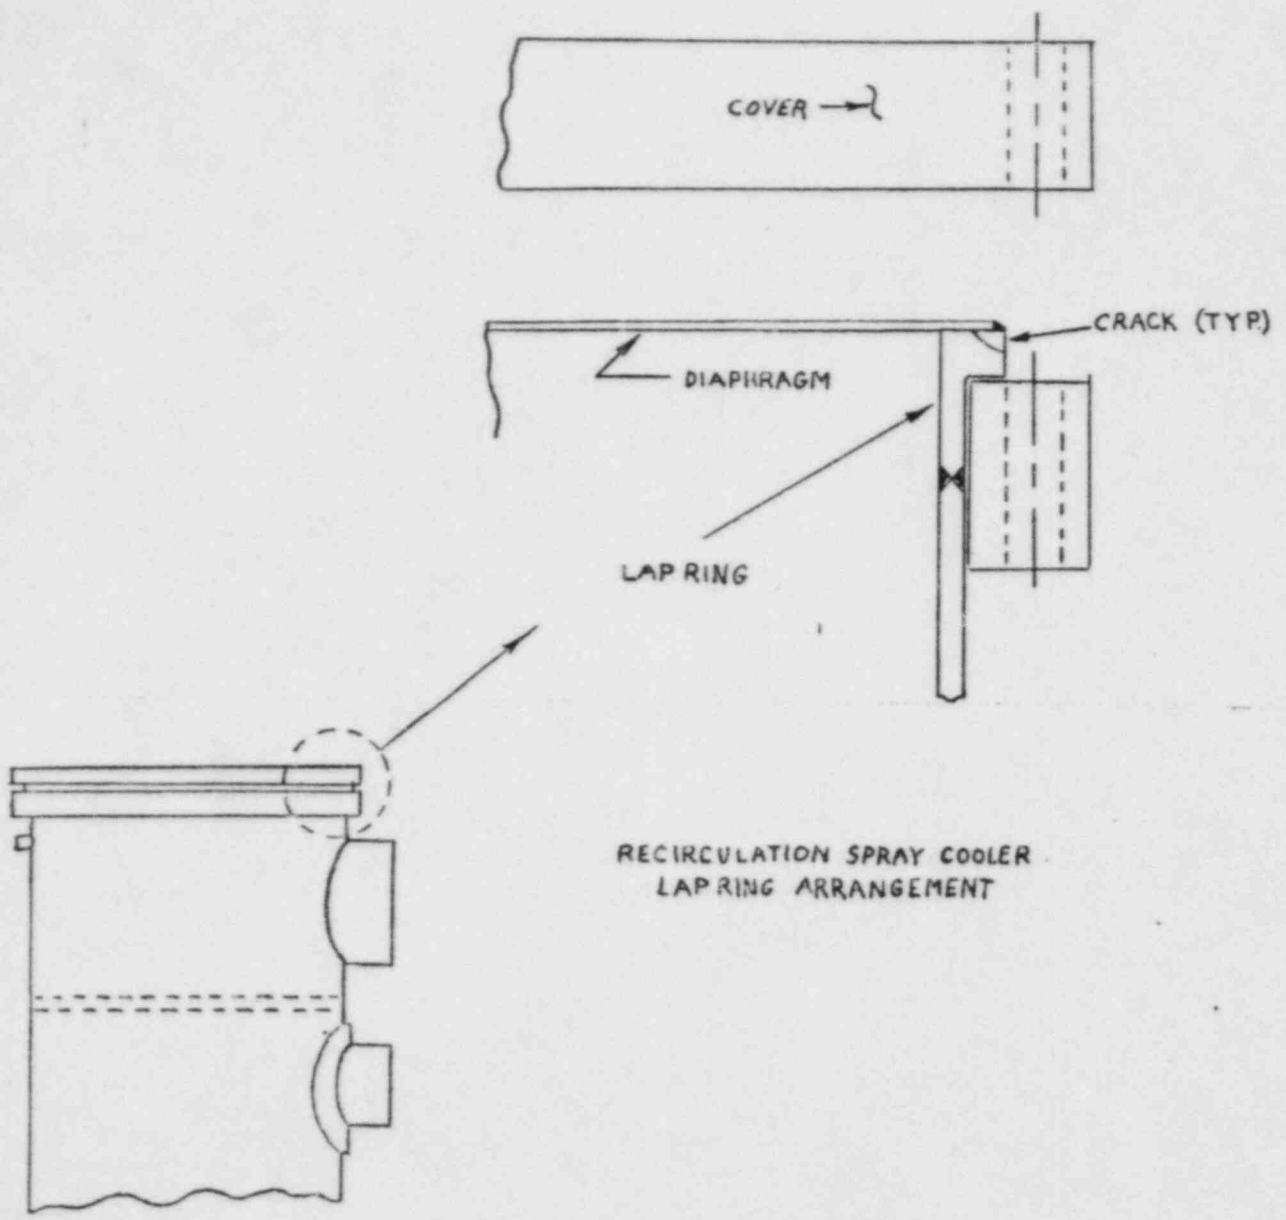
Figure 1

During the 1984 North Anna Unit 1 Type 'A' Containment Pressurization Test, the Recirculation Spray Coolers were suspected as a possible air leakage source. After removal of the 'D' Recirculation Spray Cooler diaphragm from the lower lap ring and subsequent examination of the lap ring by L.P. visual examination, surface flaws caused by crevice corrosion became evident. Subsequent excavation in the area of the flaws revealed radial cracking initiating from the point of crevice corrosion pitting to the outside diameter of the lap ring. The lap ring is a welded extension to the cooler shell. The bottom of the lap ring is a 1" thick by 5/8" high flange against which a diaphragm is welded along the outer edge as shown in the attached figure. A ring flange (free floating) rests on the outside edge of the lap ring and bolts to a bottom end plate or cover plate. The lap ring is employed as the pressure boundary wall and a bearing surface for compression of the diaphragm. The lap ring and diaphragm are made of stainless steel type 304L.

The crevice corrosion which existed on the lap ring was caused by contact with service water at a concentration of 12 to 50 ppm chloride, and subsequent concentrating of the chlorides in the crevice area between the diaphragm and the lap ring. (The service water is treated with Hypochlorite). The radial cracking, which extended from the crevice corrosion pitting to the lap ring outer diameter, was caused by chloride concentration in conjunction with a relatively high tensile stress region which was induced during lap ring manufacturing. At no point did cracking extend into the inner 3/8" thickness of the lap ring which is under compressive stresses induced by manufacturing, and the bolted joint design.

In order to preclude further lap ring degradation a cladding of stainless steel Type 316L was applied to the lap ring surface in contact with the diaphragm. The diaphragms were also replaced with 316L. This was done to all four heat exchanger lower lap rings. Inspection will be made of the Unit 2 Recirculation Spray Coolers during the current Unit 2 refueling outage.
