UNITED STATES
NUCLEAR REGULATORY COMMISSION
WASHINGTON, D. C. 20555

Docket Nos. 50-329
and 50-330 OM, OL

APPLICANT: Consumers Power Company
FACILITY: Midland Plant, Units 1 and 2
SUBJECT: SUMMARY OF OCTOBER 6-7, 1981 MEETING ON UNDERGROUND PIPING

MIDLAND PROJECT
MIDLAND DOCKET NOS 50-329, 50-330
EVALUATION REPORT FOR THE FEEDWATER ISOLATION VALVE PITS
FILE 0485.16 SERIAL 15493
ENCLOSURES: (1) EVALUATION OF FEEDWATER ISOLATION
VALVE PITS AT MIDLAND PLANT
(2) FEEDWATER ISOLATION VALVE PIT
CRACK MONITORING PROGRAM

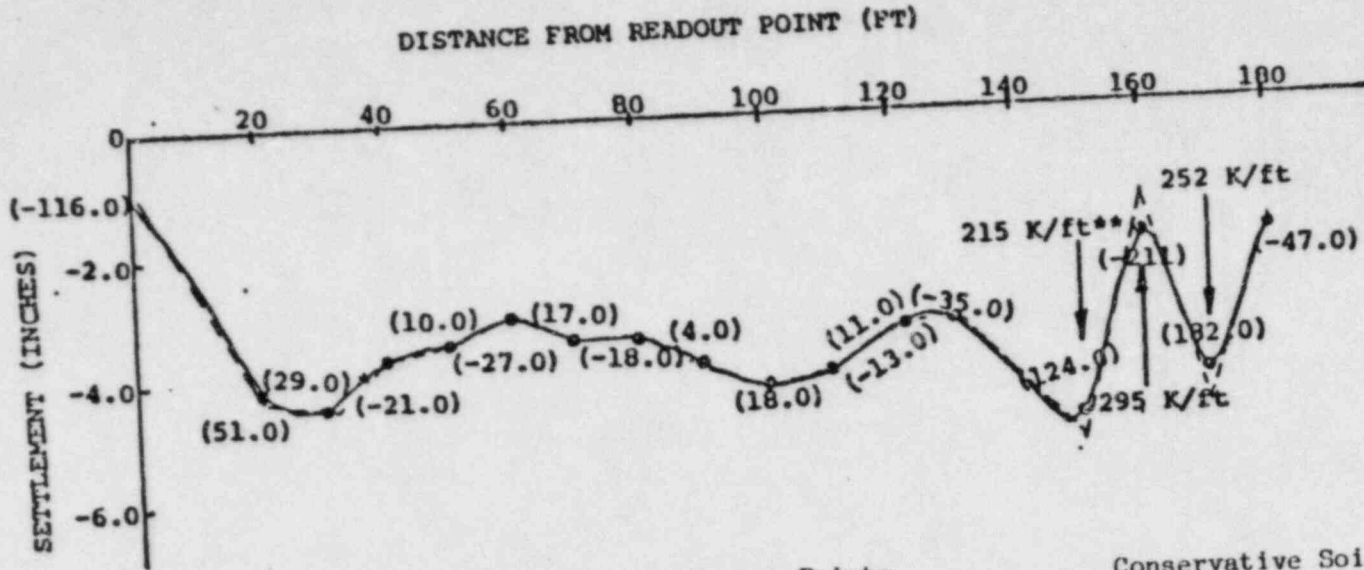
● Indicates Pipe Settlement at Survey Points

— Pipe Displacement Profile

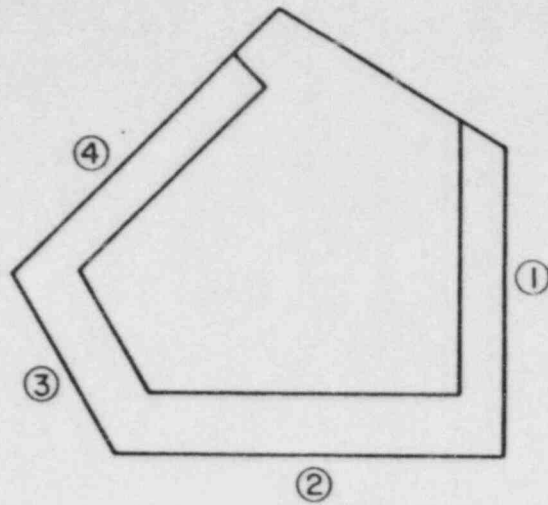
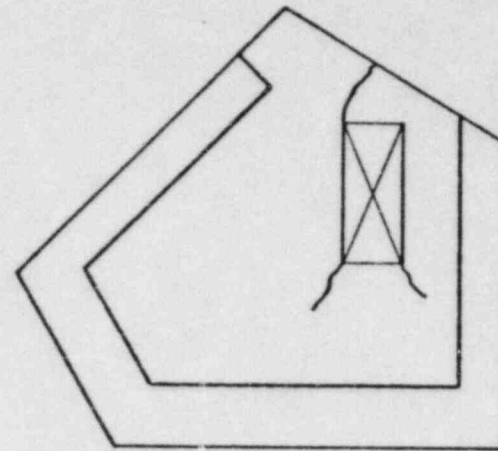
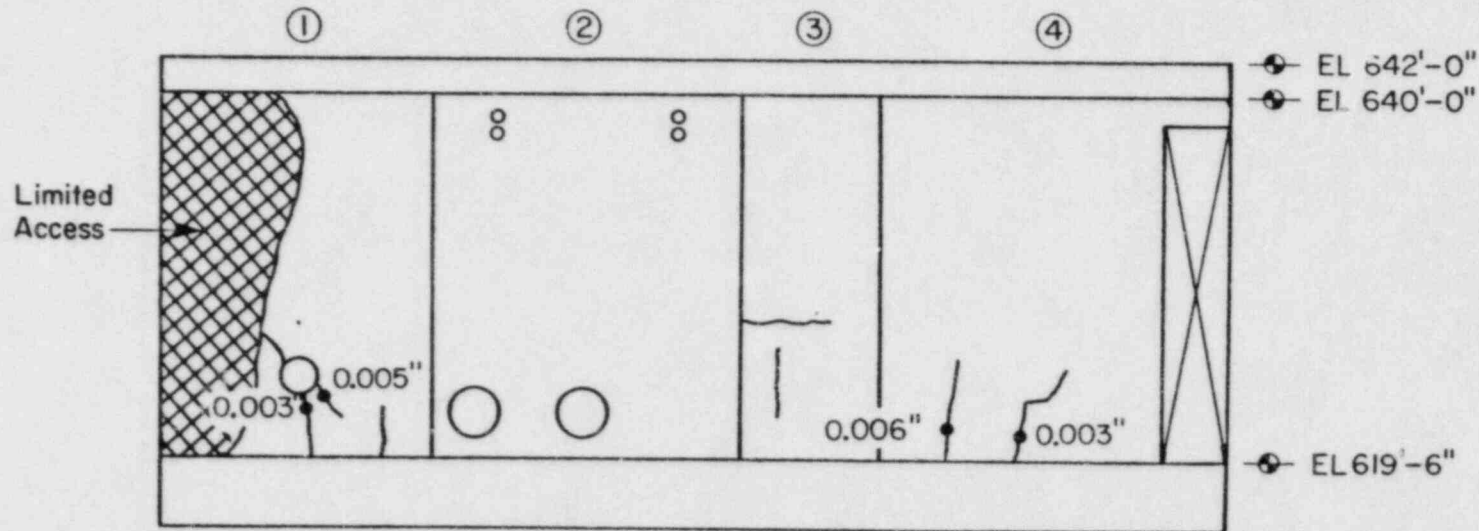
Fig.6 Feedwater Isolation Valve Pit - Unit 1 (West Unit)

Lighting conditions for inspection of Unit 2 were essentially the same as those encountered in Unit 1. Primary lighting was provided by portable electric lights and hand held flashlights. Since construction scaffolding was not available in all areas of Unit 2, access to most walls above eye level was obtained using ladders.

As was the case in Unit 1, all interior wall and ceiling surfaces were covered with a glossy clear coating. Some crazing was observed on all surfaces of the walls and the roof. Although the floor area in Unit 2 was covered with some

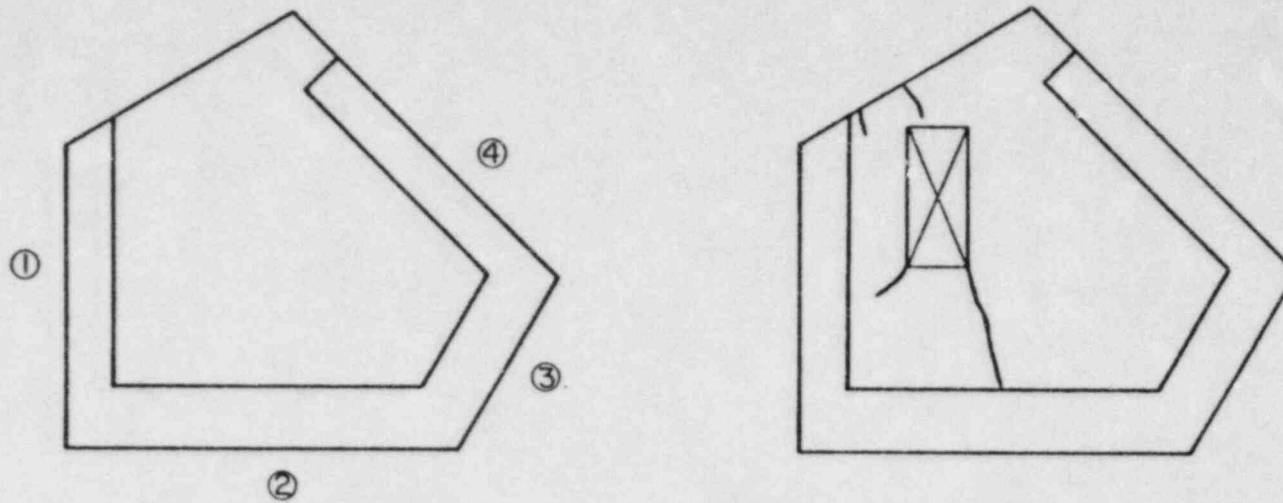
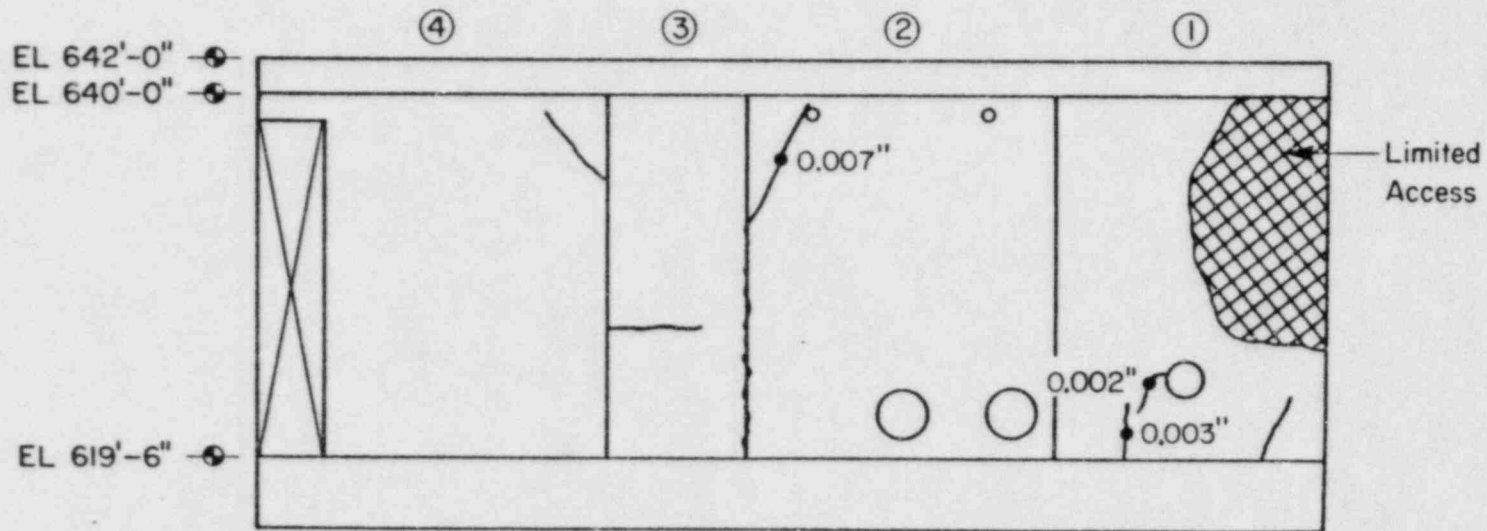
Fig. 7 Feedwater Isolation Valve Pit - Unit 2 (East Unit)

Table 1 summarizes results of this comparison for members in which cracks were observed. In the calculations, concrete

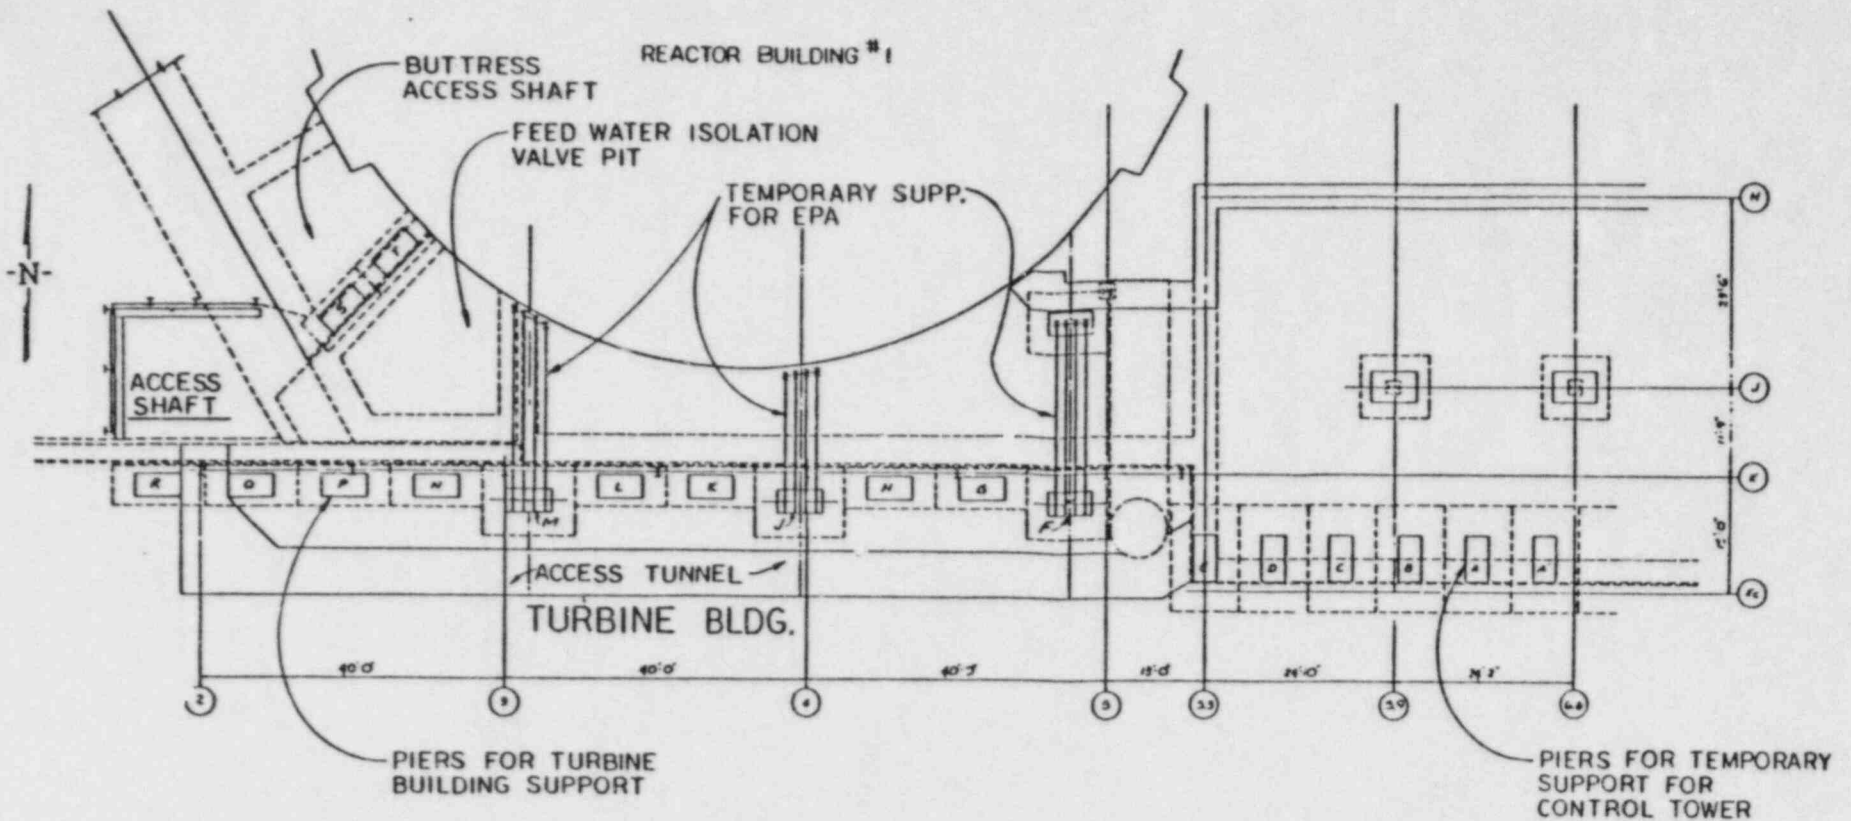
FIG. 8 UNDERPINNING CONSTRUCTION SEQUENCE PLAN

As part of remedial measures to eliminate the possibility of unsatisfactory foundation conditions, selected areas of the Auxiliary Building will be underpinned. (1) Figure 8 shows the underpinning construction sequence plan as outlined in public hearing testimony from Midland Plant Units 1 and 2. (1) The underpinning plan includes construction of access shafts immediately east and west of the two Feedwater Isolation Valve Pits and adjacent to the Turbine Building. The location of the west access shaft is shown in Fig. 8. The east access shaft will be symmetrically located.

that may be affected by underpinning operations. Feedwater Isolation Valve Pit Units 1 and 2 should be monitored.

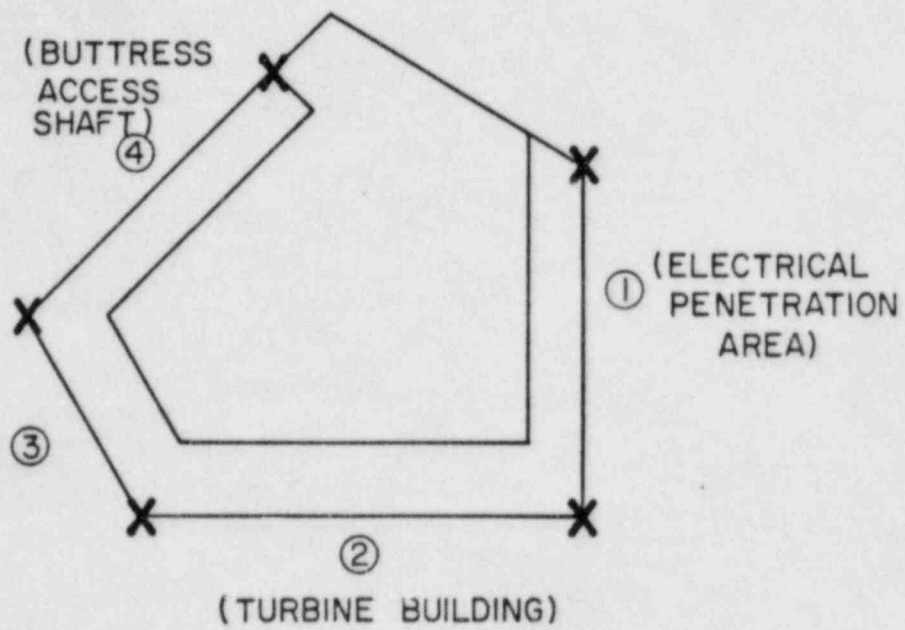
Fig. 10 Displacement Measurement Points on Feedwater Isolation Valve Pits

Displacement measurements will be made to monitor both absolute movement and relative distortions of structural elements. Figure 10 shows approximate locations of recommended displacement measurement points. As a minimum, vertical displacements of the base slab of the structure should be measured at each of these points. Relative horizontal displacements between the Feedwater Isolation Valve Pits and adjacent structures may also be measured. Displacement measurements of the

A continuous time history of displacements of the Feedwater Isolation Valve Pits should be maintained during underpinning operations. It is recommended that readings be taken on a daily basis with a maximum interval of one week. Additional readings should be taken at selected construction milestones.
