EVALUATION OF THE OPERATIONAL AND
MAINTENANCE HISTORY OF, AND RECENT
MODIFICATIONS TO, THE MAIN ENGINES IN THE
M.V. COLUMBIA

SES Report No. 123-01

April 1983

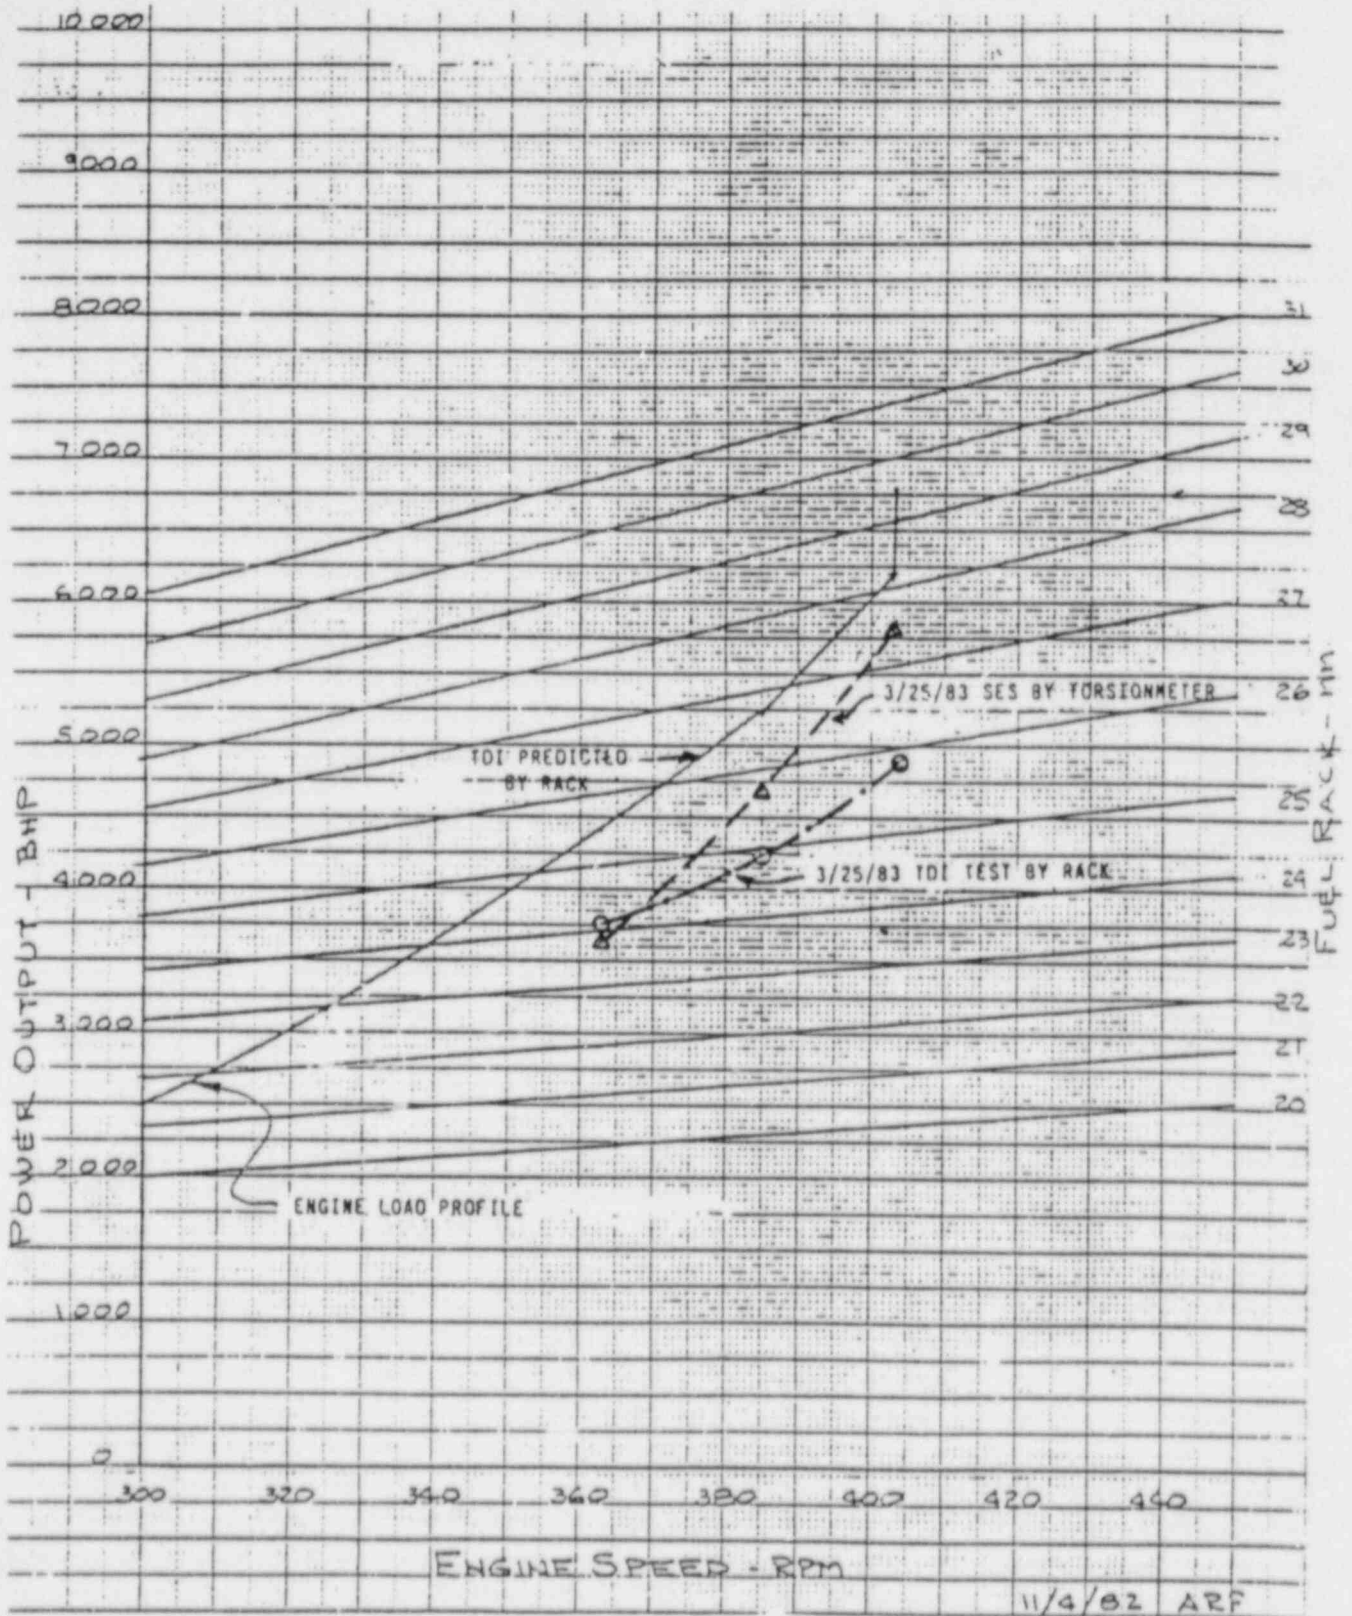
Power Output: Figure 2.1 presents plots of brake horse power (BHP) produced by the de-rated main engines, including power as predicted by TDI versus fuel rack setting and ERPM, power determined as a result of average rack setting observed during trials versus ERPM and a final curve of BHP developed, corrected

From an inspection of the data presented in Figure 2.1 and Table 2.2, neither power determined from actual fuel rack setting and ERPM or as measured at the shaft very closely matched the predicted engine load profile, shown in Figure 2.1. Further, at all test ERPM's but 363, TDI observed rack BHP falls below that determined from measured SHP. Relative to contractual performance, TDI test data and resultant plotted Brake Horsepower data fails to meet anticipated outputs for Design, Maximum Continuous and 10% overload service ratings of 385 ERPM/5284 BHP, 403 ERPM/6164 BHP and 403 ERPM/6791 BHP, respectively.

is noted here that the adjustment and calibration of the starboard engine's number one right bank fuel pump and rack assembly had been altered and never reset prior to the trials. This fuel rack position is used as the master command signal indicator for that engine's speed and load control program. In consideration of the previously discussed factors, the data obtained from the torsionmeter reading is felt to be more closely representative of actual power produced.

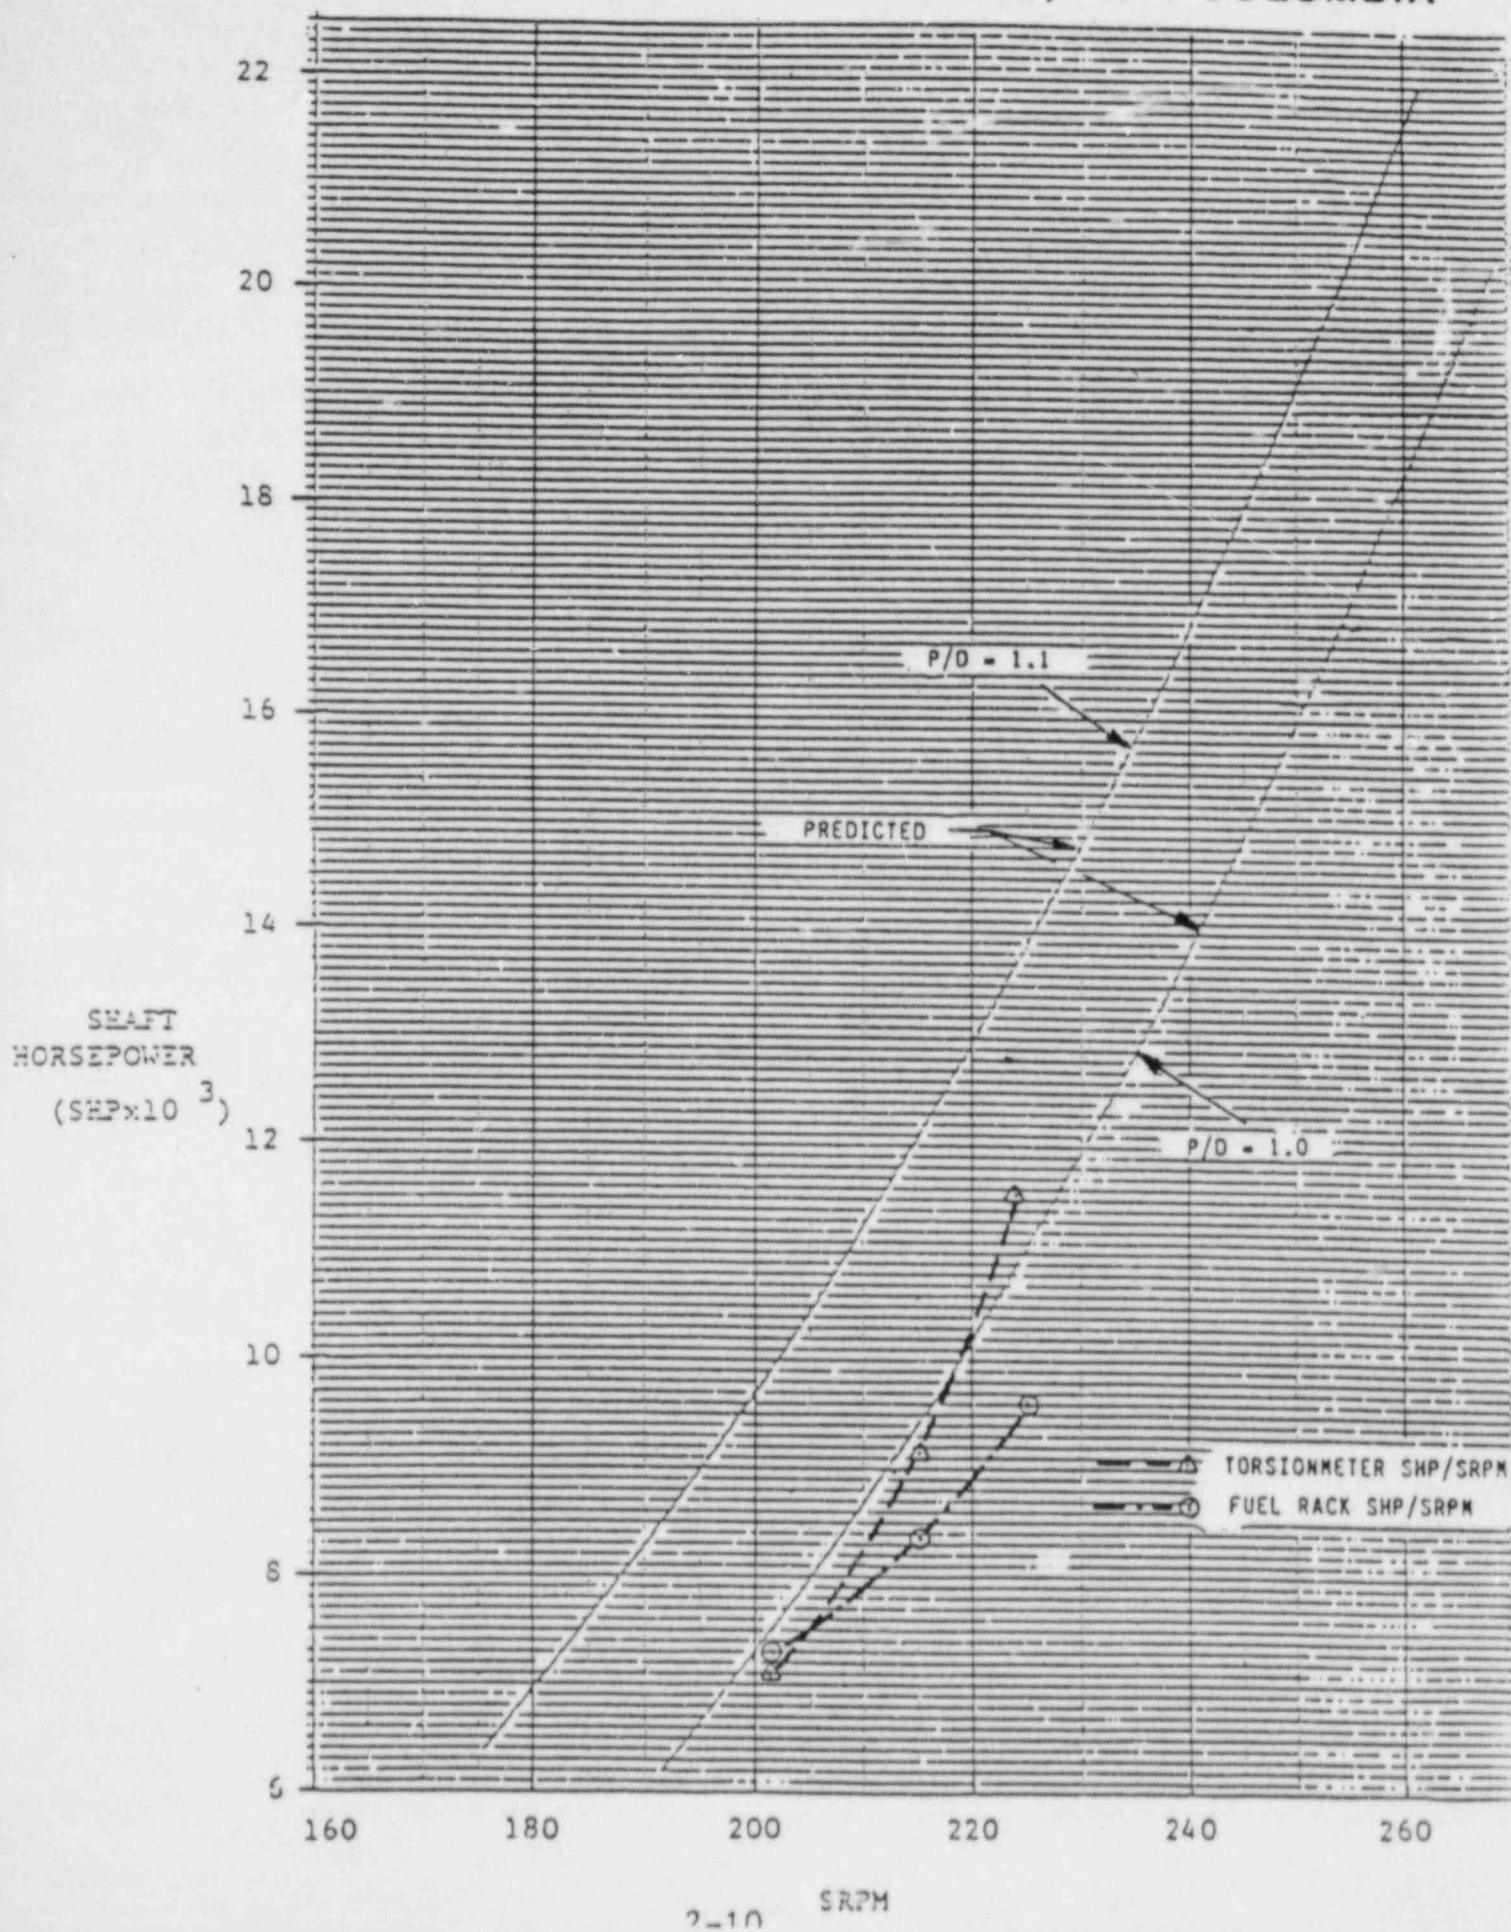
Figure 2.2

The predicted speed, SRPM and SHP data plotted in Figures 2.2 and 2.3 was extrapolated (in Reference No. 2) from model test data and initial delivery sea trial data. It also contains adjustments for estimates of increased hull roughness as a function of time out of drydock and additional wetted surface areas which would result from a planned lengthening of the existing skeg to improve the vessel's maneuvering characteristics. It is estimated that these adjustments increased required SHP by three (3) to four (4) percent over what would be the case for the hull at the time of testing on March 25, 1983. This results from the fact that the hull was freshly painted and that the skeg had not been lengthened. The ship speed and shaft horsepower data recorded during the test was taken with the vessel operating at a draft of 13'5" FWD and 16'0" Aft, resulting in a mean draft of 14'8.5". The draft on which predicted speed and power curves were based was 16.0 feet even keel. Again, based on a comparison of the observed trial vessel speed/power data with predicted vessel speed/power data, the BHP's determined from the torsionmeter readings appear to be more closely representative of actual power produced than do the equivalent rack setting values of BHP.

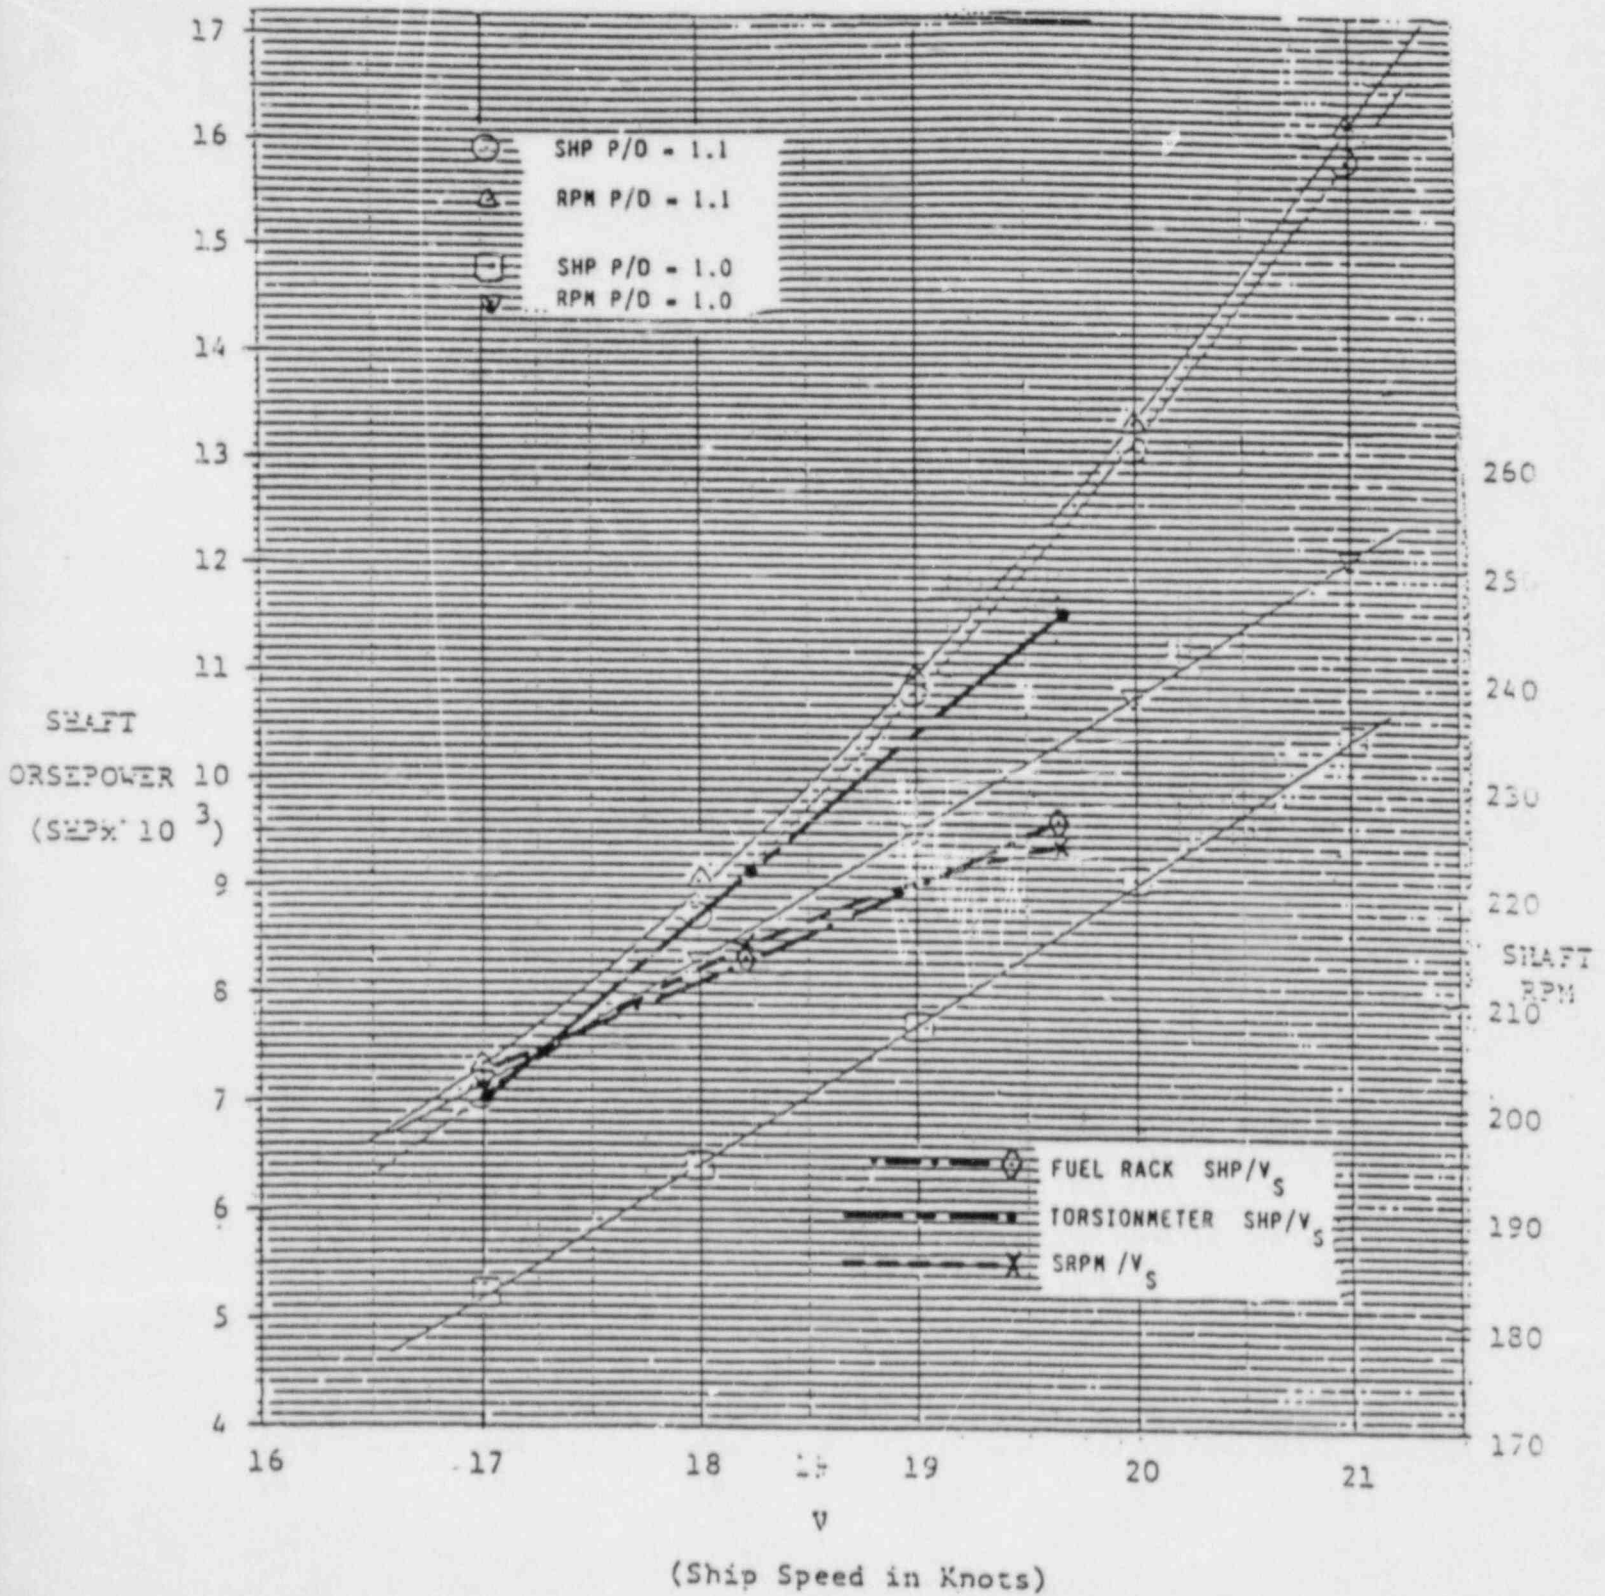
Figure 2.3

plotted for vessel speed and SHP for P/D ratios is shown in Figure 2.3. Here also, the observed uncorrected speed/SHP points recorded during the test from the torsionmeter show a much closer agreement with vessel speeds predicted for P/D ratios of 1.0 and 1.1 than speed/SHP data based on and plotted for fuel rack settings.

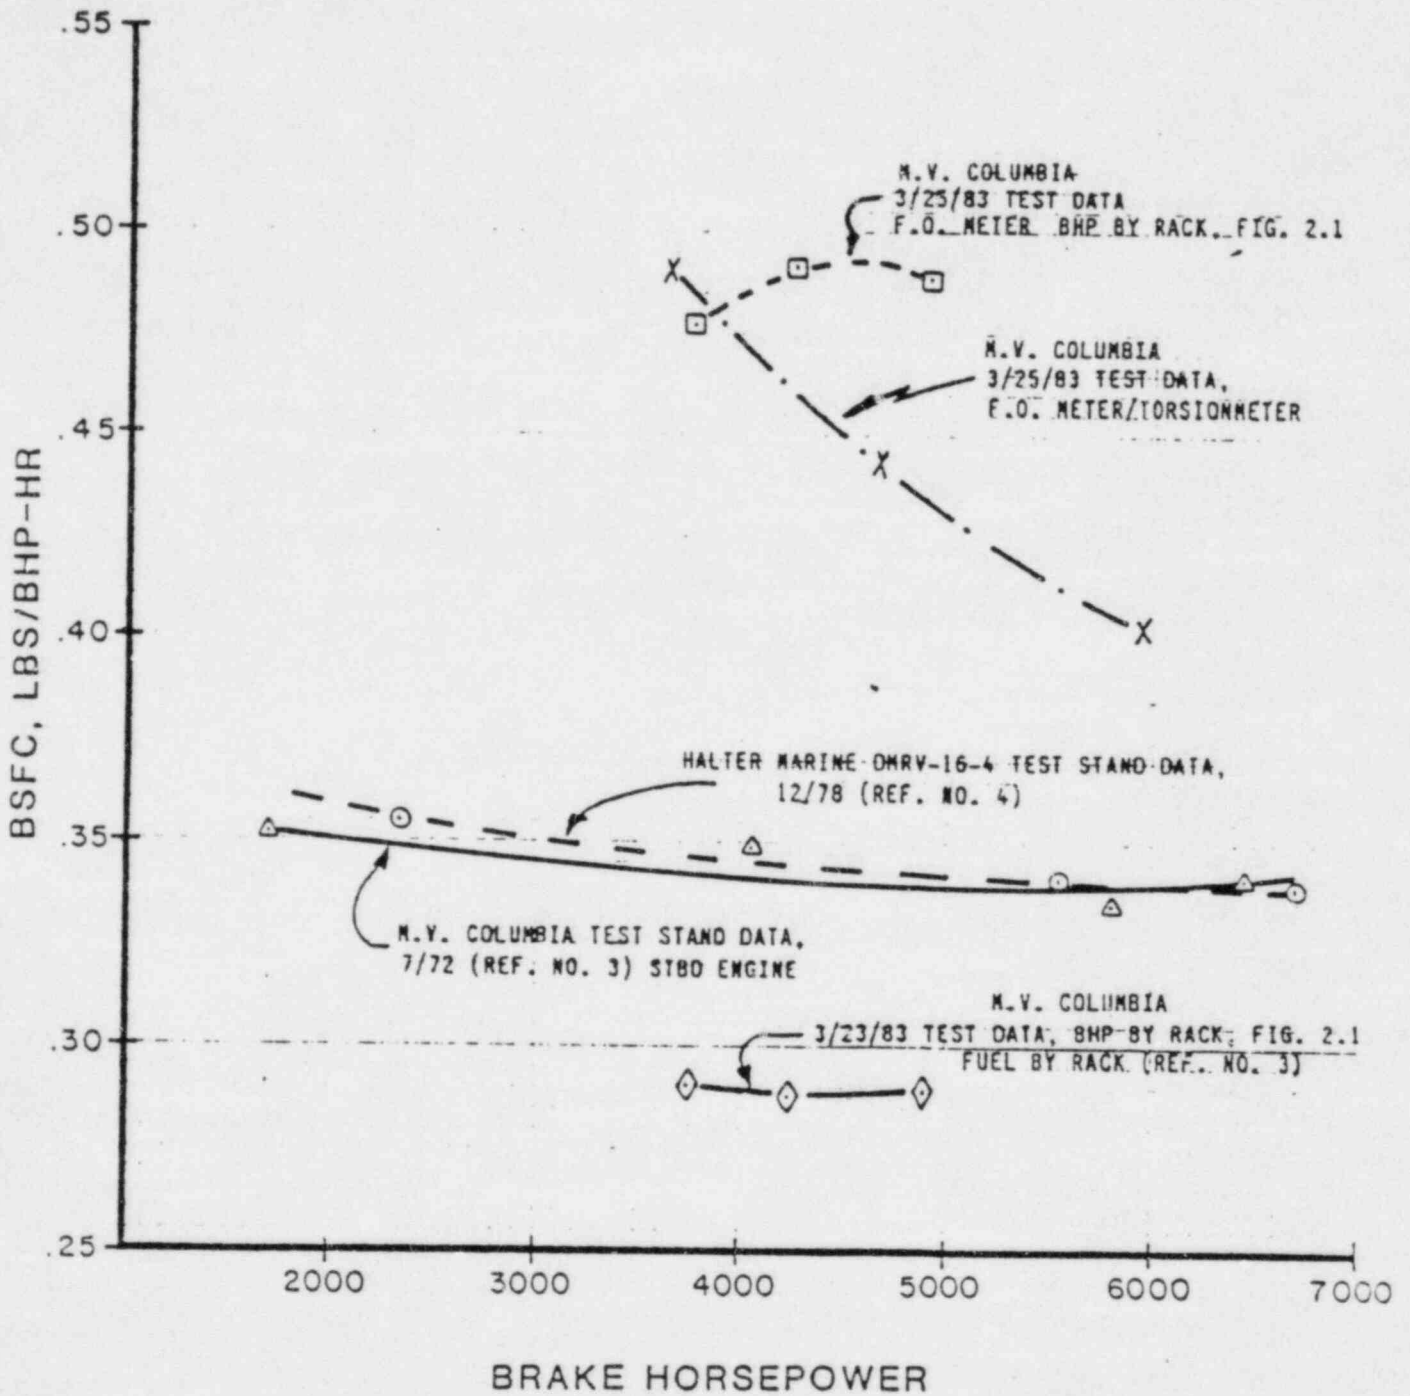
Figure 2.5

power data sources obtained during the sea trials, curves representative of actual in-service performance have also been plotted in Figure 2.5. Two curves based on fuel consumption from the test meters and TDI fuel consumption as predicted by rack setting (Reference No. 3) and TDI test de-rated engine brake horsepower from rack and ERPM (Figure 2.1) were also plotted. These curves are the upper and lower most lines on Figure 2.5. They show virtually no agreement between either the predicted fuel flow or the flow as measured, one being 45 percent higher and the other 14.7 percent lower than original test stand BSFC values shown in Figure 2.5. The fifth and final curve plots BSFC for the vessel's starboard engine from data obtained from the test fuel oil meters and from power as measured by the torsionmeter installed for the trial. This curve shows a much greater slope than the test stand data, with fuel rate decreasing with increasing engine load. From this curve, at 5815 BHP, the difference between the test stand performance and the observed BSFC for the starboard engine is 18%. A plot of BSFC based on power from the torsionmeter and fuel from the rack setting would, in fact, result in a curve that would fall well below the abscissa of Figure 2.5. As in the case of the TDI data plot, resultant fuel rates in the range of 0.233 to 0.30 LBS/BHP-HR, equating from 45% to 62% thermal efficiency, are well outside the range of the most efficient medium speed diesel engine capability and therefore, are unacceptable. BSFC data derived utilizing fuel meter flow rates in both instances (TDI predicted

and torsionmeter power outputs) show brake specific fuel rates considerably in excess of the factory test stand rates. As stated in the introduction to Section 2.0, the absolute magnitude of fuel flow values recorded by the test meters may be open to challenge. Based on the past history of these engines, it would seem reasonable to assume that they are in fact consuming fuel at a rate considerably in excess of original and design predicted performance, perhaps by as much as 10%. Potential sources of this increase may include operation at reduced ERPM, cylinder load imbalance, improper fuel injection timing, lack of an optimized fuel metering system (nozzle, injector, pump) for low load operation, increased cylinder liner/piston clearances, reduced BMEP and less than anticipated turbocharger efficiencies.

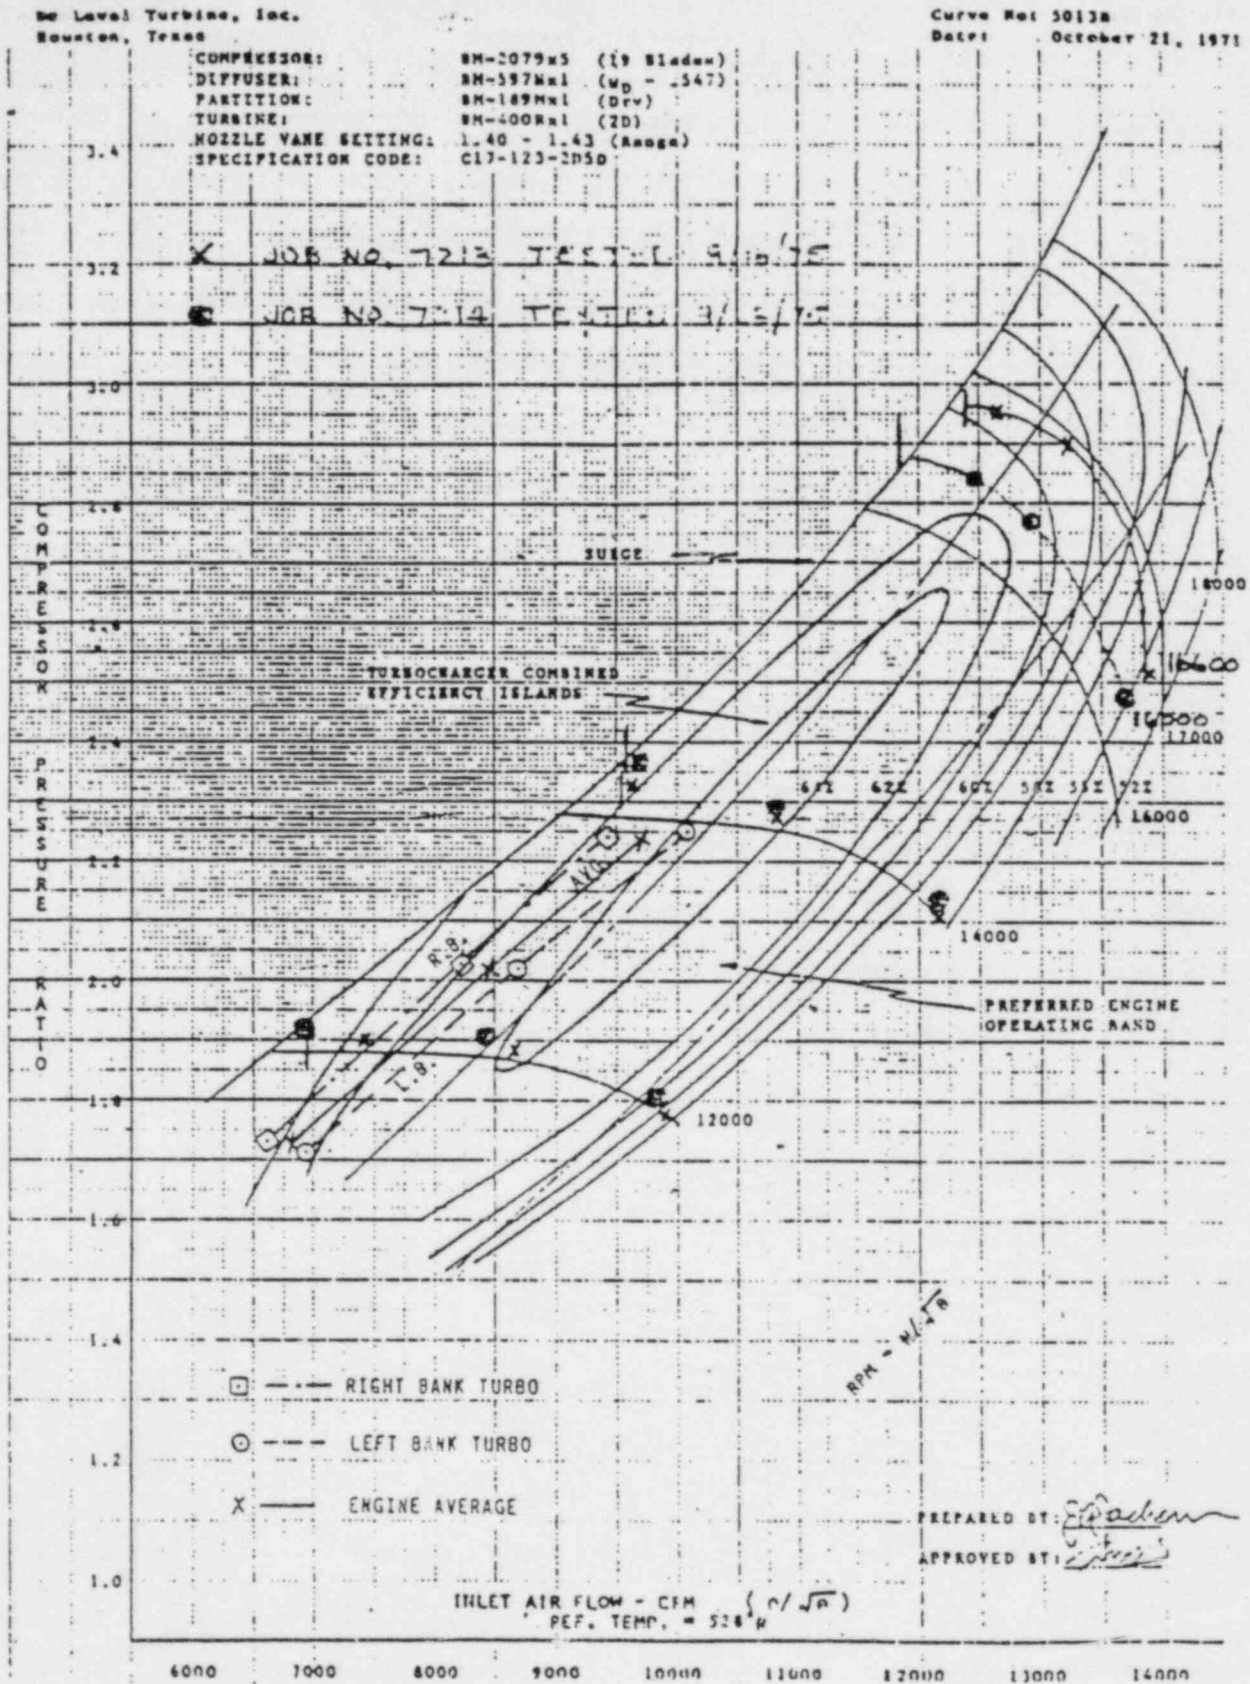
and to the left of the preferred engine operating band also shown on Figure 2.6. The right bank blower pressure ratio/total air flow curve is closer to the predicted surge line than the left bank plot. Subsequent to the sea trials and during initial voyages, a turbo on the starboard engine was observed going into surge. It is most likely that this is the same turbo identified as the right bank turbo by the sea trial data, as indicated by this unit's plotted performance falling closest to the theoretical surge line in Figure 2.6. Therefore, it must be concluded from this data that the turbos as supplied by TDI are not properly matched to the engines' new de-rated output.

Another observation on sea trials relative to the turbos and verified during data reduction is the disagreement in plotted flows and pressure ratios in Figure 2.6 and apparent turbo RPM. The turbo RPM's logged in Appendix B by TDI, even after correcting for observed temperature, do not correlate at all with predicted RPM's on Figure 2.6. At the time of trials there was some question as to the accuracy of the turbo tachometers supplied as part of the de-rating workscope. (Two (2) tachometers failed during the trials.) It would appear that the turbo tachometer readings are in error.

Turbo Surging: The frequency of observed turbo surging increased during the initial voyage, primarily on the port engine. Turbo surge is defined simplistically as the range of unstable operation which occurs when air flow through the compressor is reduced while the compressor pressure ratio (pressure at discharge divided by pressure at the suction) remains constant, shifting the operating point on the compressor map (Figure 2.6) to the left of the surge line. In severe cases, a flow reversal in

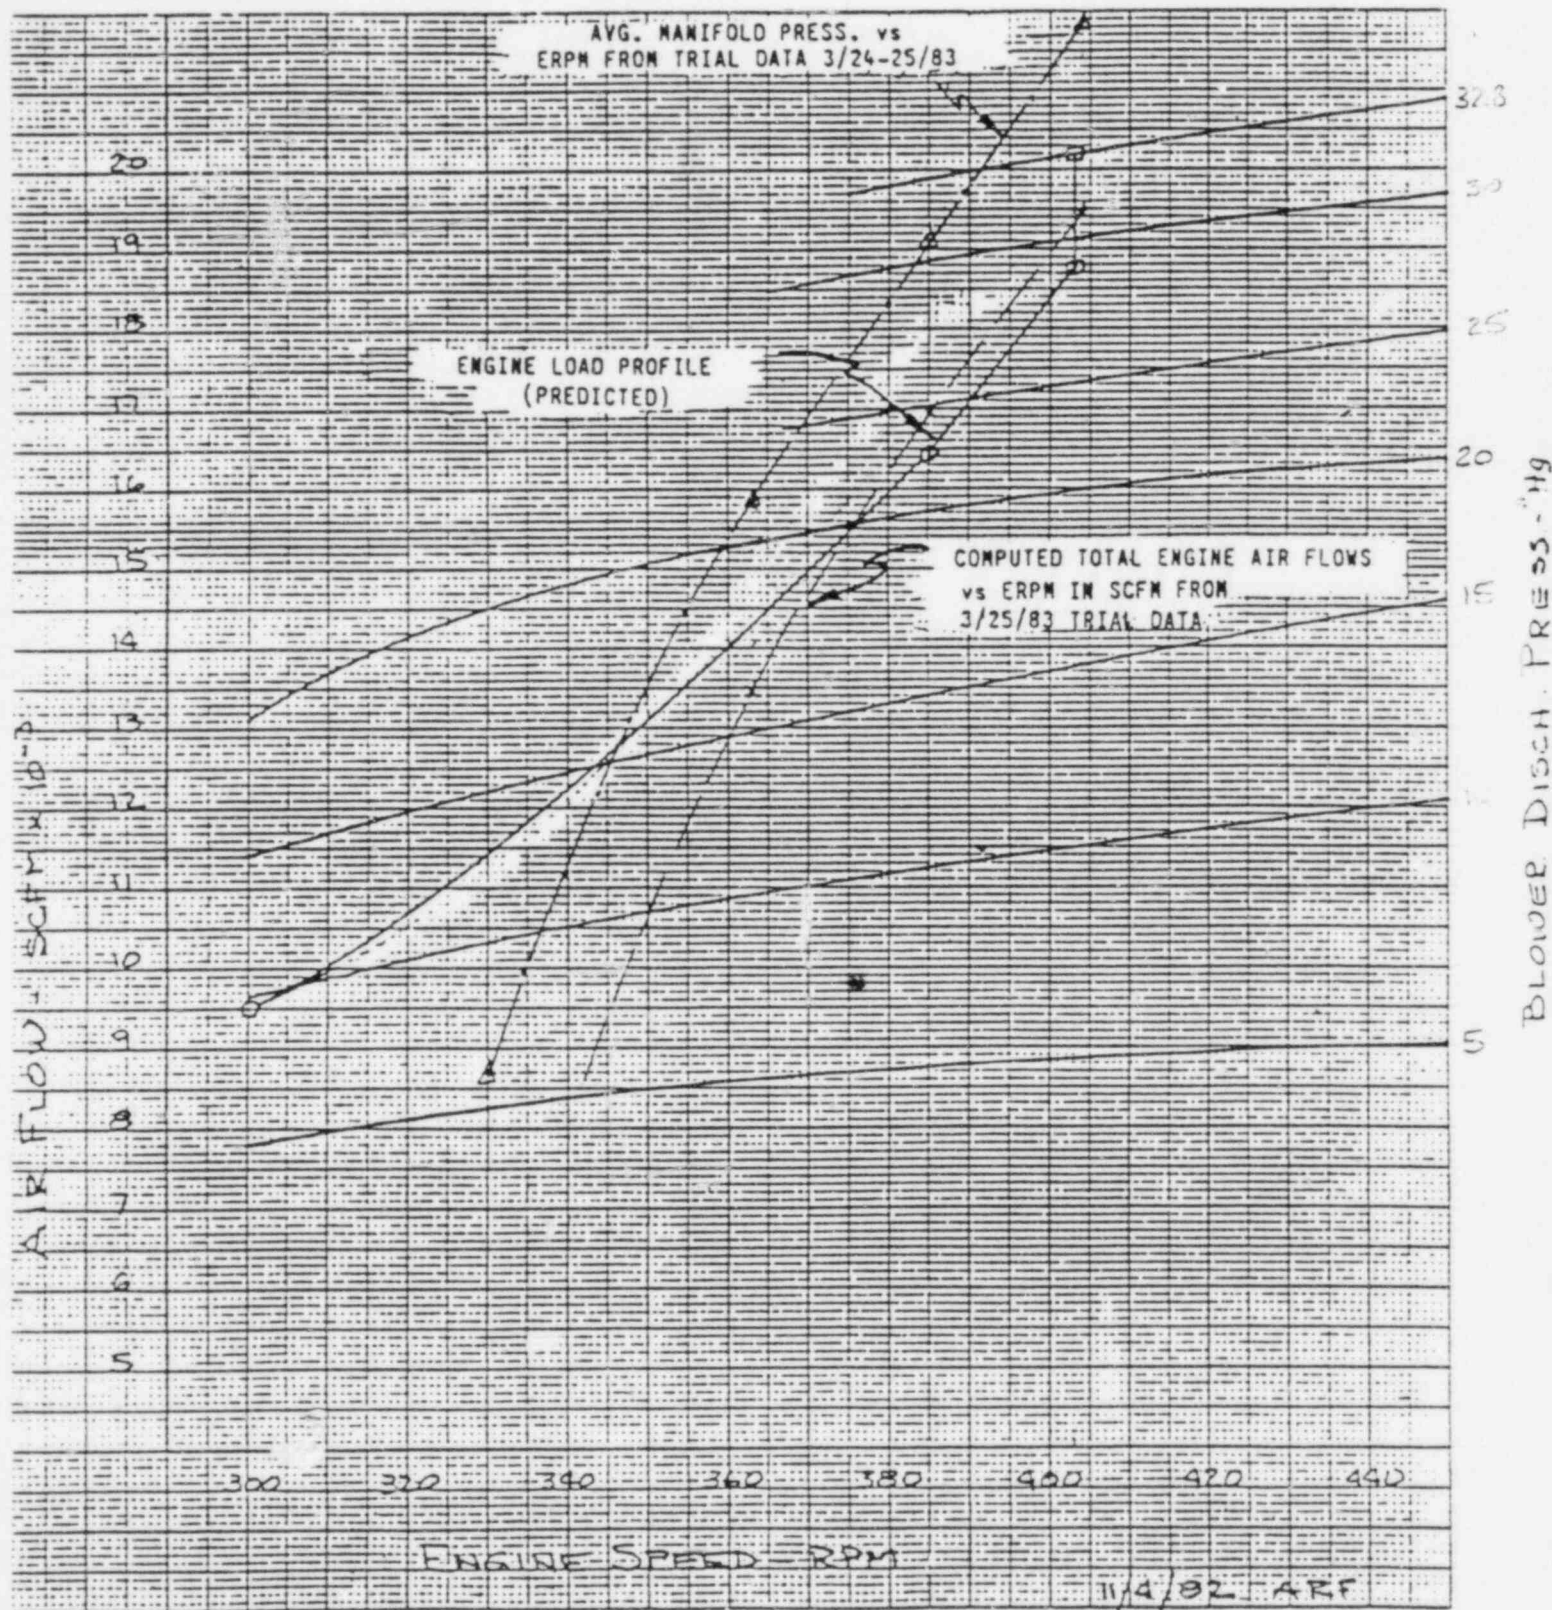
- * Charge Air Manifold Pressures: Figure 2.7 presents a plot of anticipated charge air manifold pressures versus ERPM provided by TDI for the new turbos. Overlaid on this graph are additional curves which plot actual manifold pressure observed versus ERPM (dash-dot line) and computed total engine air flows in SCFM versus ERPM (dashed line). The

predicted air flows corresponding to the observed manifold pressures are significantly higher than the computed values shown. Referring to Figure 2.6, this would have been the case had the observed operating line for the turbos fallen within the preferred engine operating envelope with correspondingly higher turbo efficiencies. Also, in the case of both curves plotted from the March 25, 1983 sea trial data in Figure 2.7, more total air flow at 385 and 403 ERPM's is indicated than from the TDI plot of predicted performance. However, both plots of the observed data indicate that air flow from the turbos appears to fall off much more rapidly than predicted at lower engine loads. This performance may account for the observed surging during trials after rapid application and removal of propeller pitch (engine load) during response testing.

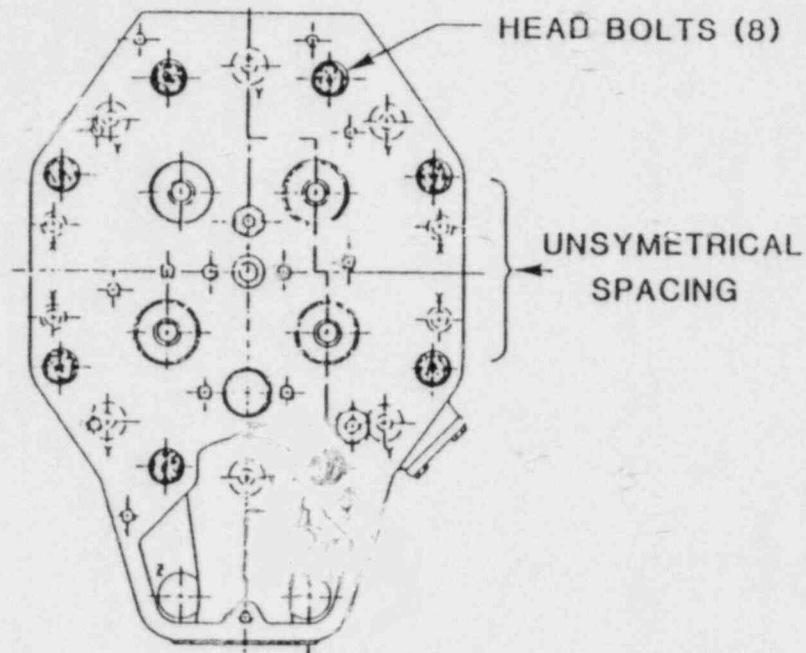
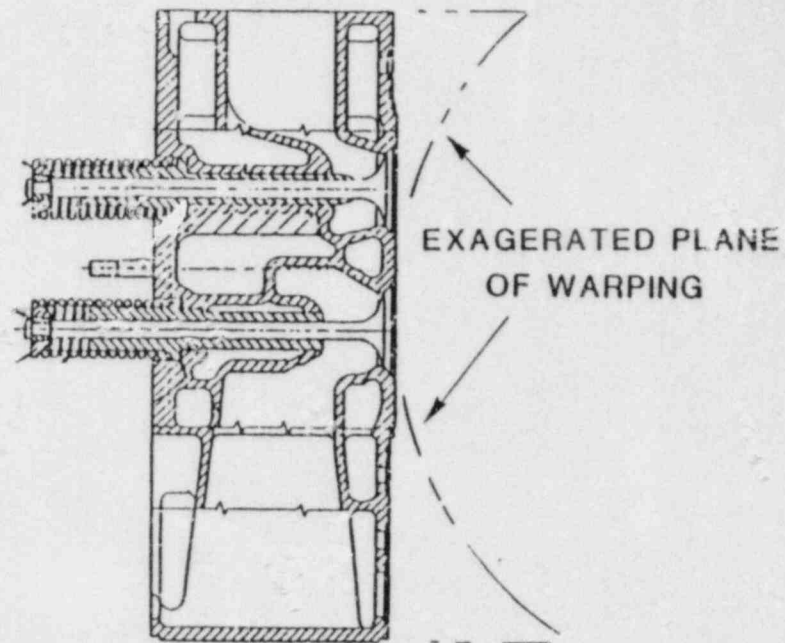
Figure 3.2
DMRV-16-4 Cylinder Head and Valves

Two additional problems which have plagued the head construction and interface areas are the exhaust valve guides and head warping along the 3-9 o'clock axis. In the case of the valve guide problems, insufficient documentation was available to reflect the number of occurrences chargeable to guide failures or valve guide induced failures such as carbon build-up on the valve stems which resulted in stuck valves or guide damage. The 1975, '75 and '76 files contain reports of pieces of valve guides breaking off and causing foreign object damaged (FOD) to turbochargers but insufficient numerical data has resulted in this type of failure being omitted from the historical summary. However, the head/valve guide area has been subject to continuous modifications starting with the 1976/77 overhaul when all the guides were machined flush with the exhaust gas passage and continuing to the 1982/83 overhaul when additional valve guide length was removed and a valve guide oiling/sealing (Trabon) system was added to control the rocker box sooting problem.

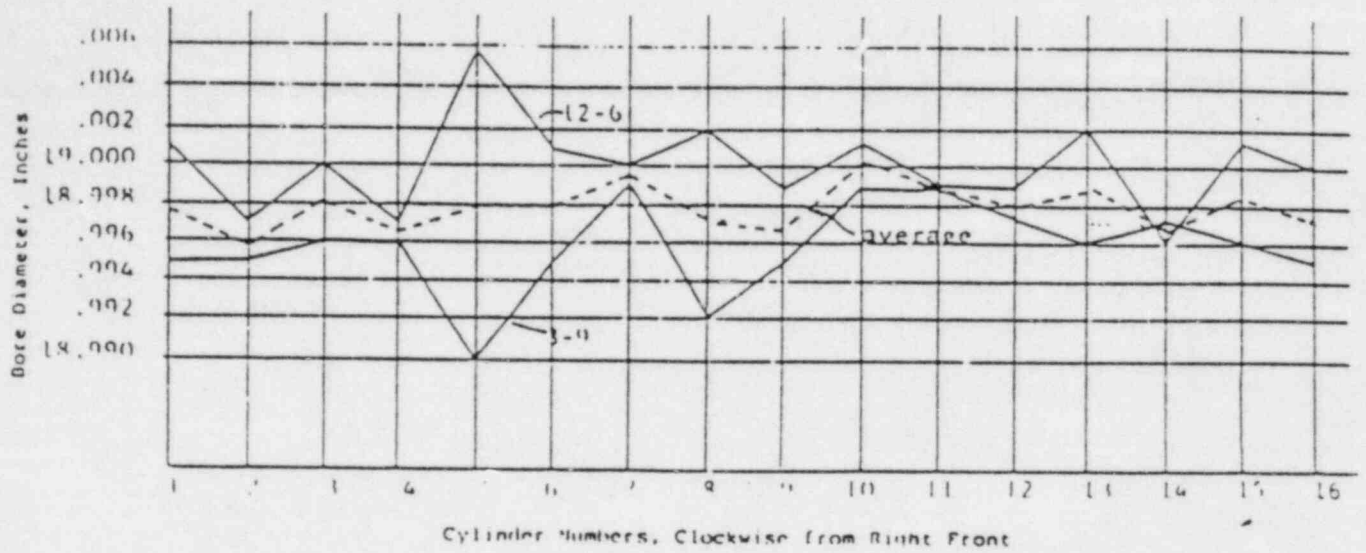
Figure 3.3

Permanent Liner Deformation, Bore Diameter

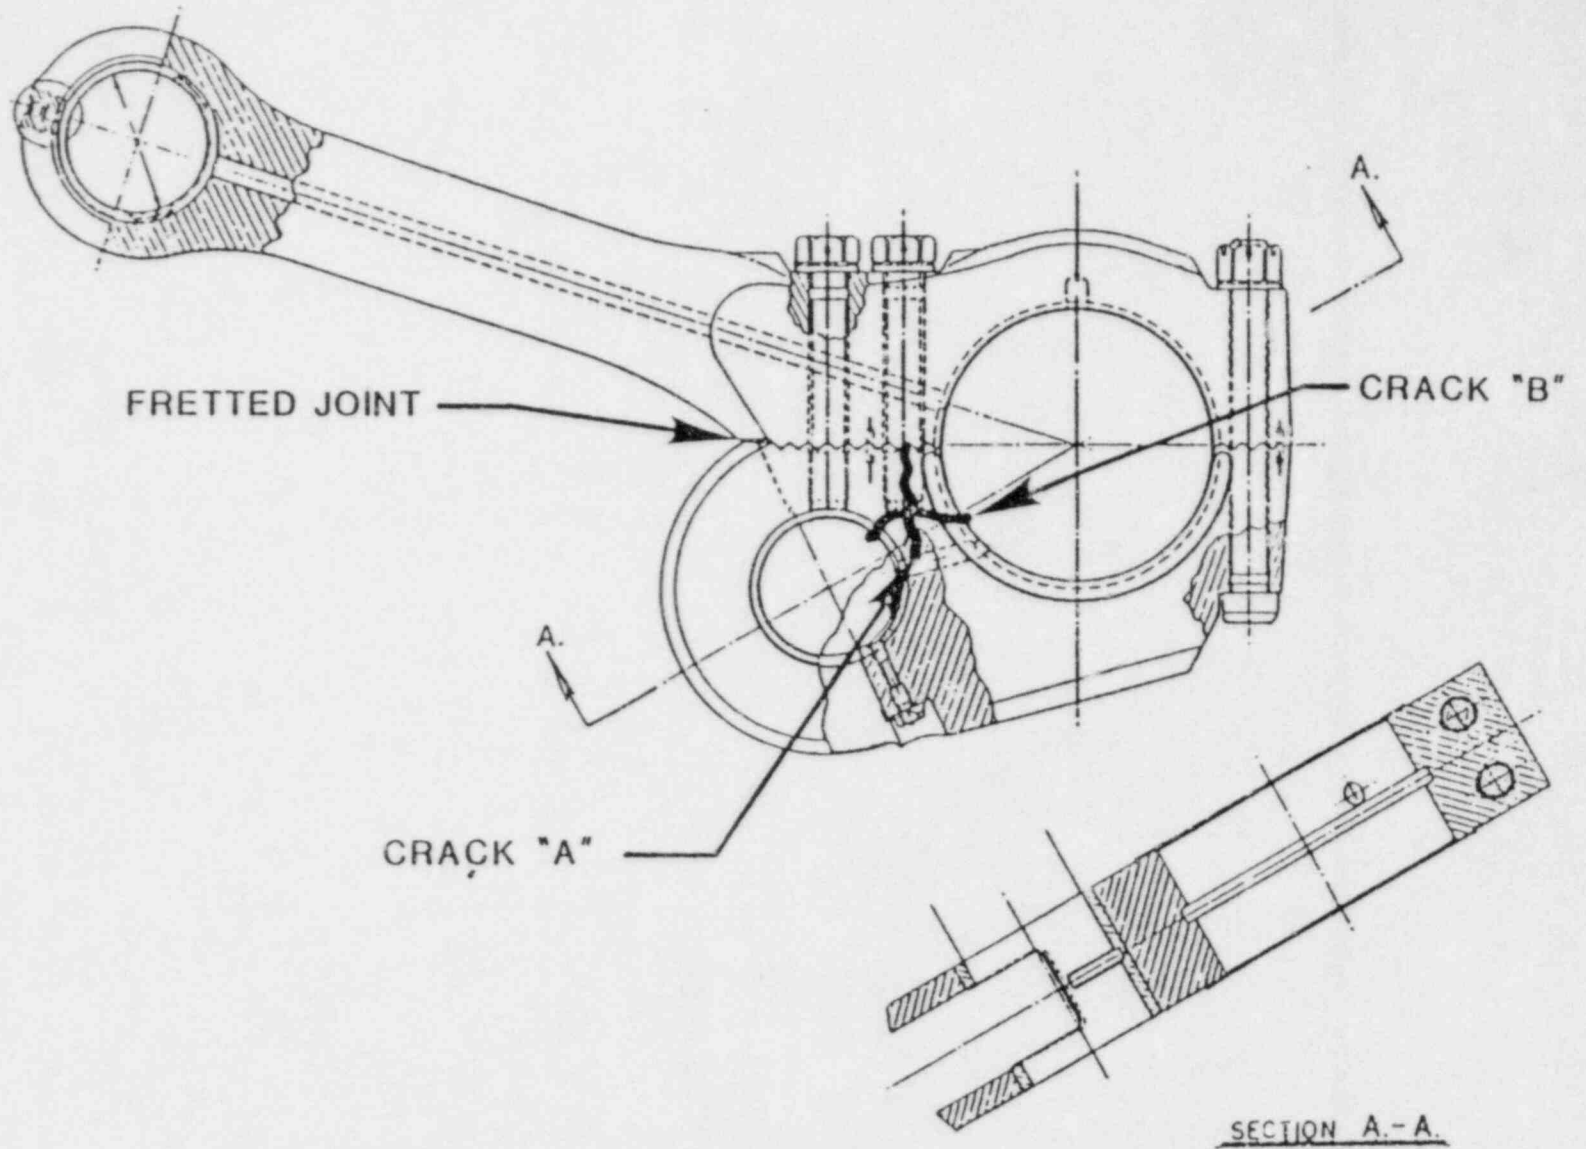
The articulated connecting rod has been the location of failures which could have been catastrophic if the cracked rods had not been discovered when they were. Prior to 1979, there had been one failure by cracking of a connecting rod, coupled with a link rod bearing failure. This same type of failure was later discovered at approximately 21,000 hours of operation in the Fall of 1979. At that time, approximately 25% of the link rod boxes were found fractured in the link pin area between the link pin bushing and the serrated joint. Figure 3.5 shows the orientation of two typical crack propagations (crack A & B) which were found in two (2) separate rod boxes. These fractures occurred in high stress areas in a high cycle fatigue mode, as illustrated, following.

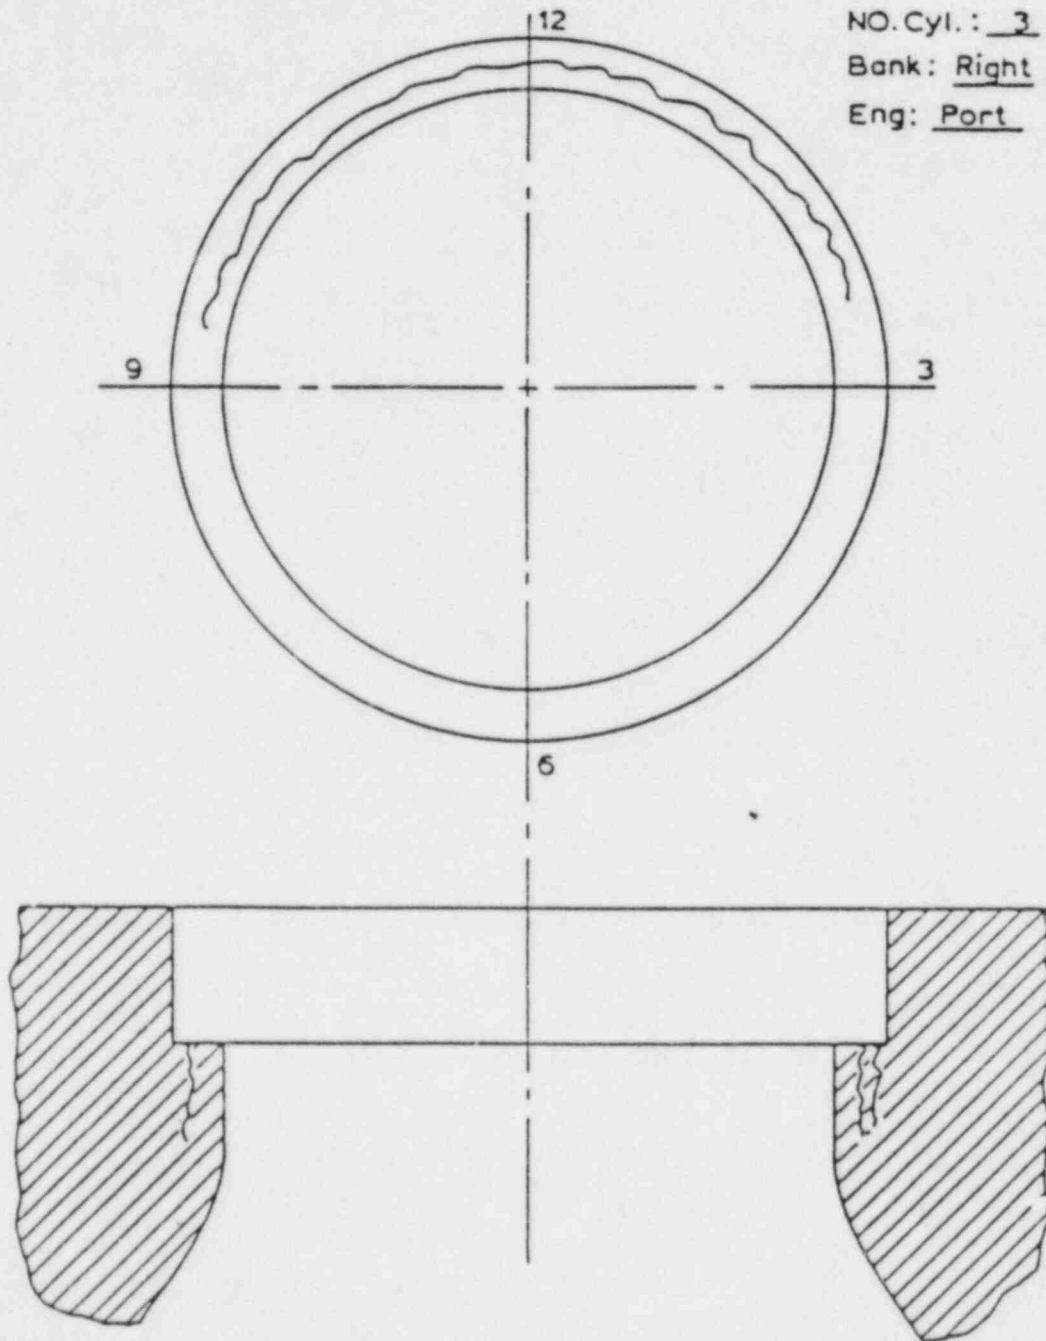
Figure 3.8

Nondestructive Testing, Cylinder Block, Shear Cracks, Counterbore Lip
