EVALUATION OF THE OPERATIONAL AND
MAINTENANCE HISTORY OF, AND RECENT
MODIFICATIONS TO, THE MAIN ENGINES IN THE
M.V. COLUMBIA

SES Report No. 123-01

April 1983

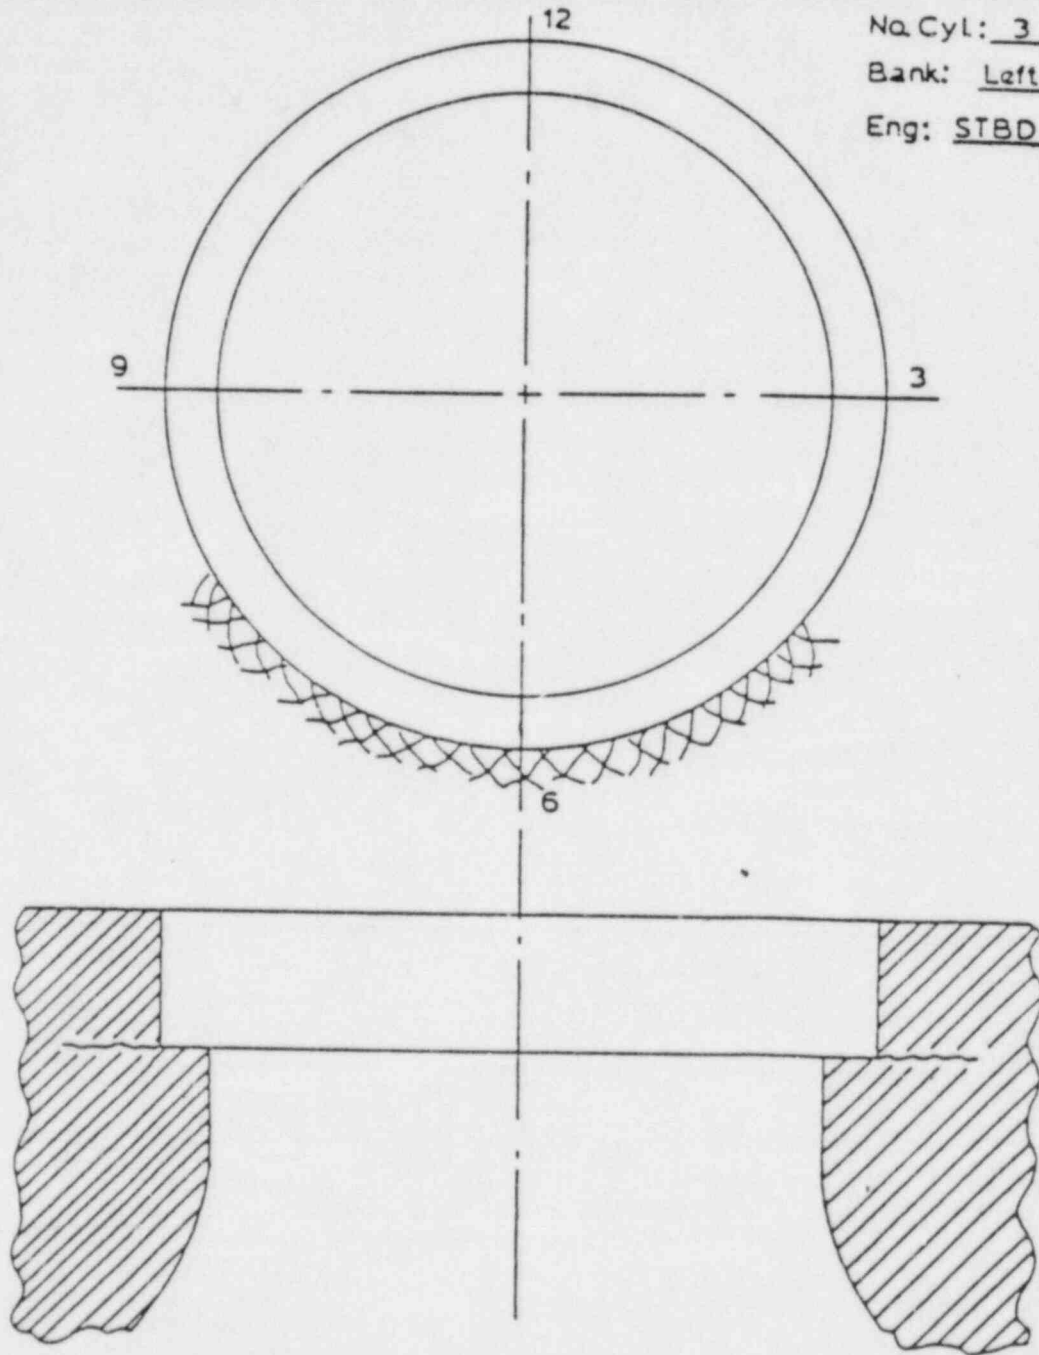
Figure 3.9
Nondestructive Testing,
Cylinder Block, Delamination Cracks

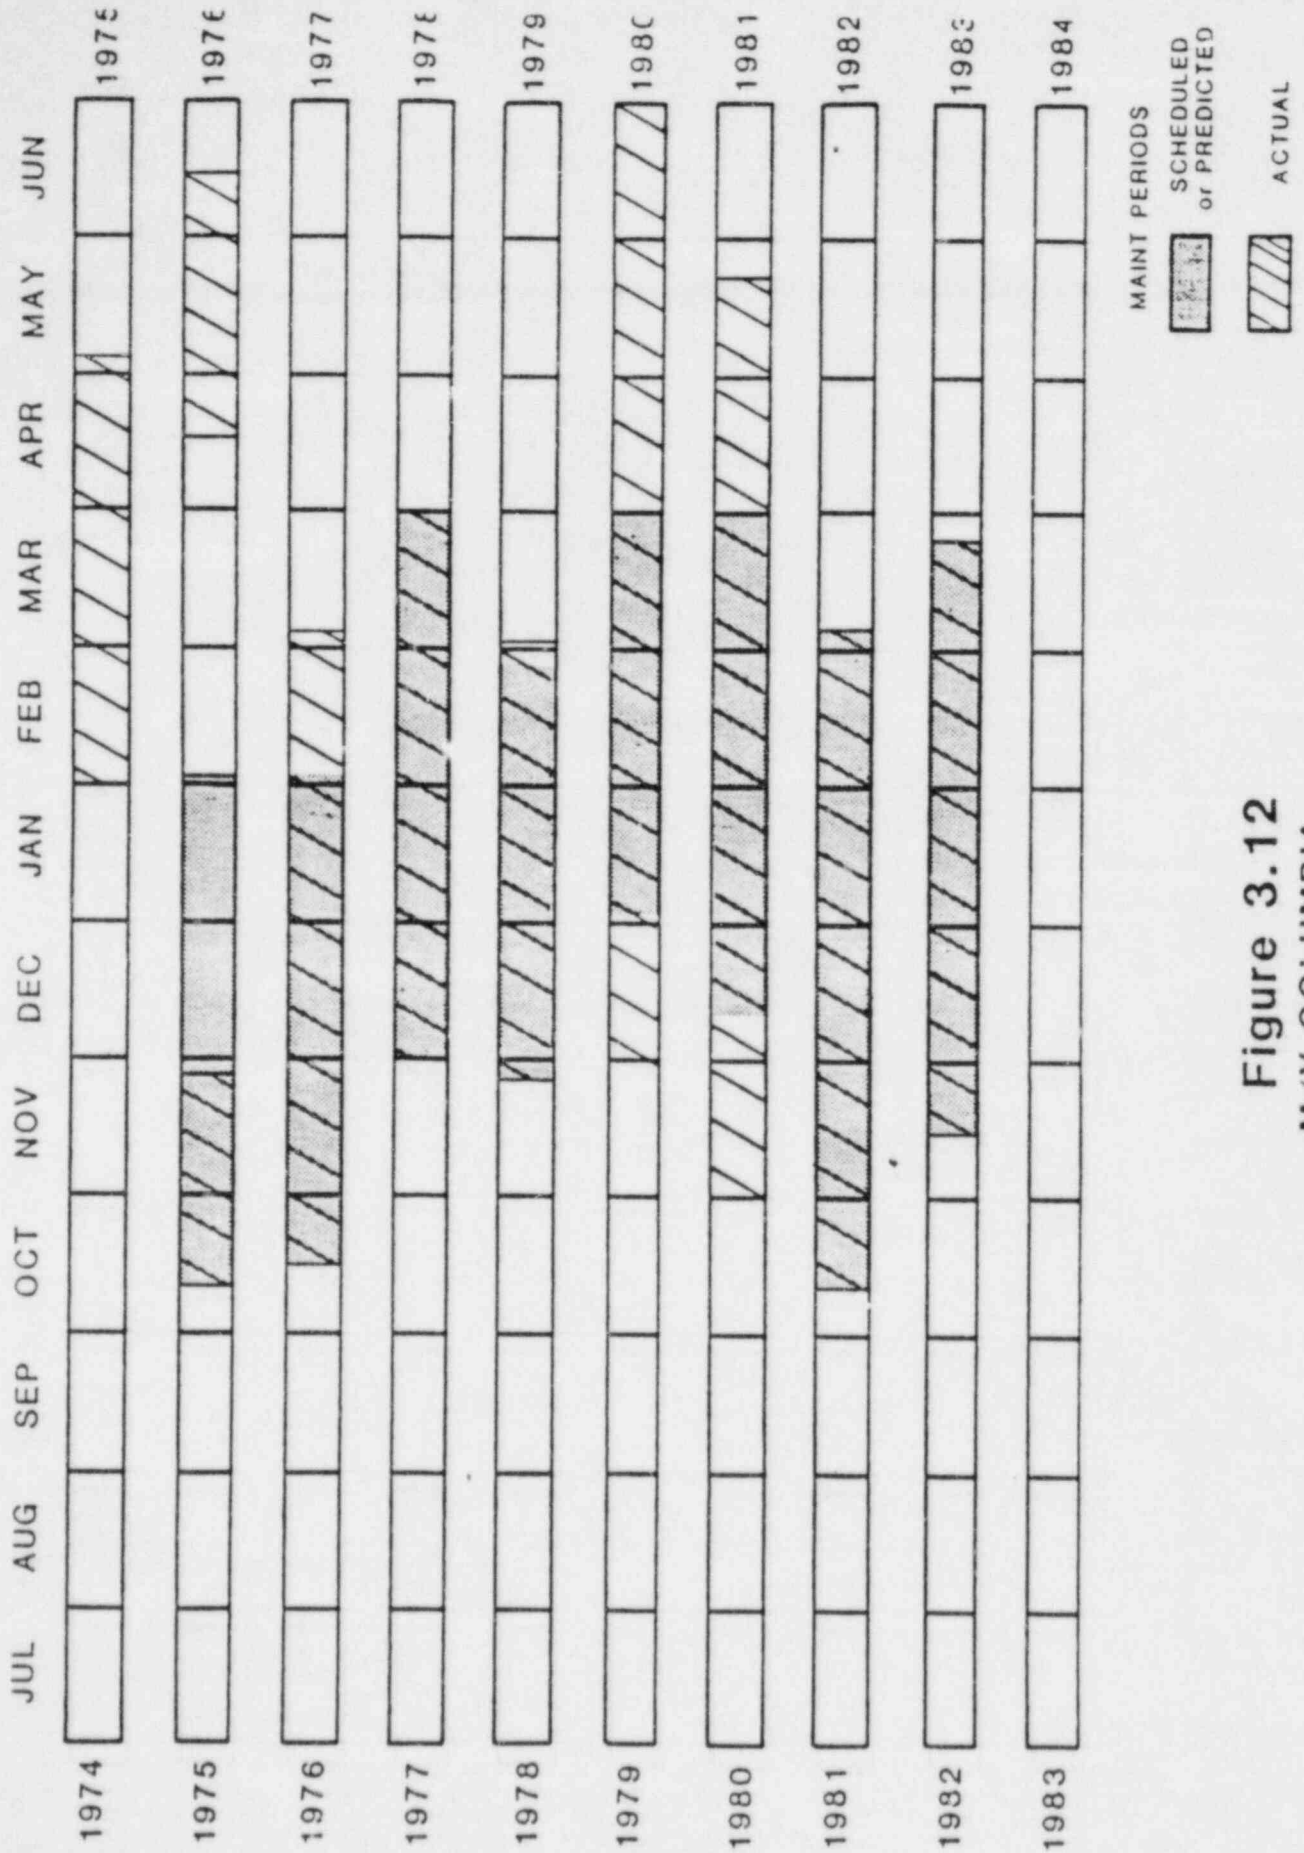
Another item of significance is the extended overhaul time required due to the greater amount of corrective maintenance which impacted the operational schedule as illustrated in Figure 3.12. The Figure shows that actual maintenance periods exceeded

projected periods by 30%, resulting in a loss of thirteen (13) months of potential revenue. Original planning records show generating time that for the five (5) years preceding 1980, maintenance periods of three (3) months were allocated for the entire ship. Post-1980 overhaul periods witnessed a consistent lengthening of the maintenance cycle as dictated by the engines' requirements. Finally, in 1982 and 1983, the maintenance period had increased by a total of one month and the in-service dates were being set to accommodate the engine overhauls.

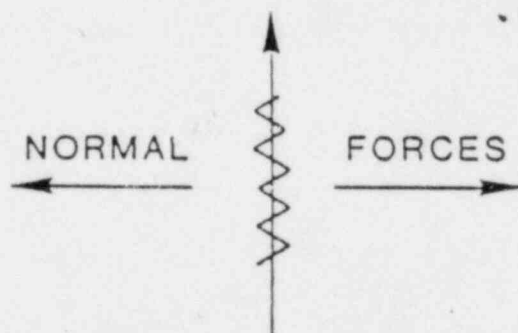
Stress Transfer Plane

The fasteners and link rod box cracking phenomenon was addressed by TDI as previously discussed in Section 3.3.4. The decrease in bolt diameter from 1-7/8" to 1-1/2" resulted in a net width gain of .75 inches on the total width of the connecting rod assembly. This modification plus the radius changes should increase the expected life of the component. It should be realized, however, that the shorter connecting rod for an equal stroke and crank throw radius has the greater angular swing and greater side thrust, hence greater loading on the piston and link pin and bushing. Integral with the fastening mechanism is the serrated joint which has been the site of repeated observations of fretting and therefore relative movement. The employment of the serrated joint is recognized for its value in transferring stress loads in the plane perpendicular to the serrations, however, it would appear that the resultant forces acting normal to the serration plane are contributing to the induced movement.

In a four-cycle engine this is especially pronounced when it is considered that there is a reversal of loading on each connecting link rod from compression to tension on each cycle along the legs of the "V" which is formed by the centerline of the connecting rod axis. The serrated joint surface then is constantly

being subjected to the normal and parallel forces induced by the two pistons. This type of a joint is also subject to controversy among manufacturers because of the argument that bearing distortion is more easily induced because of variation in serrated surface irregularities and bolt tightening. Two of these factors have been observed to date. This is further reinforced by the failure mechanisms noted in the Northwest Laboratories Report (Reference No. 17) which concluded that the connecting rod bearing was damaged by localized over heating. This finding reinforces the observations made during the 1979/80 overhaul of distressed connecting rod bearings with localized loading spots, fretting damage and carbonized oil deposits.
