ENGINE REBUILD REPORT

Motor Vessel Columbia

State of Alaska

January 30, 1981

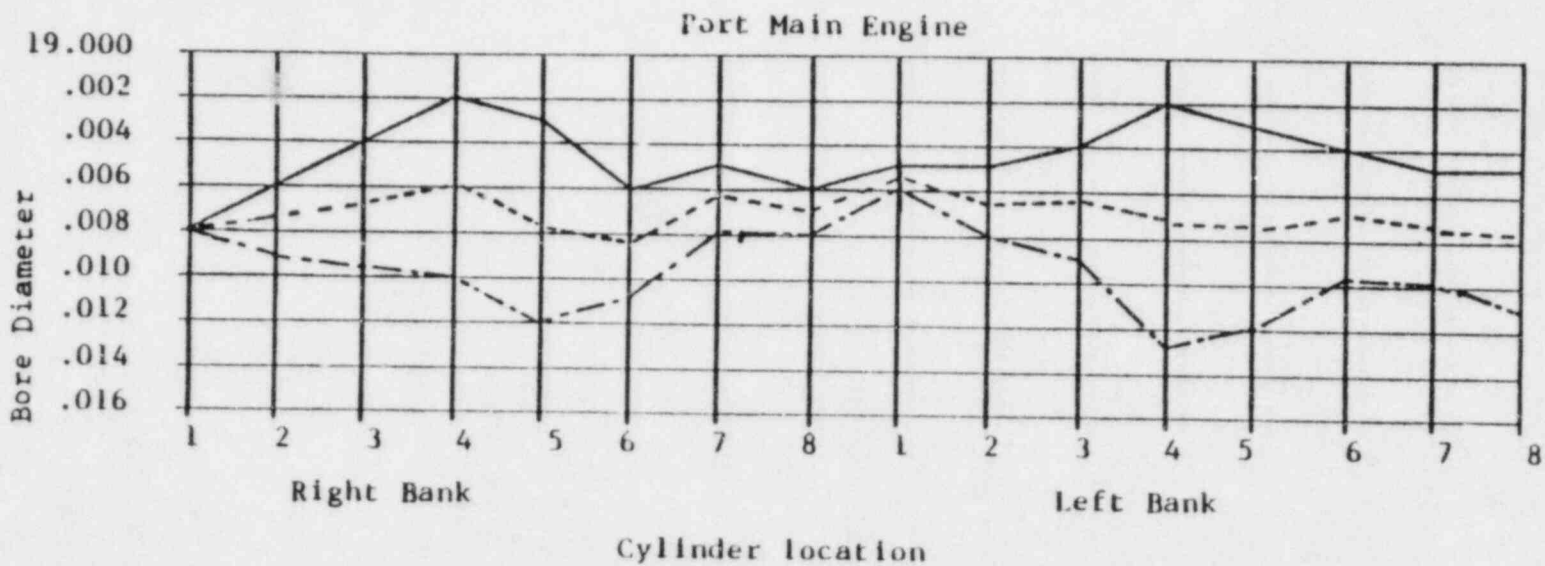
Figure 5 shows the data from the December 19, 1980 measurements apparently taken from data recorded on December 3, 1980 (see Figures 1, 2, 3, and 4). In addition to diameter measurements, these figures also show data on the crush measurements for the counterbore. The curve in Figure 5 was added by the investigator to show the average growth in diameter for all cylinders.

The ovalness of the cylinders, which are greatest in the center of each block, is probably a result of the same combination of effects producing the uniform growth of the cylinder bores. Because growth is seen to be greatest in the middle of the block where temperatures are highest, the cause is probably a creep-temperature relation. At the ends of the block where metal is at room temperature large expanses of metal are resisting this deformation. Because the center of the block is hotter than the metal at the ends, the pattern of growth into non-round cylinders is expected to continue. The cylinder bores are all growing at about the same rate throughout both engines and can be expected to continue at the same or an increasing rate.

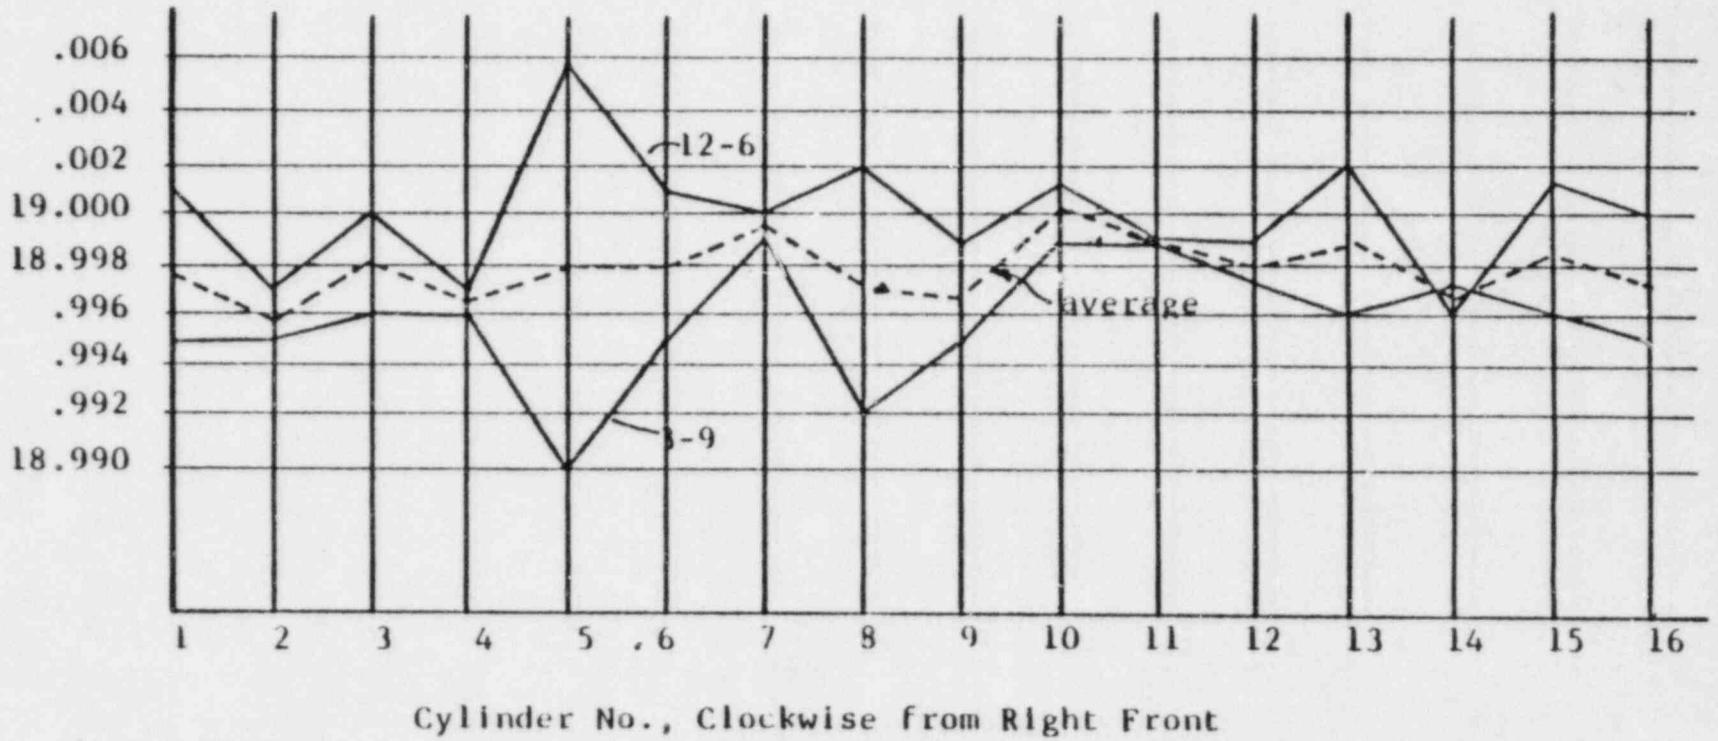
Figure 9

The liners do not show as great an oval shape as does the block. The starboard engine liners are plotted in Figure 6. In Figure 7, the average values of liner change are plotted with the average values of block change showing the block to have increased in diameter more than the liner. This difference is plotted in Figure 8.

Perminent Deformation of the Cylinder bore and the Liner Bore

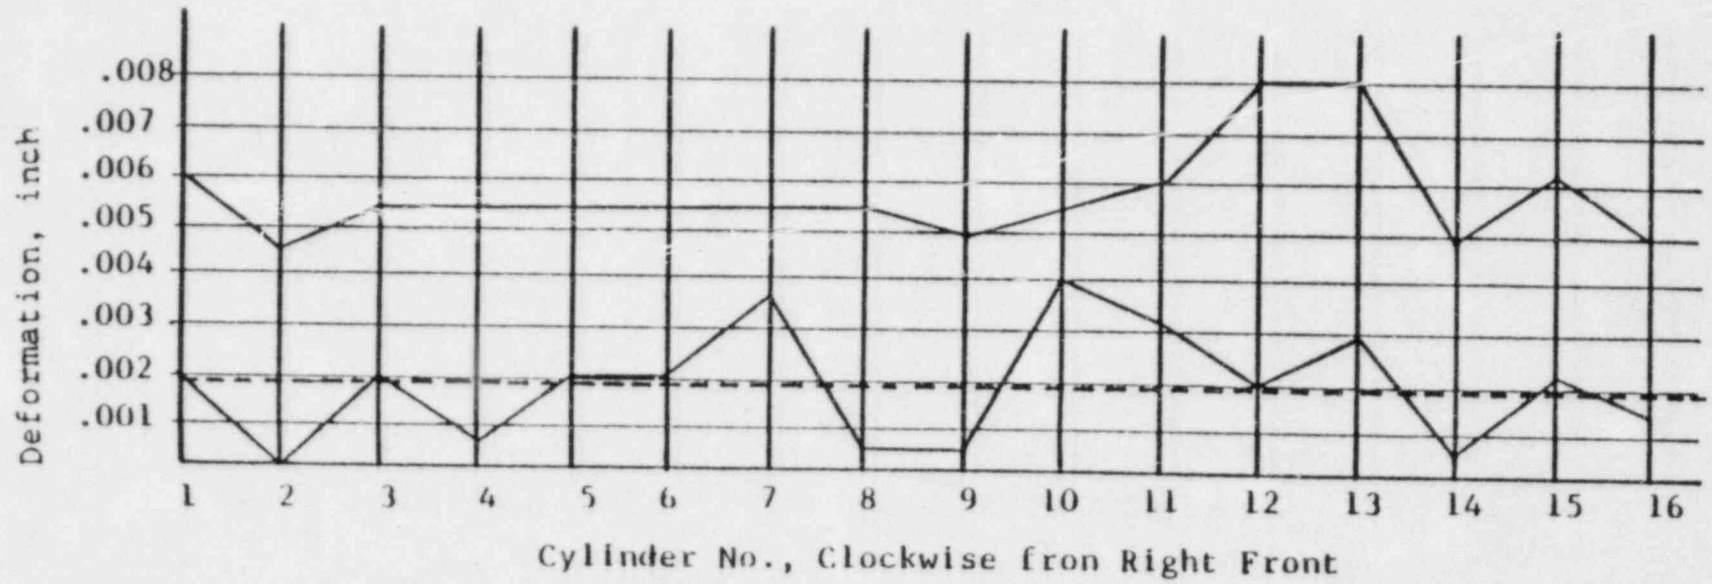
Figure 10

Average Difference between the Block and the Liner Bore Diameter

The average clearance between the liner and the block has increased .005 inch. The clearance difference explains why it was easier to remove the liners when they were cold. Under operating conditions, the effects of internal pressure and temperature gradient from the interior of the cylinder to the water jacket produces liner expansion to where it deforms to follow the shape of the block. Initial calculations indicate that during operation in the firing cycle, the cylinder-to-block compression force will be 27,000 psi.

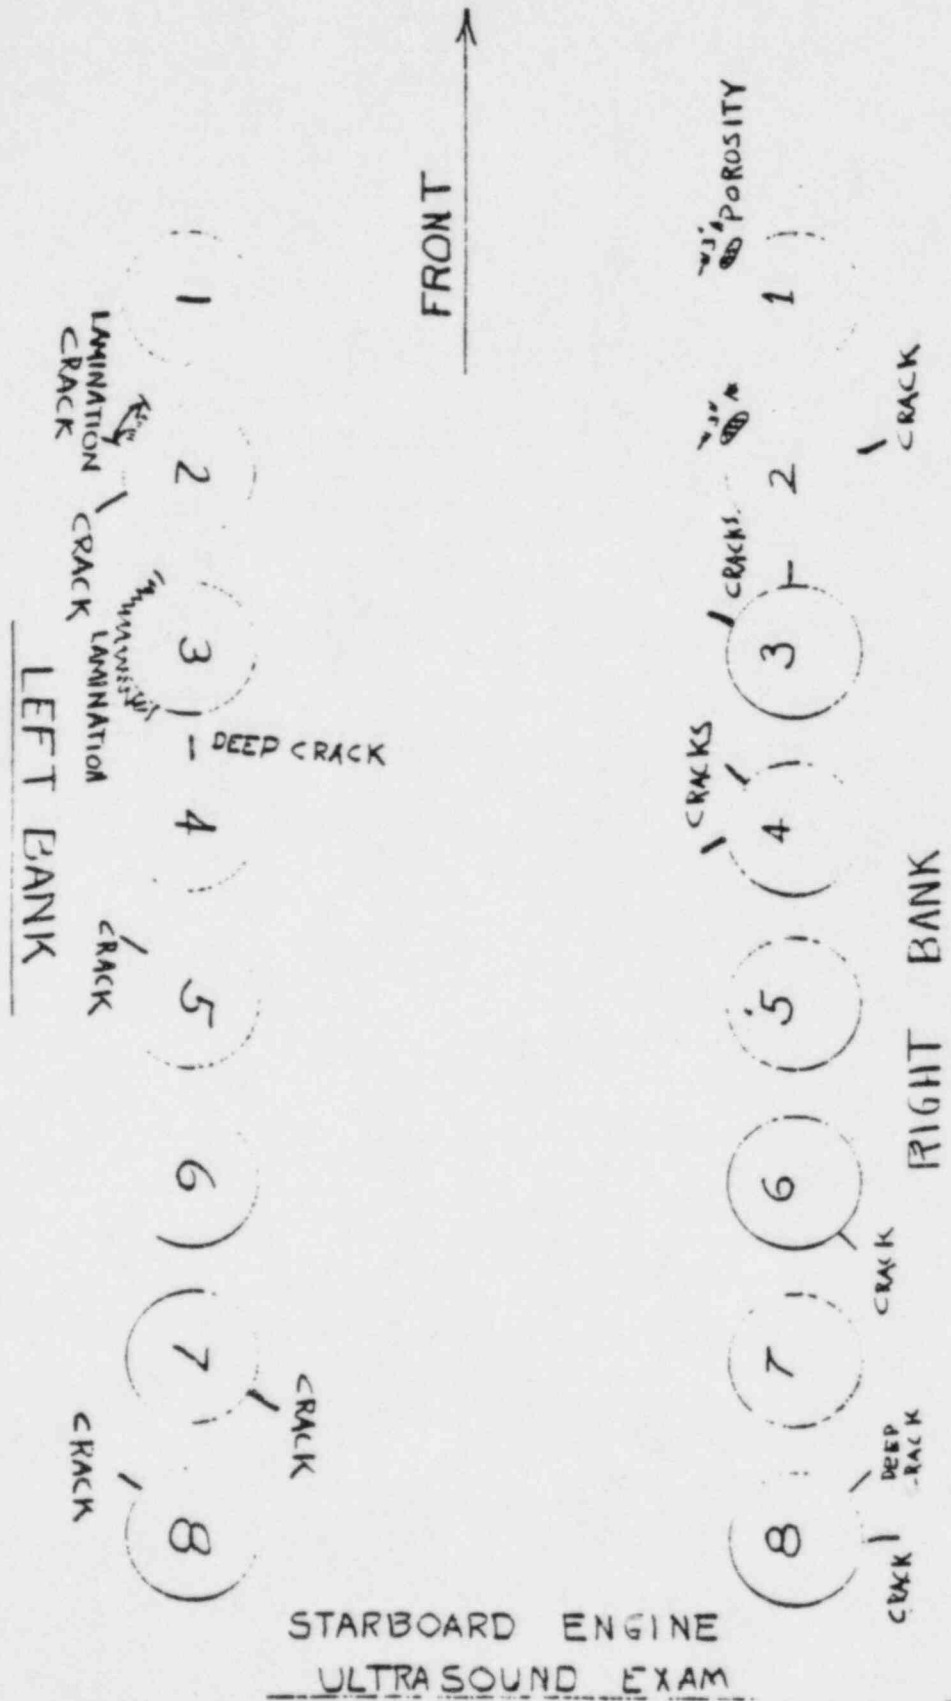
Figure 10

Non-destructive testing was performed on all cylinders about the circumference of the bore at the top of the block. Figures 10 and 11 show the results of these studies. Radial cracks were found on one or more cylinders in all four blocks. These cracks are a result of the creep and fatigue at the top of the block. These cracks are radial extending outward from the cylinder bore and are generally either between the cylinder bore and a smaller block drilling such as head stud, or water-jacket passage. These openings will have produced local stress concentrations and, hence, the resulting fractures from creep and fatigue stresses.

NONDESTRUCTIVE TESTING

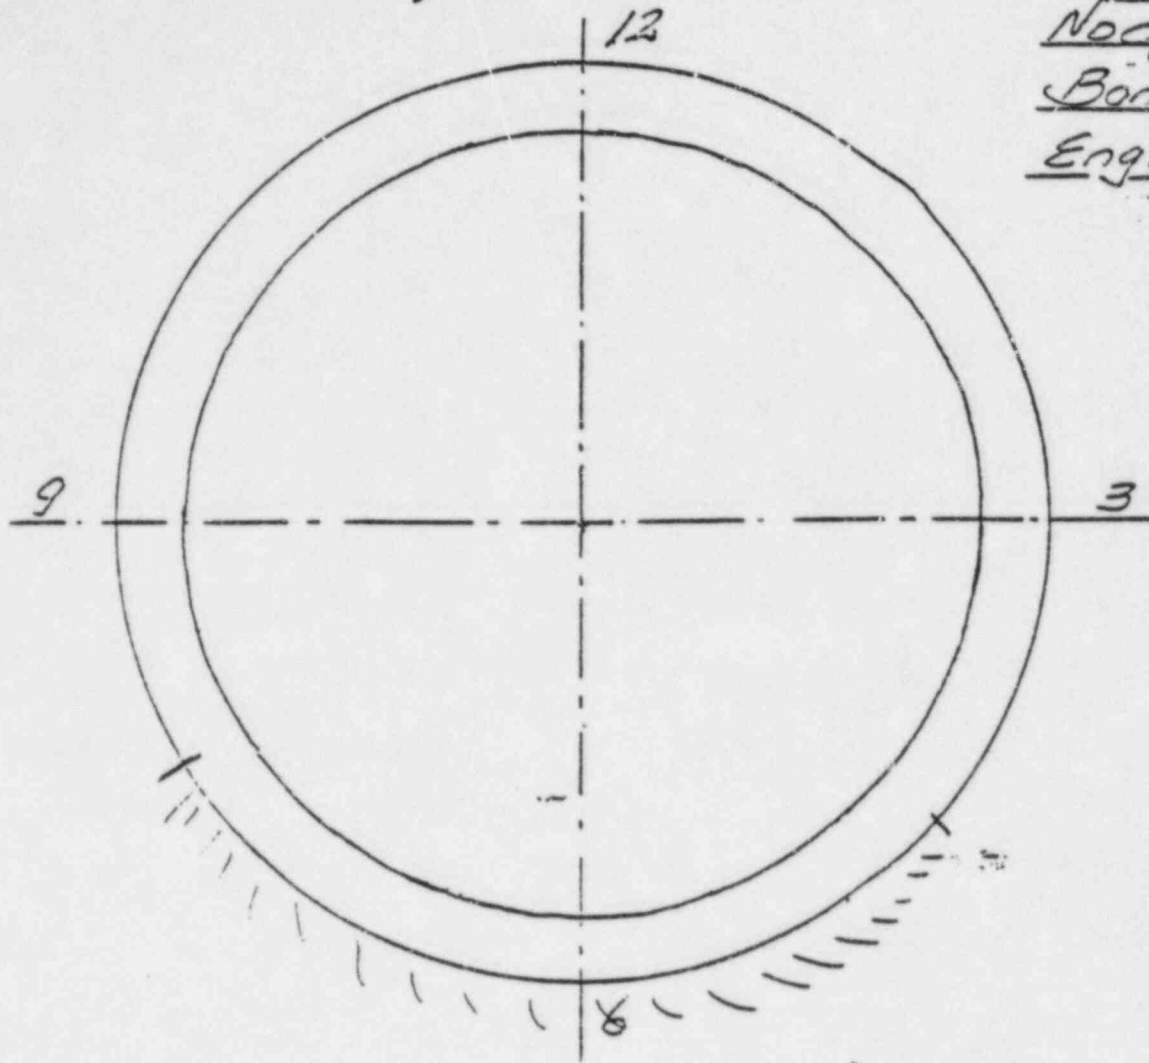
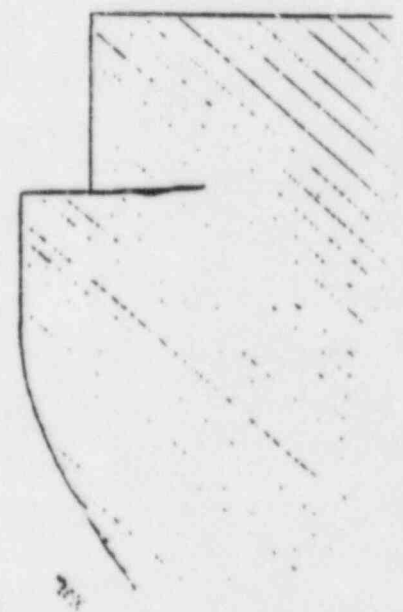
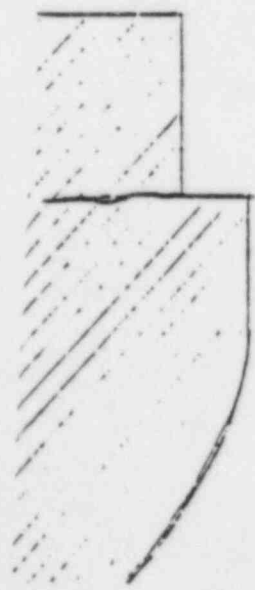
Figure 15

Laminar fractures outward from the root of the counterbore in cylinders 3 and 4 of the left bank of the starboard engine (Figure 15).

Confirmation of the extent of the above fractures by showing their entrance at the metal surface in the roots of the counterbore in cylinders 3 and 4 of the left bank of the starboard engine.

No cyl: 3  
Bank: left  
Eng: ST80

5. The laminar fracturing of the left block of the starboard engine has rendered it unserviceable; it or the entire engine must be replaced.
6. Because the remaining three blocks have been shown to have radial cracks about several of the cylinders, this condition must be closely monitored to observe the cylinder diameter growth in an attempt to perform corrective maintenance before major problems occur.
7. Plan to replace the remaining three blocks in the near future.
8. Consider redesign of the upper portion of the block for replacement to alleviate observed block failure.

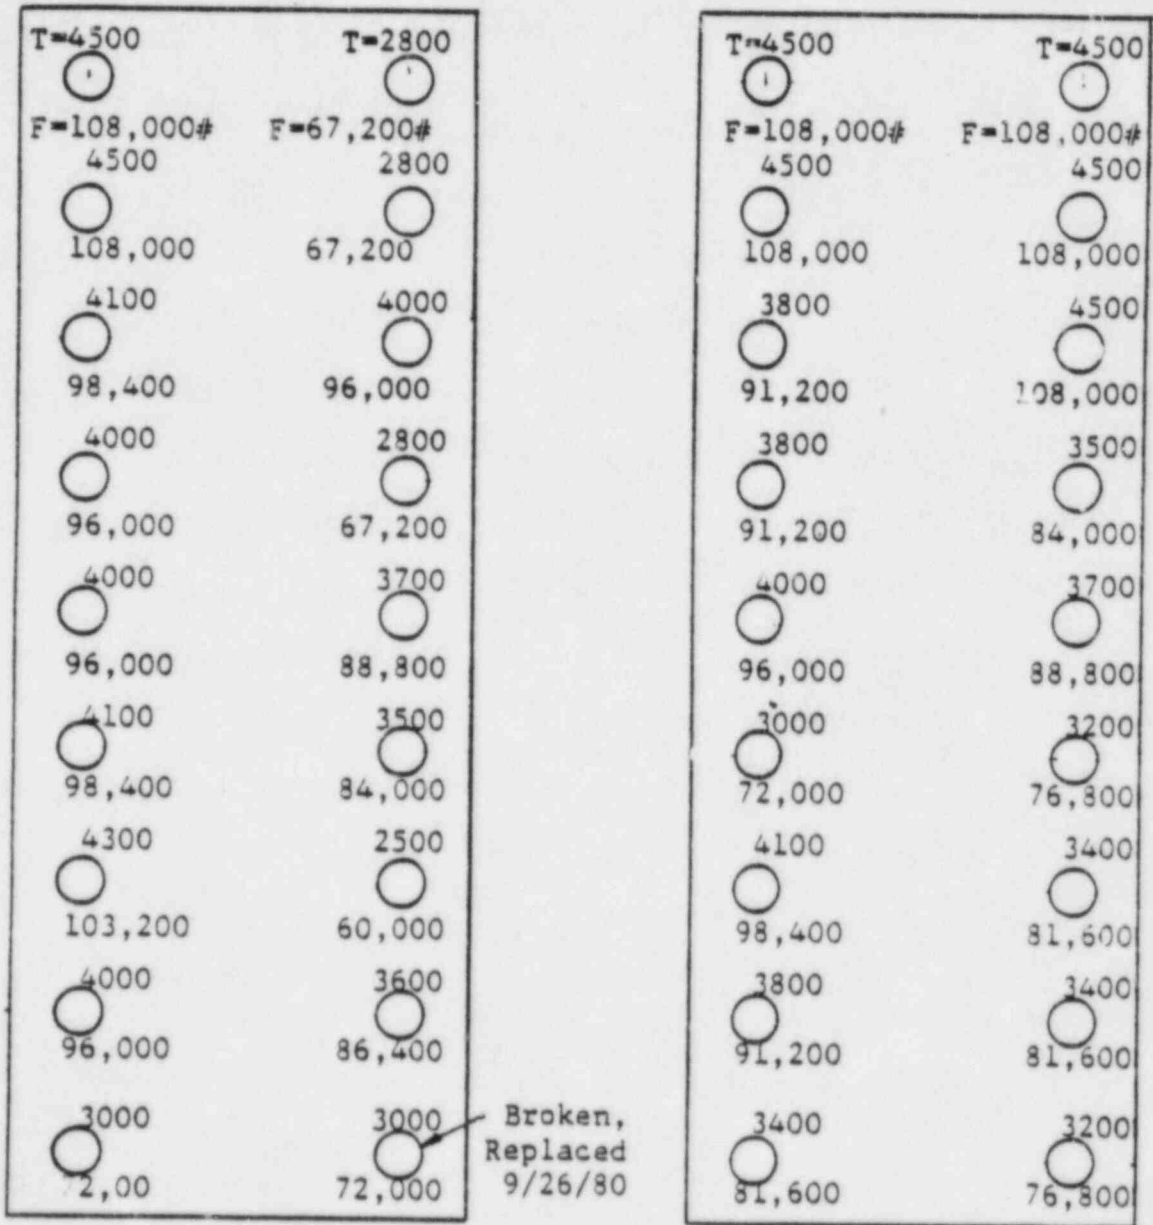
Figure 16

Discussions with ship personnel indicated that one of the hold-down bolts for the block had broken. The bolt at cylinder B, left bank of starboard engine, had been replaced, and the remaining hold-down bolts had just been retorqued up to 4500 ft-lbs. During retorquing the maintenance personnel had moved in a circular fashion about the periphery of the block, recording the torque value where the nut began to turn.

An analysis was made of the port and starboard engine hold-down forces resulting from the bolt preload to determine the strength of the block-to-base attachment. The forces were calculated using the standard dry-torque coefficient (.20). Hold-down forces for each cylinder were obtained using the four bolts at the corners of each cylinder. The forces generated during maximum operating conditions was taken, using  $D_{cyl} = 17$  in. and  $P_{max} = 1500$  psi. When this force was plotted for the operating condition (see Figure 18), it was seen that the starboard main engine was only marginally operable before retorquing. Two cylinders (R-6 and L-8) were grossly below acceptable limits of block-to-base preload, and cylinders R-4, R-5, R-7, R-8 and most of the left bank were close to separating from the base.

1. That all block-to-base bolts be torqued according to the procedure described in the instruction manual, page 5-6, using the value given in Appendix IV, page 8-5, Torque = 4500 ft-lb. This procedure requires loosening, relubricating, and retorquing to factory specifications. Retorquing is a definite requirement for the starboard engine and highly recommended for the port engine.

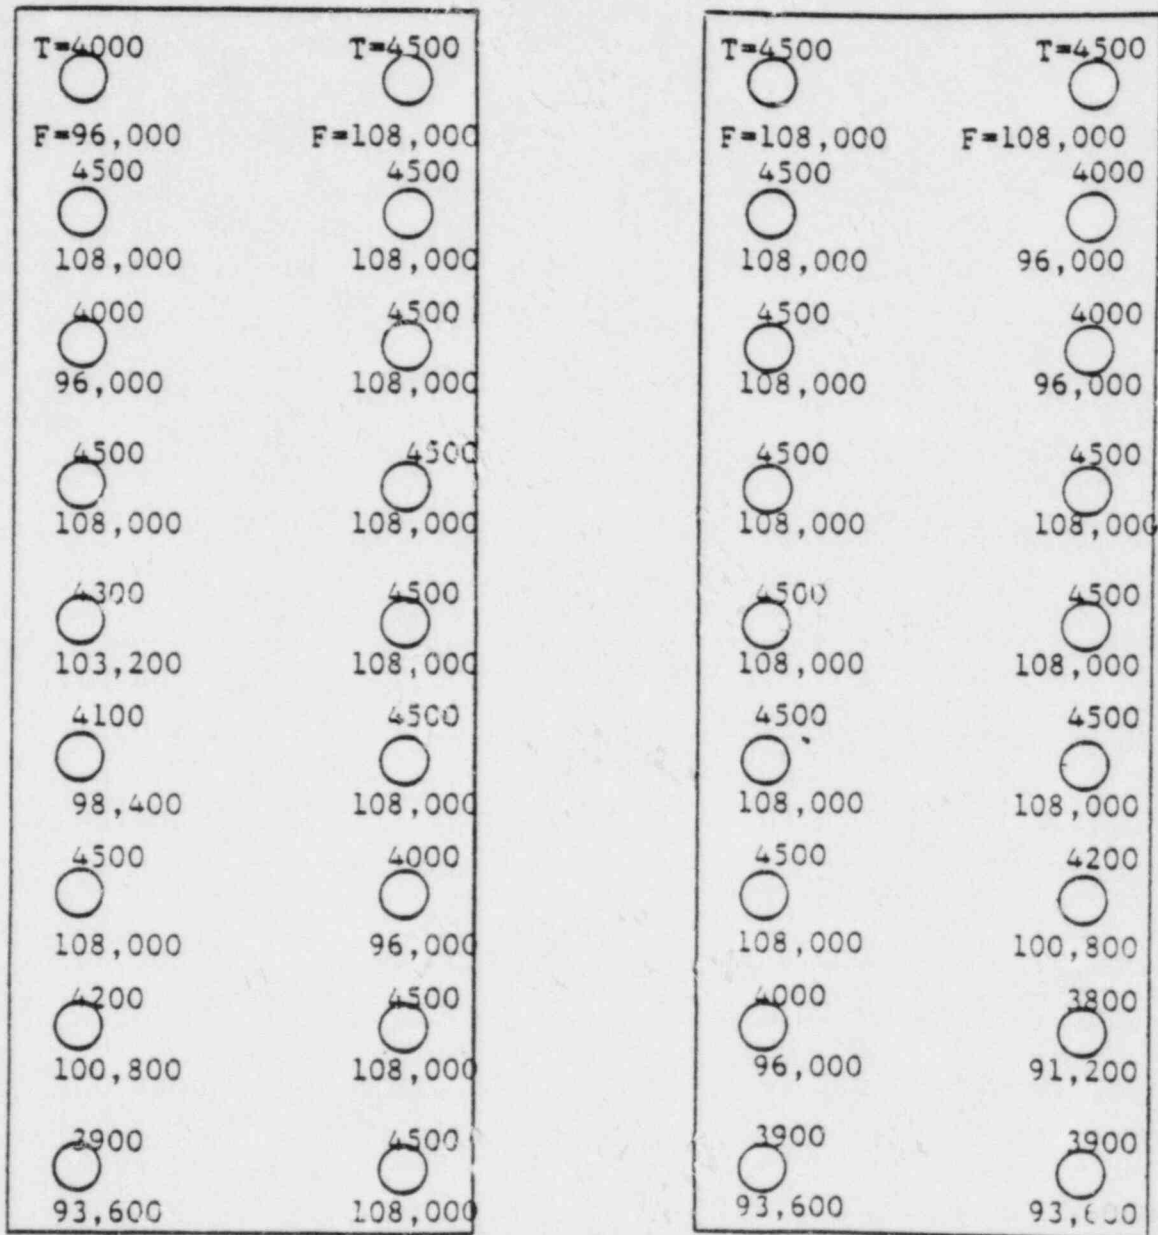
Figure 17

The fracture of the hold-down bolt for the block and the subsequent retorquing of all bolts indicates a need to repeat the retorquing procedure following methods outlined in the engine manual.
