Subject: Final Report - DER 84-46  
A 50.55(e) Reportable Condition Relating to Refueling Water  
Tank Penetration Sleeves.  
File: 84-019-026; D.4.33.2

FINAL REPORT - DER 84-46  
DEFICIENCY EVALUATION 50.55(e)  
ARIZONA PUBLIC SERVICE COMPANY (APS)  
PVNGS UNITS 1, 2, 3

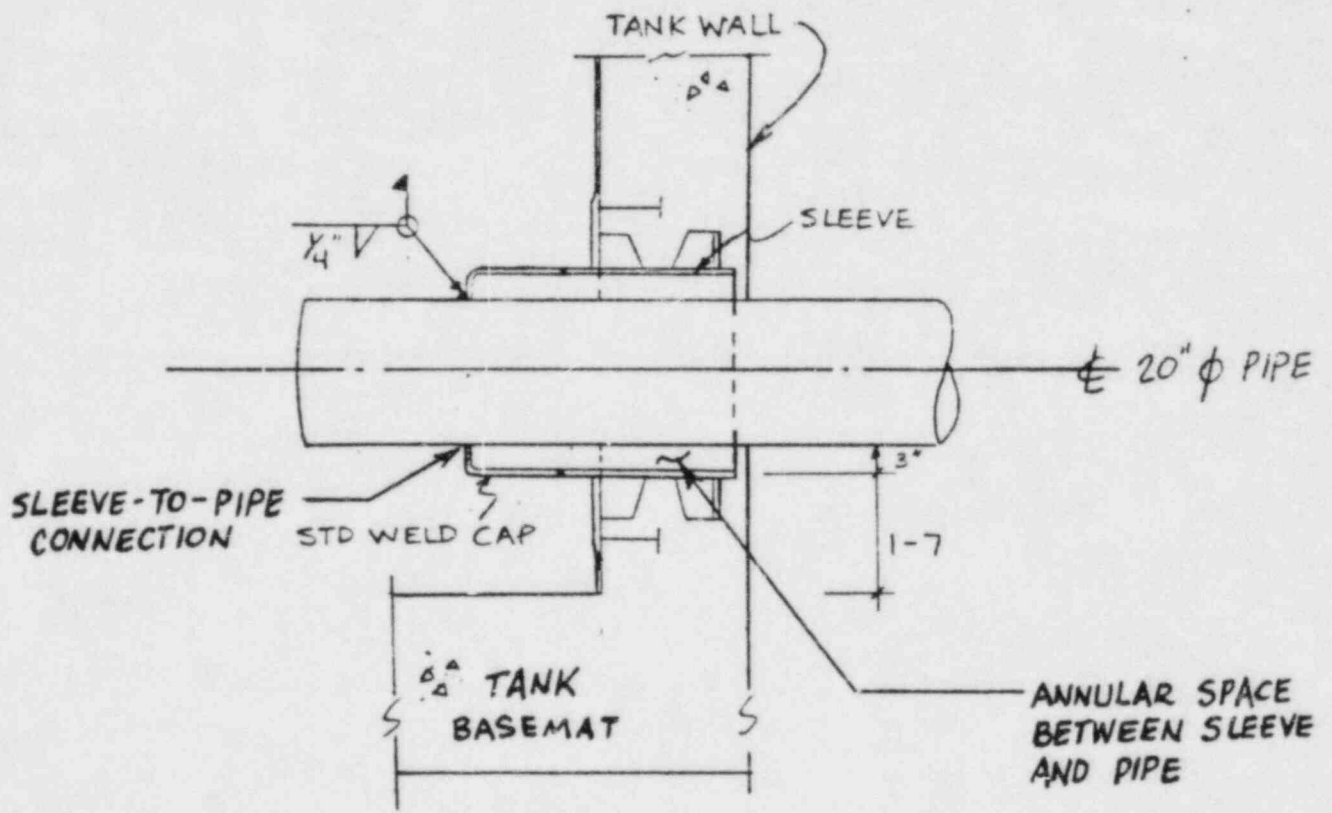
FIGURE 1

Following completion of the final stress calculation for the Chemical and Volume Control system (CH), it was determined that no design calculation had been performed for the sleeve-to-pipe cap plate connection for two 20-inch diameter pipes penetrating the Refueling Water Tank (See Figure 1). Calculations were performed and revealed that the connection would be overstressed during a seismic event due to loads resulting from seismic anchor movement.

In the original configuration, relative movement between the Refueling Water Tank and the Essential Pipe Tunnel during a seismic event would cause a relative transverse movement between the sleeve and the pipe. This movement created the overstress condition in the sleeve-to-pipe connection. To prevent this movement, the annular space between the sleeve and the pipe shall be filled with non-shrink grout. Calculation No. 13-CC-CT-015 has been performed to verify that this modification will prevent the overstress condition. This action will ensure that the system will not fail in the event of an SSE and that the leak-tight integrity of the Refueling Water Tank will be maintained.

The root cause is an oversight on the part of design engineering to perform a required evaluation. The final stress calculations provide a check on this type of oversight, and the lack of this calculation was discovered during final stress analysis.

Design Change Packages (DCPs) 1SC, 2CC, and 3CC-ZY-134 have been prepared and will be issued to perform and document the required grouting work for all 3 Units.
