U.S. NUCLEAR REGULATORY COMMISSION
REGION I

Report No. 50-317/84-18
50-318/84-18

Facility Name: Calvert Cliffs Nuclear Power Plant, Units 1 & 2

Inspection Conducted: June 12 - July 10, 1984

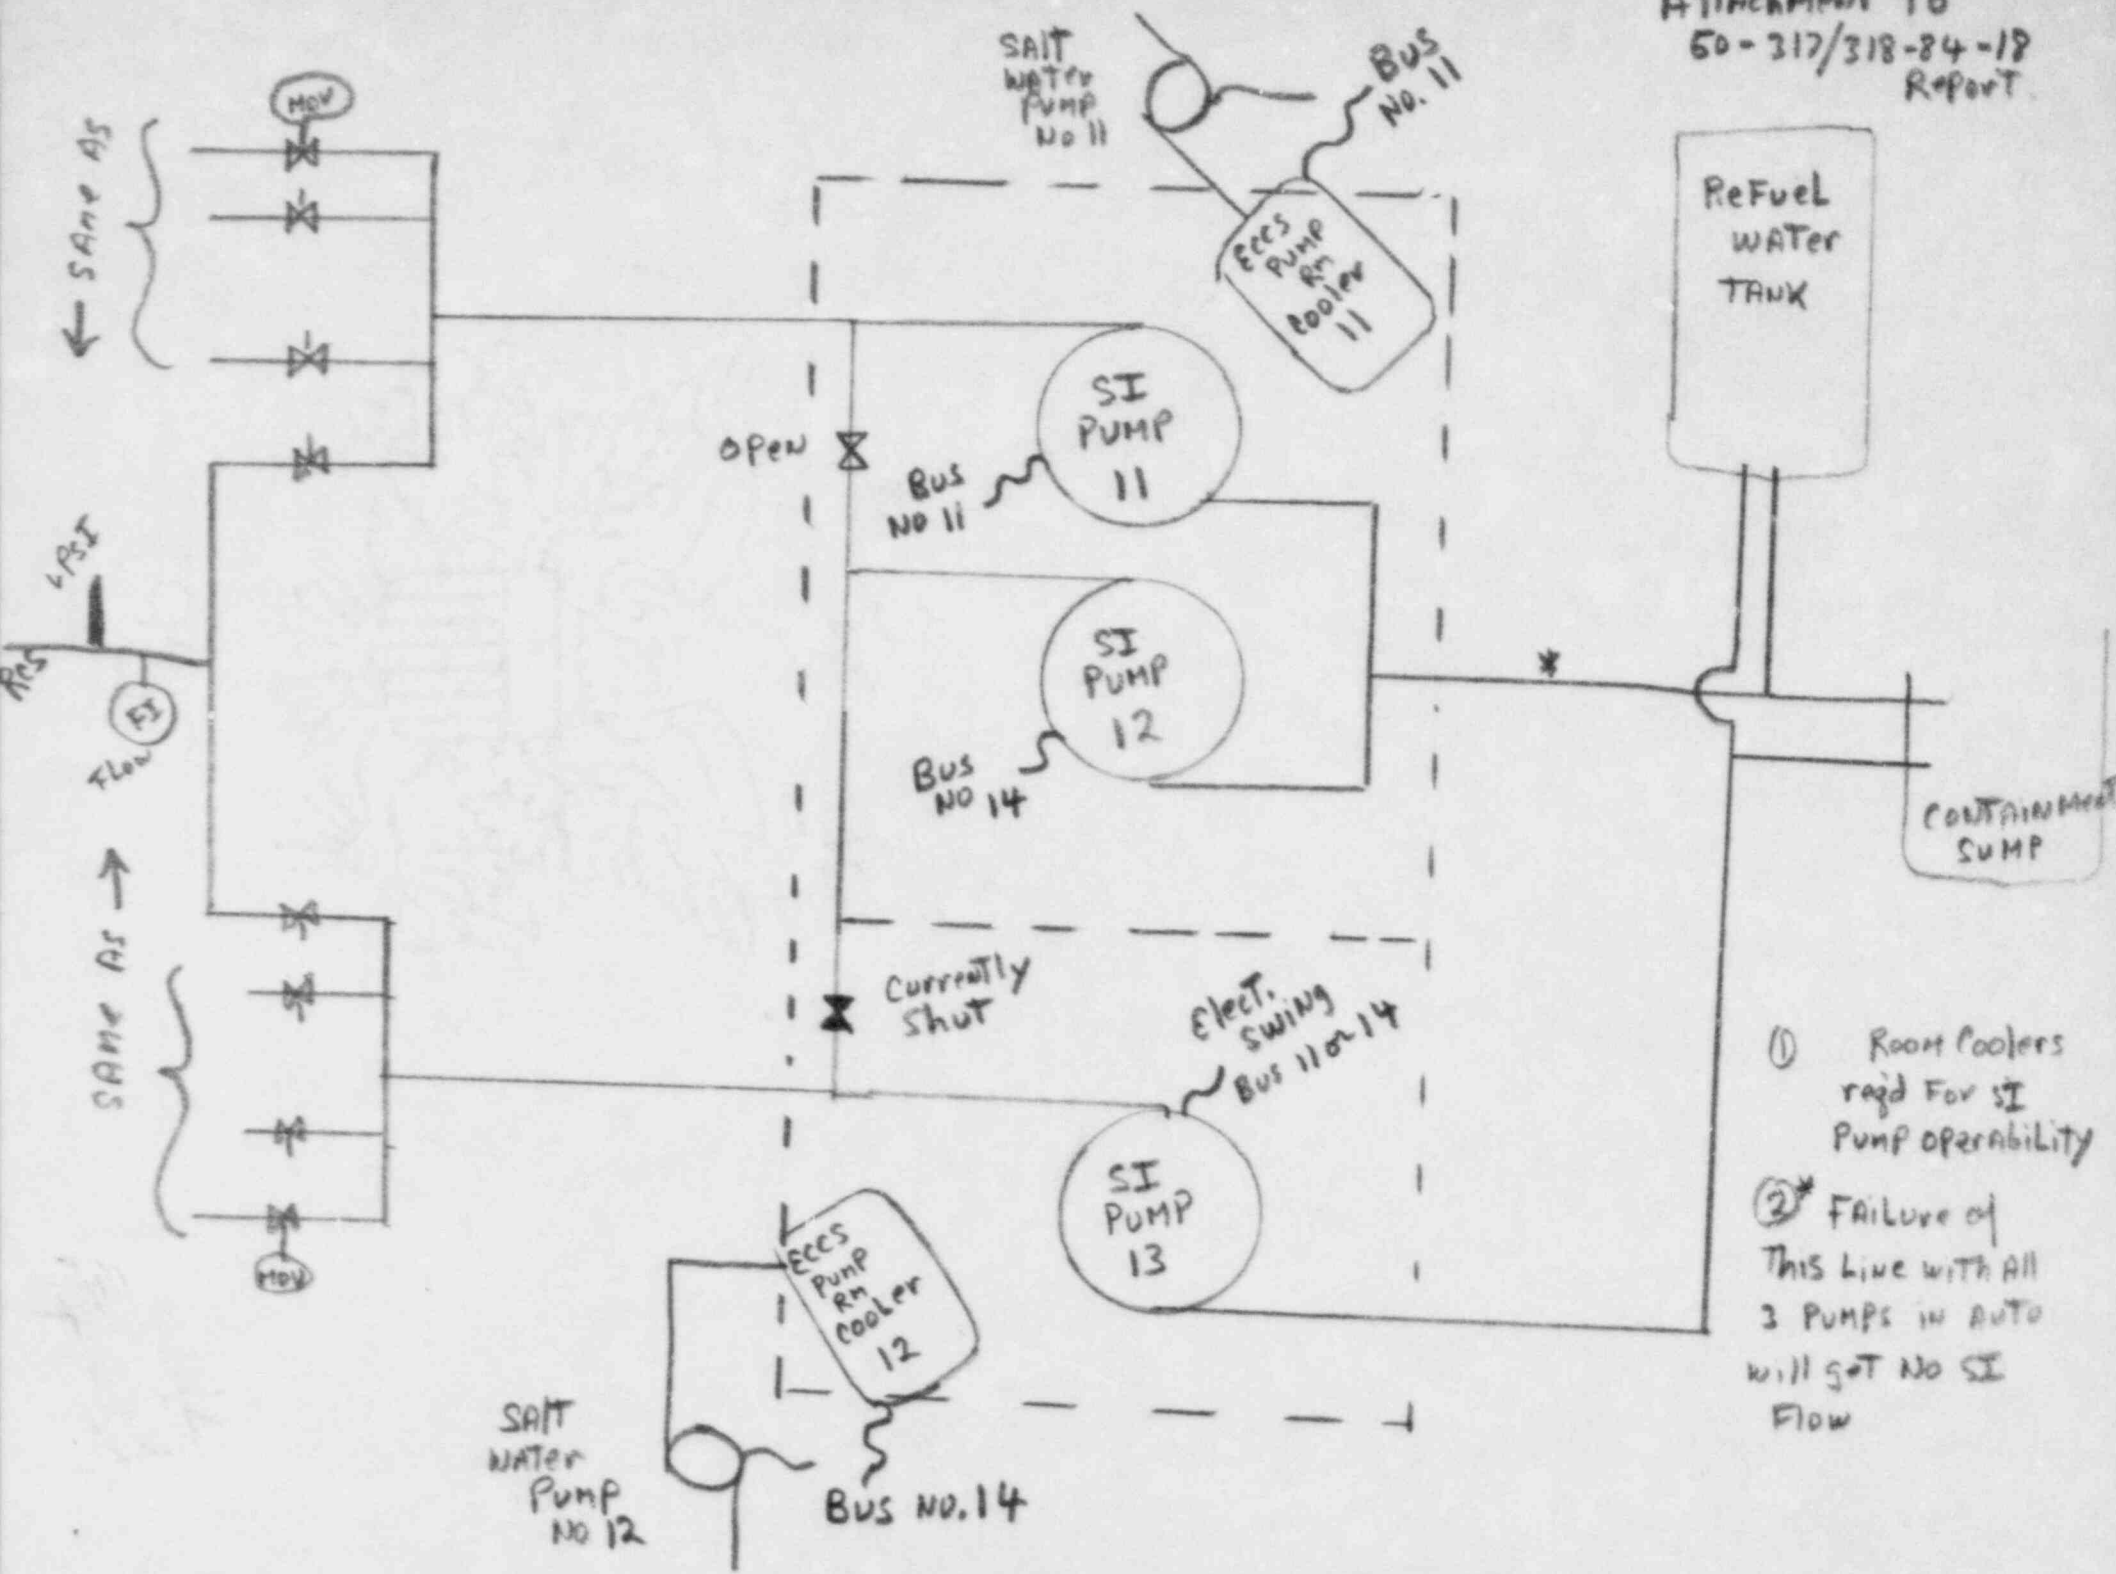
Further investigation of this revealed that the licensee had postulated a particular scenario where a Loss of Coolant Accident (LOCA) occurred simultaneous with a loss of offsite power and failure of one diesel generator. The postulated scenario with the previous operation conditions (one SI pump electrically powered from one vital bus and the other two SI pumps connected to the other vital bus) would result in a failure of the vital bus that powers the two SI pumps connected to it, and leave just one SI pump to mitigate the accident. The licensee also postulated that with just one SI pump operating under full flow conditions the single pump would have a high probability of "running out" causing cavitation and possible loss of suction if both piping headers were cross connected as in past practice (closing MOV-653 separates the headers). The licensee further explained that because of the physical arrangements, the design of suction piping and electrical configuration and logic, that separating the discharge headers and placing one HPSI pump in pull to lock provided more reliability and assurance that two separate redundant trains of emergency actuating features would be available in the event of an accident (see drawing attached at end of Report).

The placing of the number 12 and 22 HPSI pump handswitches in the "pull-to-lock" position changes the HPSI pump starting logic as described in the FSAR.

10 CFR 50.59 requires that the licensee make a determination that an unreviewed safety question does not exist for changes made to the facility as described in the FSAR and that a written safety evaluation be recorded which provides the basis for the determination. Such a written safety evaluation was not provided for the HPSI handswitch position changes. This is a violation. (317/84-18-01)

- ① Room Coolers req'd For SI Pump operability
- ② Failure of This Line with All 3 Pumps in AUTO will get NO SI Flow
