Commonwealth Edison
Braidwood Nuclear Power Station
Route #1, Box 84
Braceville, Illinois 60407
Telephone 815/458-2801

Subject: Teleconference between Commonwealth Edison Company and the
Nuclear Regulatory Commission dated October 3 and 4, 1995,
Regarding the Increase in the Interim Plugging Criteria for Byron
Unit 1 and Braidwood Unit 1
NRC Docket Numbers:50-454 and 50-456

Inspection in the Area of Anti-Rotation Devices

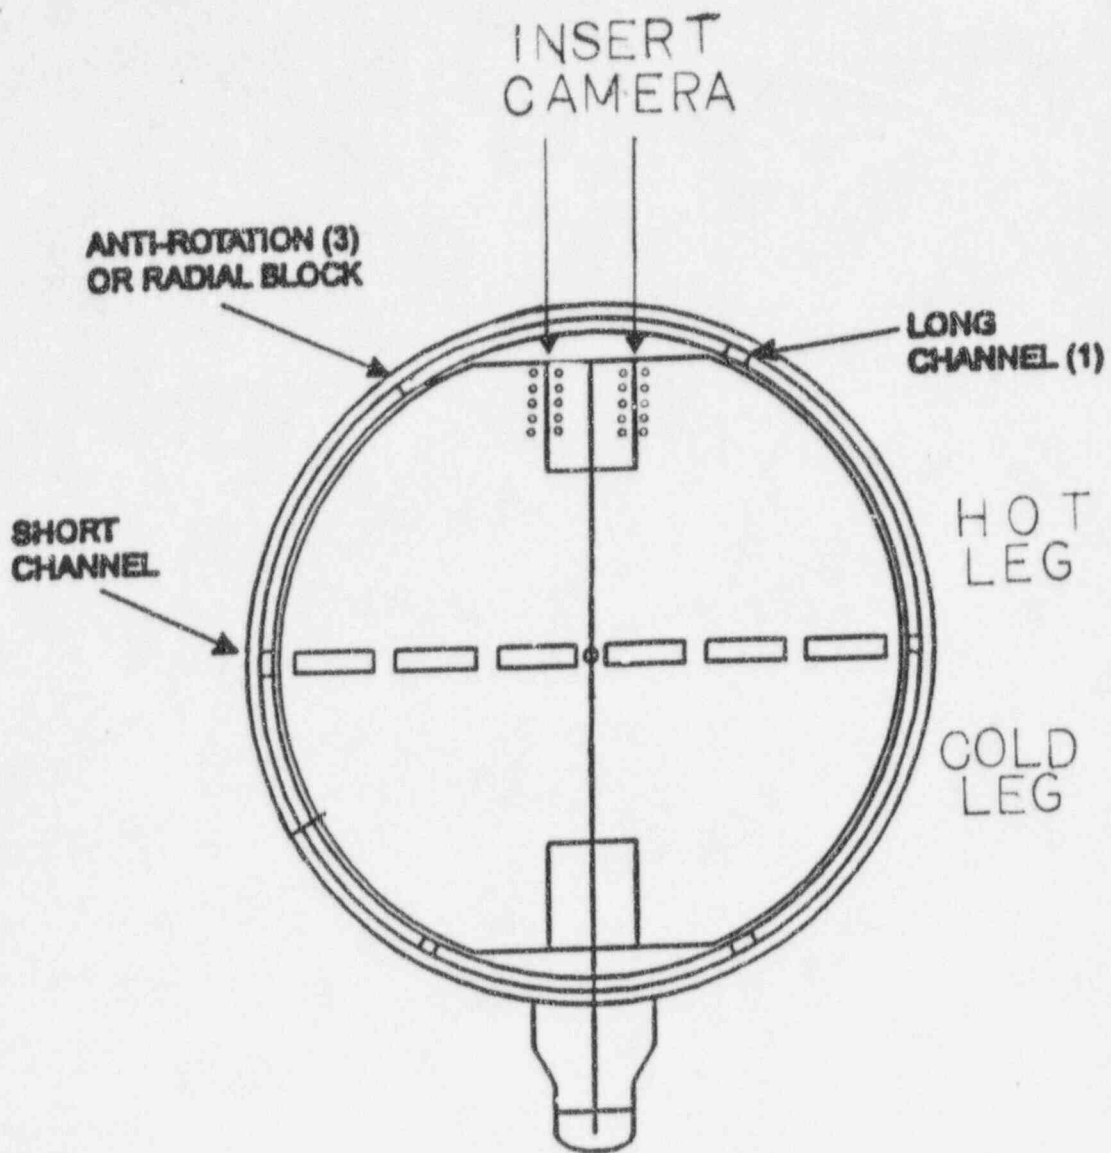
**MODEL D4
TOP PLATE**

During the Braidwood Unit 1 refueling outage a visual inspection of the "A" SG top TSP patch plate area will be performed. The inspection will consist of inserting a camera along the 2 accessible patch plate seams to a distance of 5 tube rows (see attached sketch). This visual inspection is intended to determine if TSP degradation is present in this area. Those TSP intersections that have received visual inspection (20 tubes), will also be eddy current inspected and data analyzed using techniques and analysis guidelines developed through the EPRI program to detect TSP degradation. The eddy current responses seen in the SG will be compared to those obtained in the EPRI mockup and any ambiguous signals will be investigated and reported to the Staff.
