Steam Generator Group Project

Task 10 - Secondary Side Examination

Prepared by E. B. Schwenk, K. R. Wheeler

Pacific Northwest Laboratory
Operated by
Battelle Memorial Institute

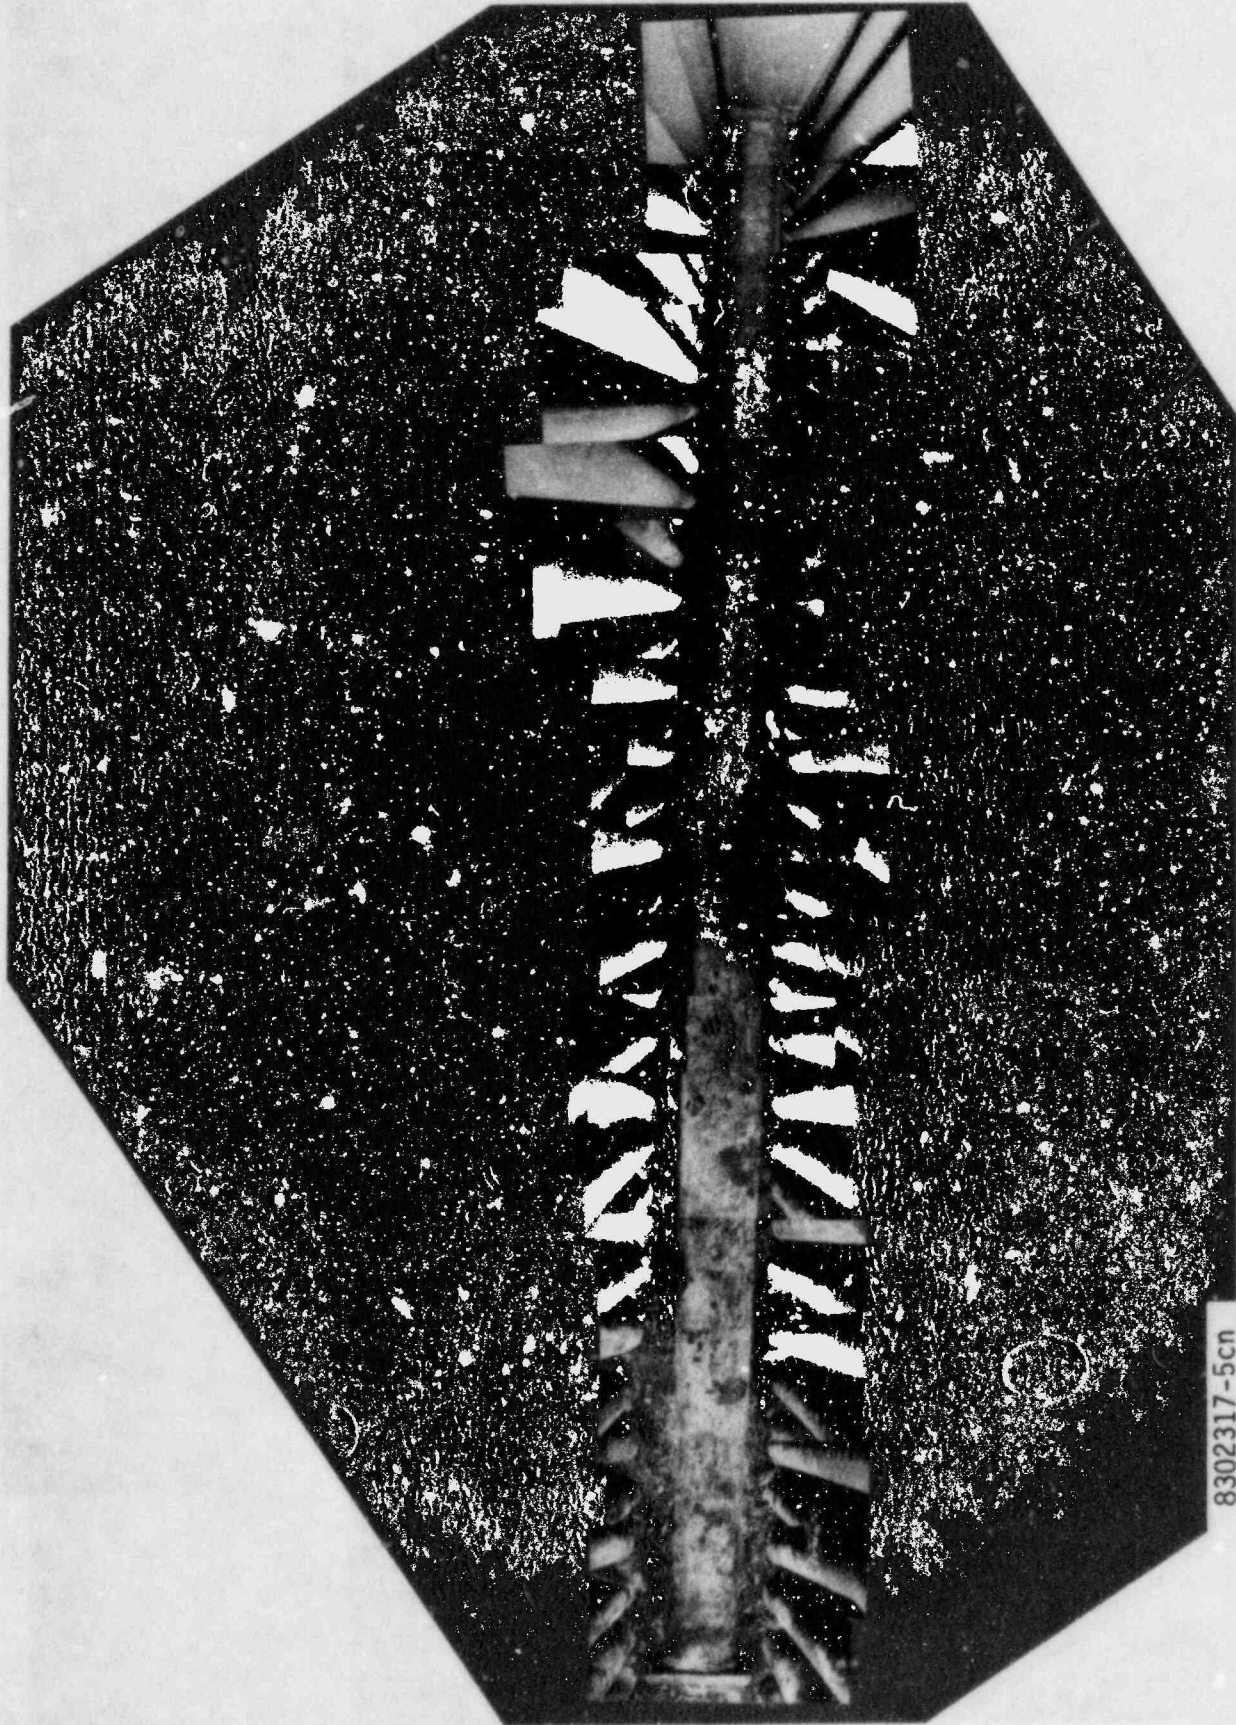
8302317-5cn

Tube Sheet at the Tube Lane - Sixteen photographs of the tube sheet lane, taken through the 0° handhole with the camera system shown in Figures 3 and 4, were joined together in a montage and are presented in Figure 9. Some of the Row 1 hot and cold leg tubes appear nonperpendicular to the tube sheet due to normal distortion caused by the camera. The camera-to-blowdown pipe distance is about 15-20 inches (38.1 - 50.8 cm.).

Changes in visual appearance in Figure 9 from the handhole region (around Column 92) to the generator center (around Column 45), suggest that vertical hydraulic flow parallel to the lane was greatest near the handhole and least around the generator center, in spite of the flow deflectors (see Figure 12). This is reflected by varying surface conditions and colors*. For example, tubes at the handhole appear to be dull brown in color, possibly with thinner deposits and there are fewer tube deposits laying in the tube sheet/blowdown pipe region. Surface features and color variations appear more distinct toward the center of the tube lane. These conditions are seen more clearly in Figures 10 and 11 which are close-ups of the mid-point and end (generator center) of Figure 9. The conditions noted in the flow lane nearest the 0° handhole are seen more clearly at the bottom of the flow deflector seen in the montage shown in Figure 12. The flow deflector channel box is uniform in cross-section from the top to the bottom of the montage photo; off-angle photography caused unreal distortion of the flow deflector.

FIGURE 9. Montage Photograph Looking Toward Tube Sheet and Blowdown Pipe, Column 92 (right) to Column 48 (Left)

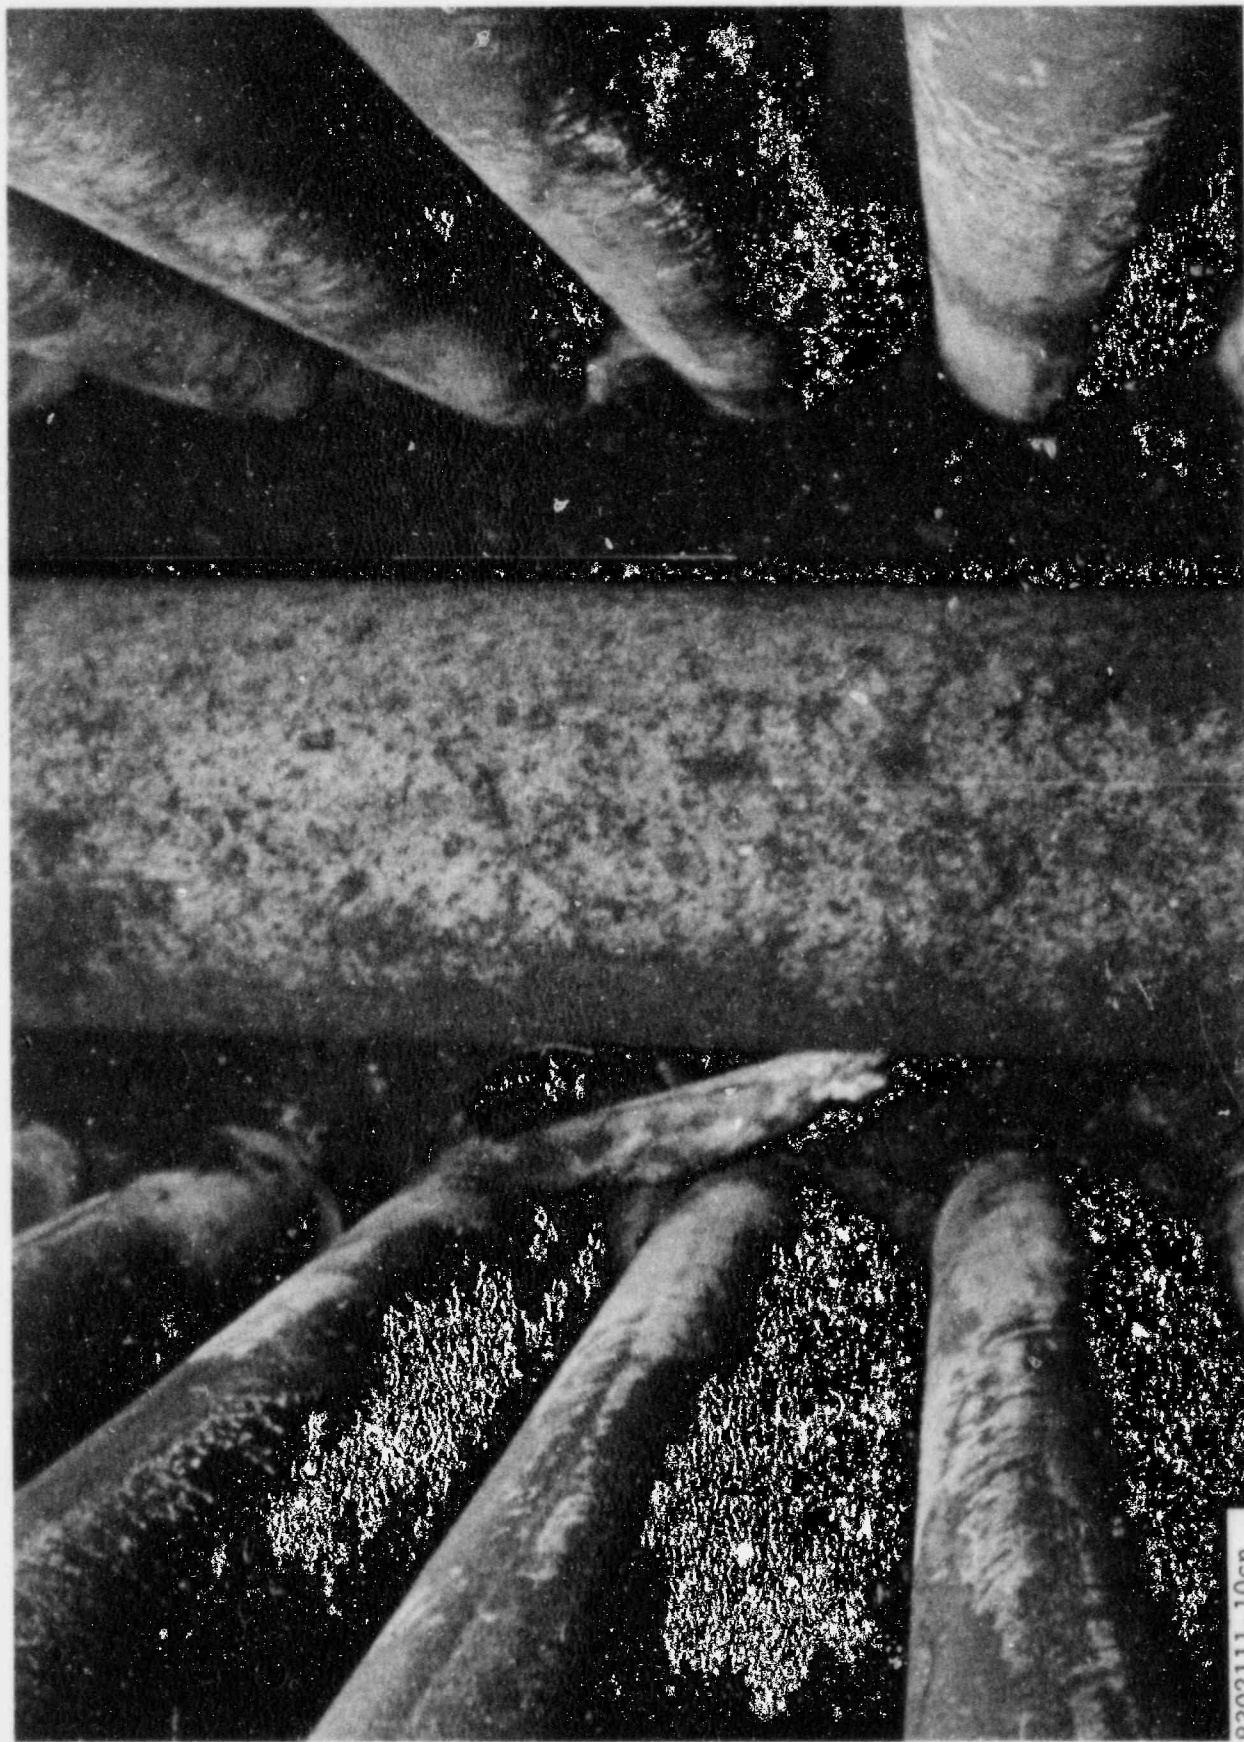
8302111-10cn

FIGURE 10. Close-Up View of Tube Sheet/Blowdown Pipe Region Around Tube Columns 75-80

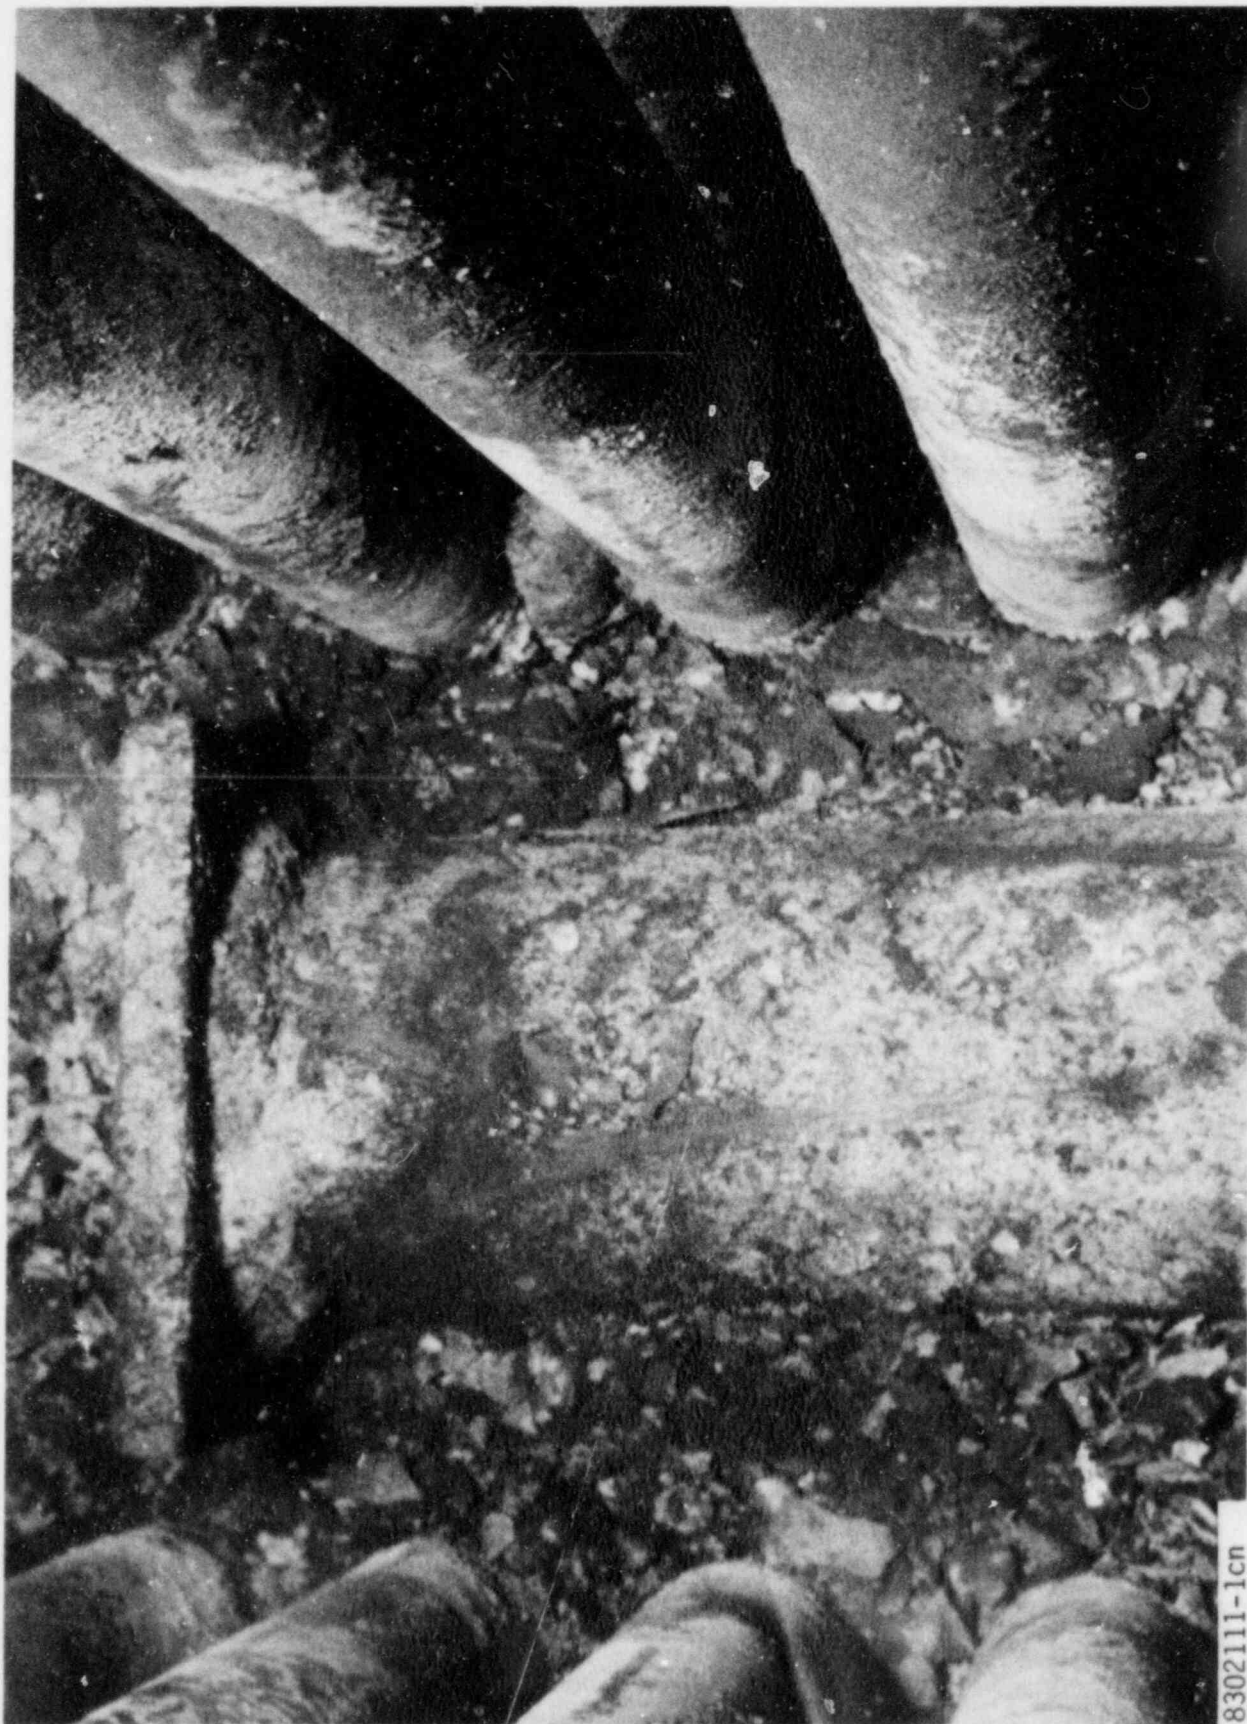
8302111-1cn

FIGURE 11. Close-Up View of Tube Sheet/Blowdown Pipe Region Around Center of Generator

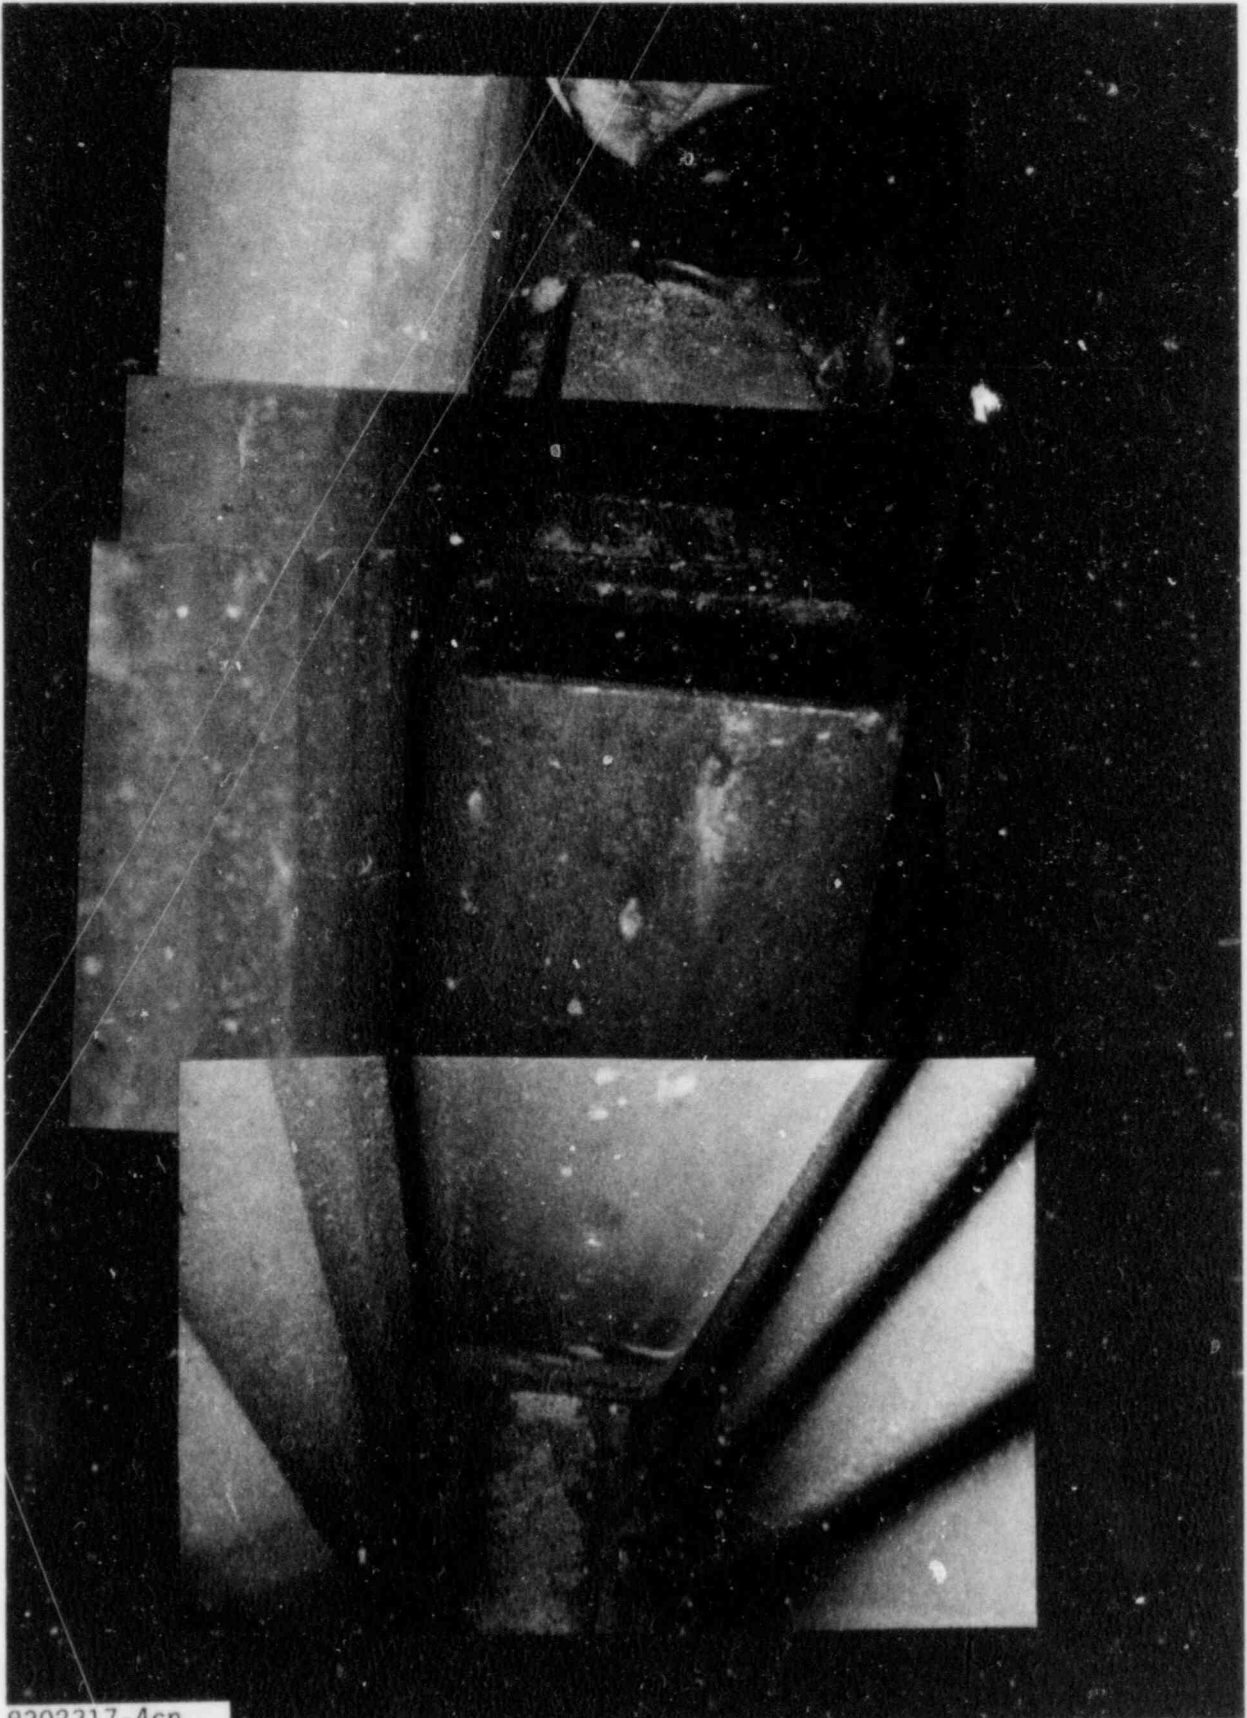
8302317-4cn

FIGURE 12. Vertical View of Appurtenance or Flow Deflector, Looking Toward the 0° Handhole

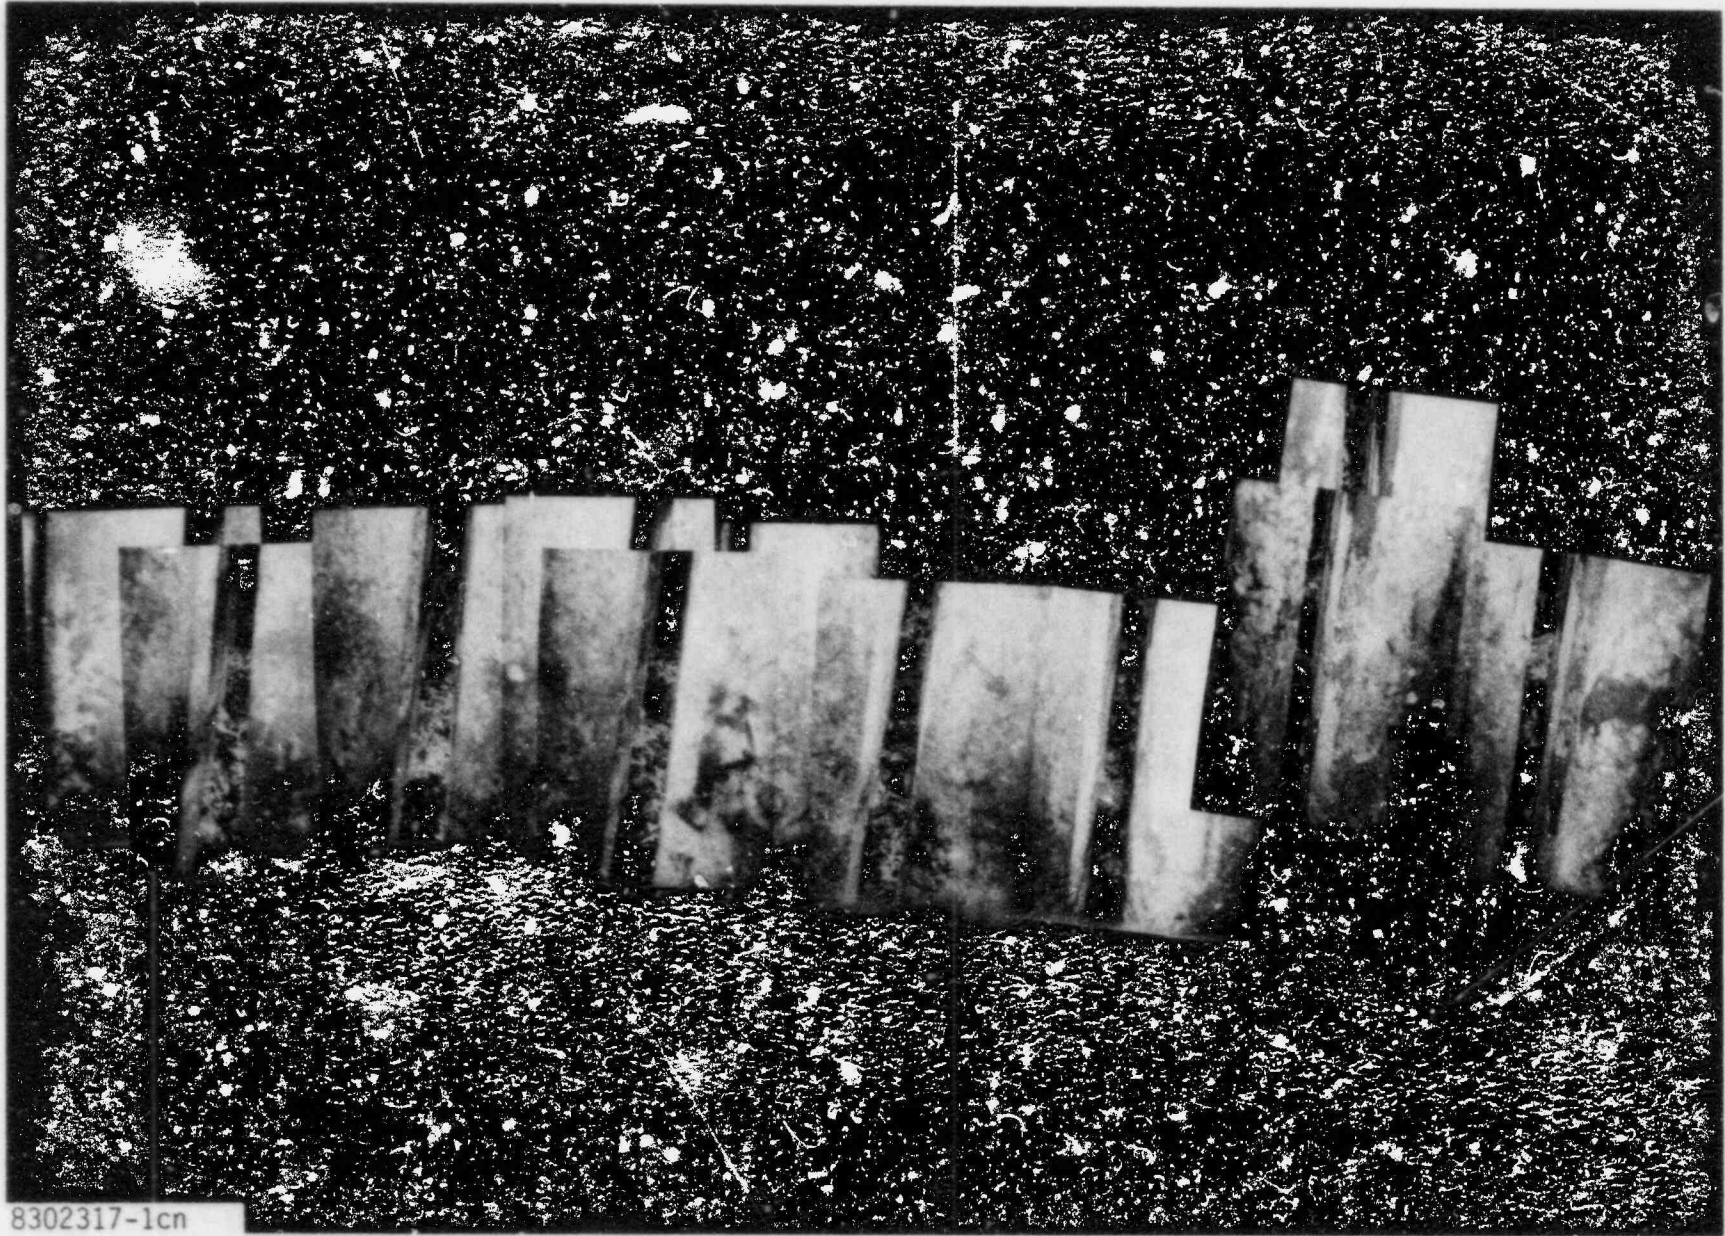
8302317-1cn

FIGURE 13. Side View of Tube Lane Cold Leg Region Between About Columns 46 and 39

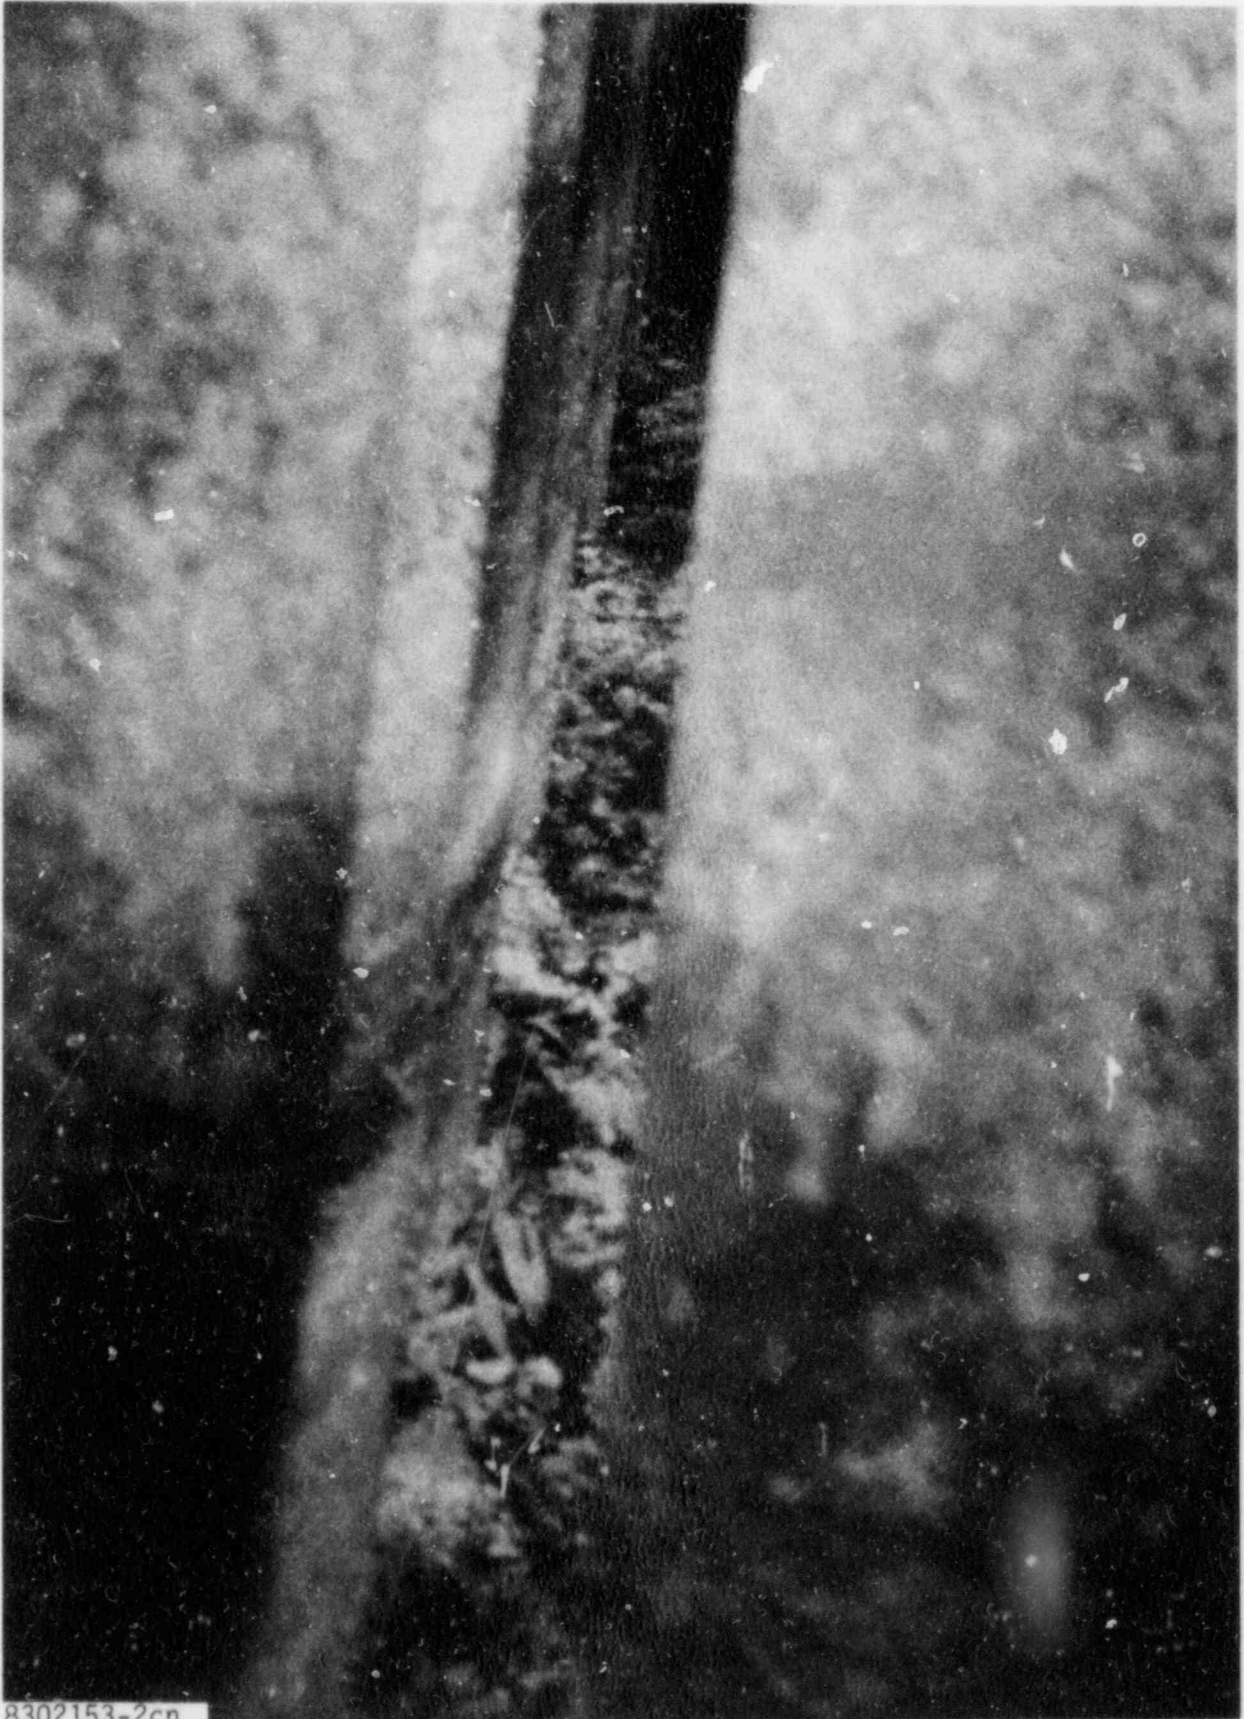
8302153-2cn

FIGURE 14. Higher Magnification View of Gap Between Columns 46 and 45 Cold Leg Side

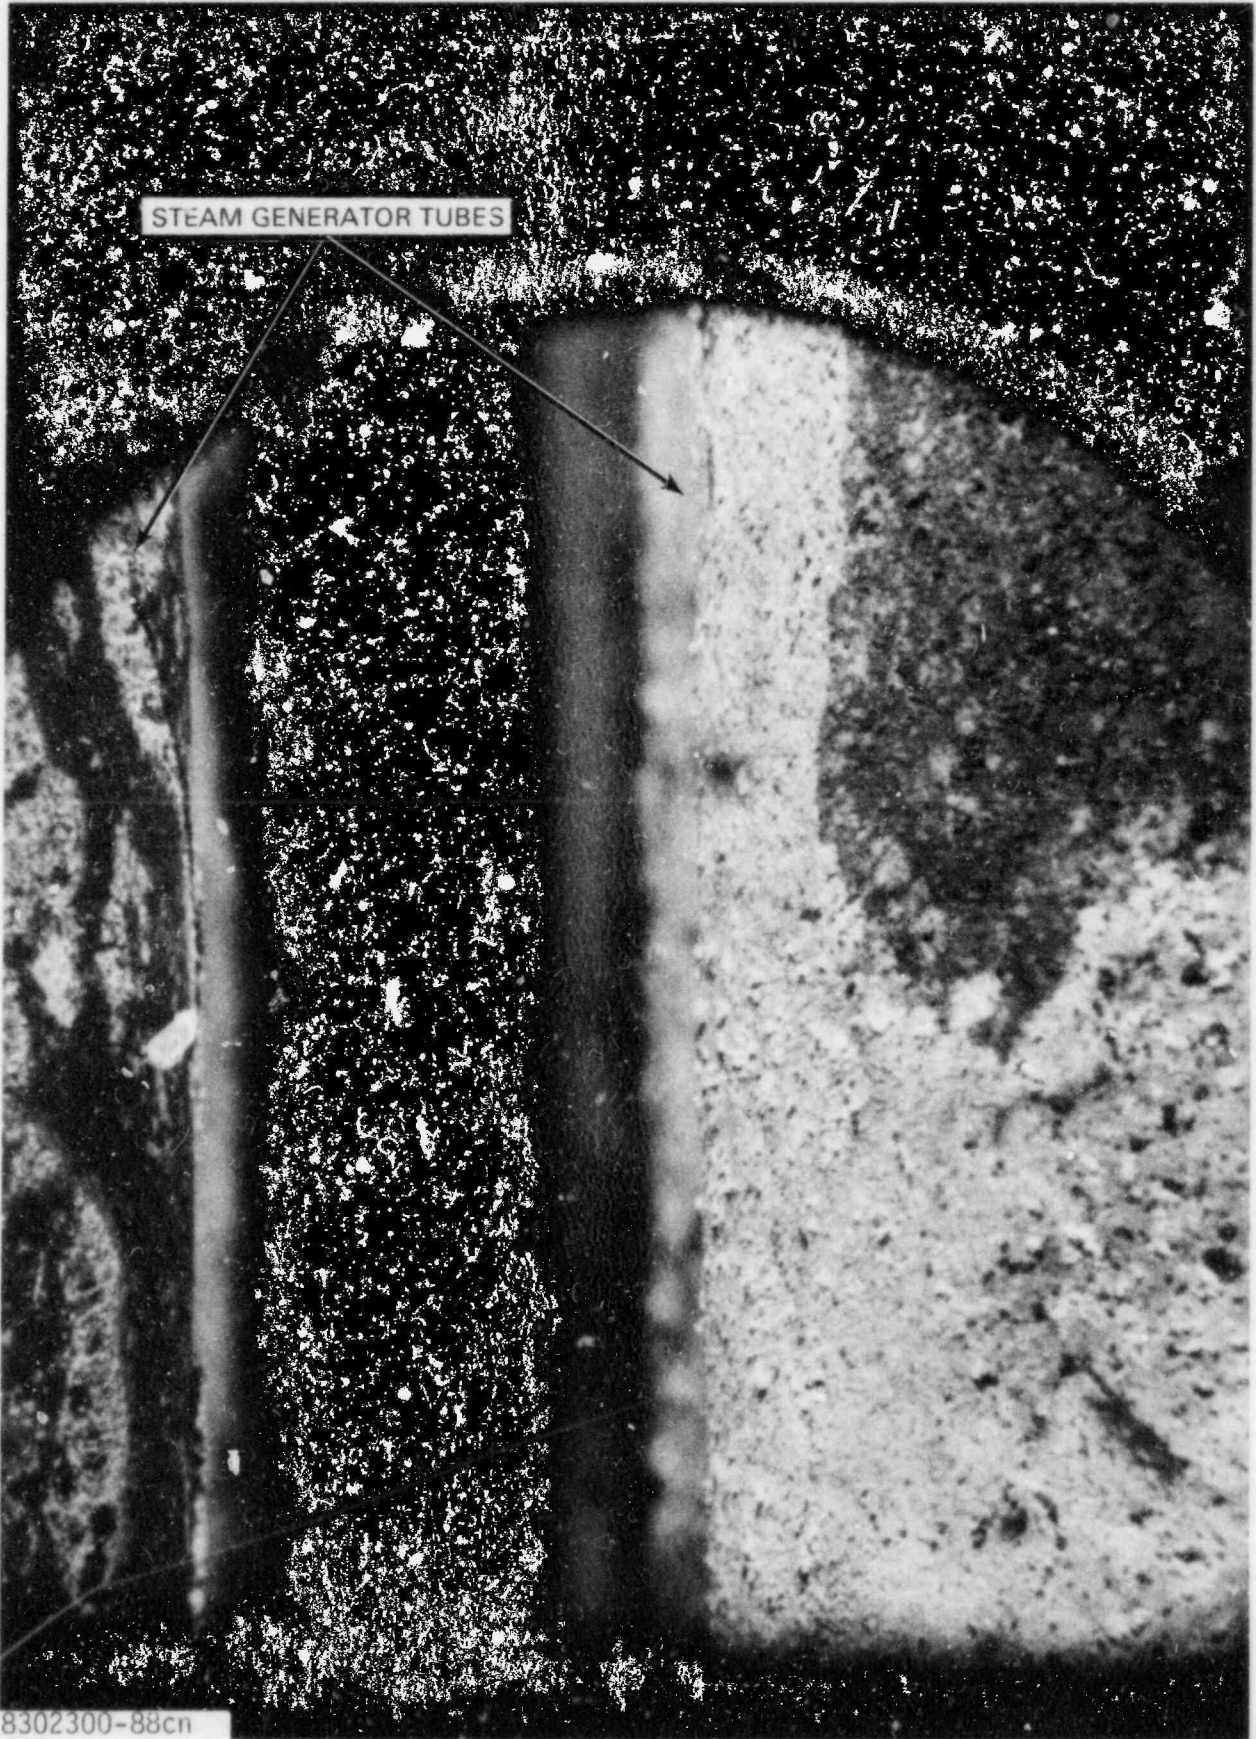
8302300-88cn
FIGURE 15. Tube Closeup Showing Multicolored Deposits on Adjacent Tubes

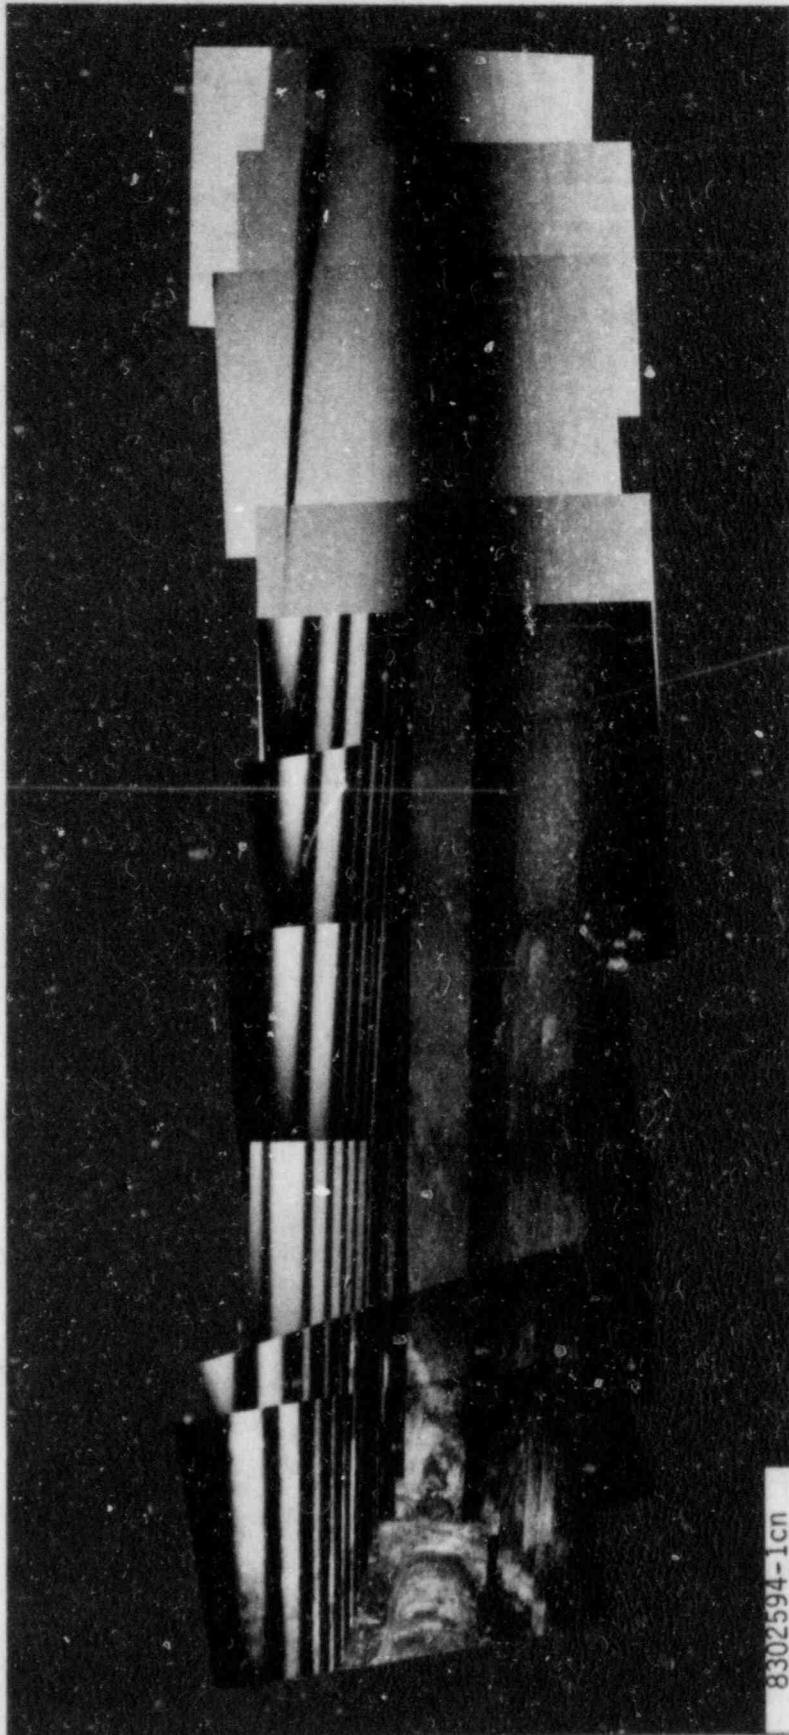
Central Column Region - Photographs were also taken parallel to the blowdown pipe (from the 0° handhole) and upward along the column for the central support plates. Figure 16 shows the support column between the tube sheet and first support plate. Color variations here may reflect the different water treatment conditions used during operation (phosphate and AVT) along with some extrinsic variation caused by some different lighting conditions used during photography. The color variations nearer the bottom of Figure 16 may be "bathtub ring effects"

FIGURE 16. View of Central Column and Adjacent Tubes Between Tube Sheet and the First Support Plate, From 0° Handhole

caused by previous sludge piles or possibly where water draw down occurred and was subsequently allowed to stand for a period of time. The color variations near the bottom are more clearly seen in Figure 17. Note also the slightly higher sludge deposit on the left or hot leg side. Referring back to Figure 16 and progressing upward, the distinct change in tube brightness (at the top) was caused by a change in location of the electronic flash to the face of the aluminum camera box which contains the forward viewing port as shown in Figure 4. Progressing further upward one can see a piece of metal, apparently wedged between the Row 1 tubes on the hot leg side. This piece of metal may have been broken out of the first support plate which is slightly above the top of the photo in Figure 16. The camera could not be moved further up toward the plate due to the narrowing gap caused by movement of the hot leg tubes toward the cold leg side. A closeup view of the metal fragment is shown in Figure 18. The fragment is estimated to be about 1/2 by 7/8 inch (1.3 by 2.2 cm.) in area. Another tube support plate fragment was removed during the post-shipment examination. A third fragment was seen on top of the seventh support plate. More fragments are expected to be found as access to the second through sixth support plates occurs.

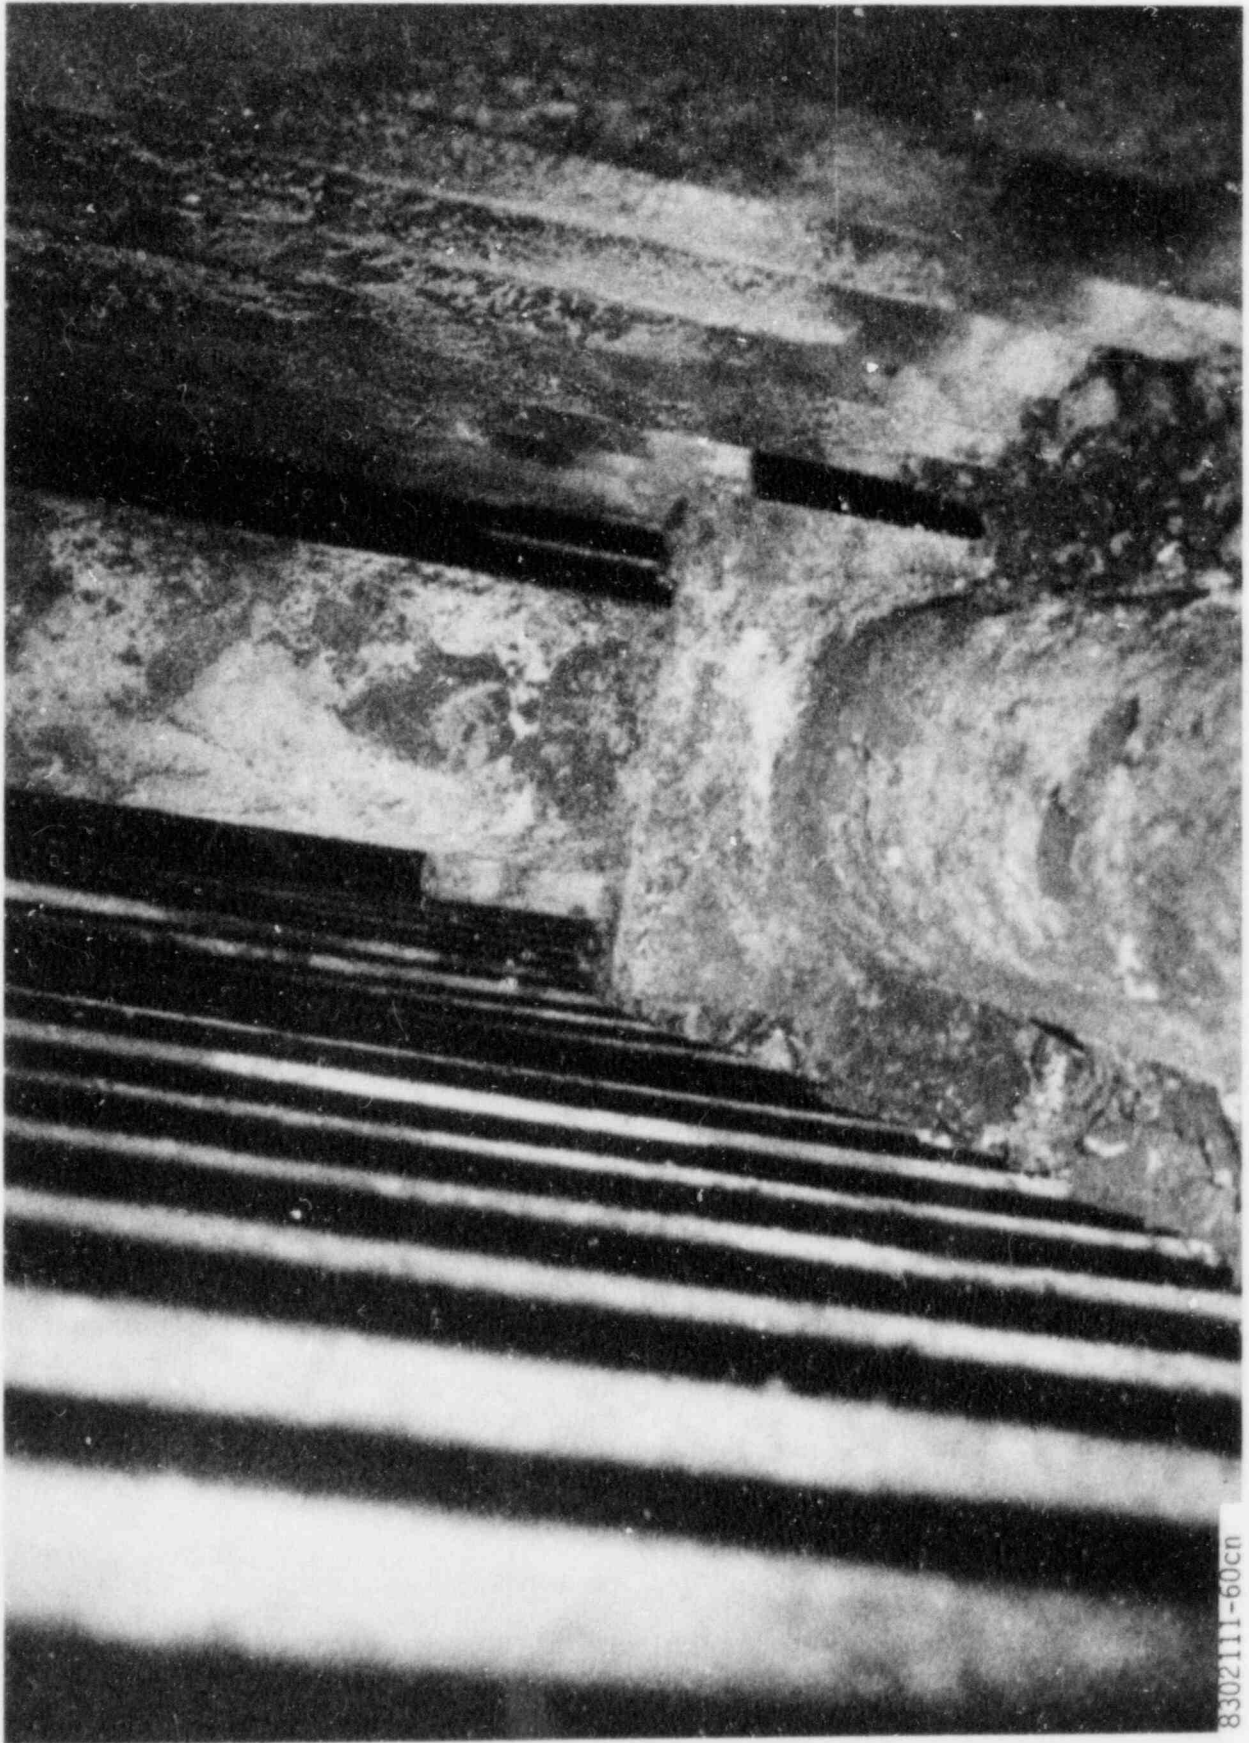
8302111-60cn

FIGURE 17. View of the Bottom of the Central Column and the Blowdown Pipe, From 0° Handhole

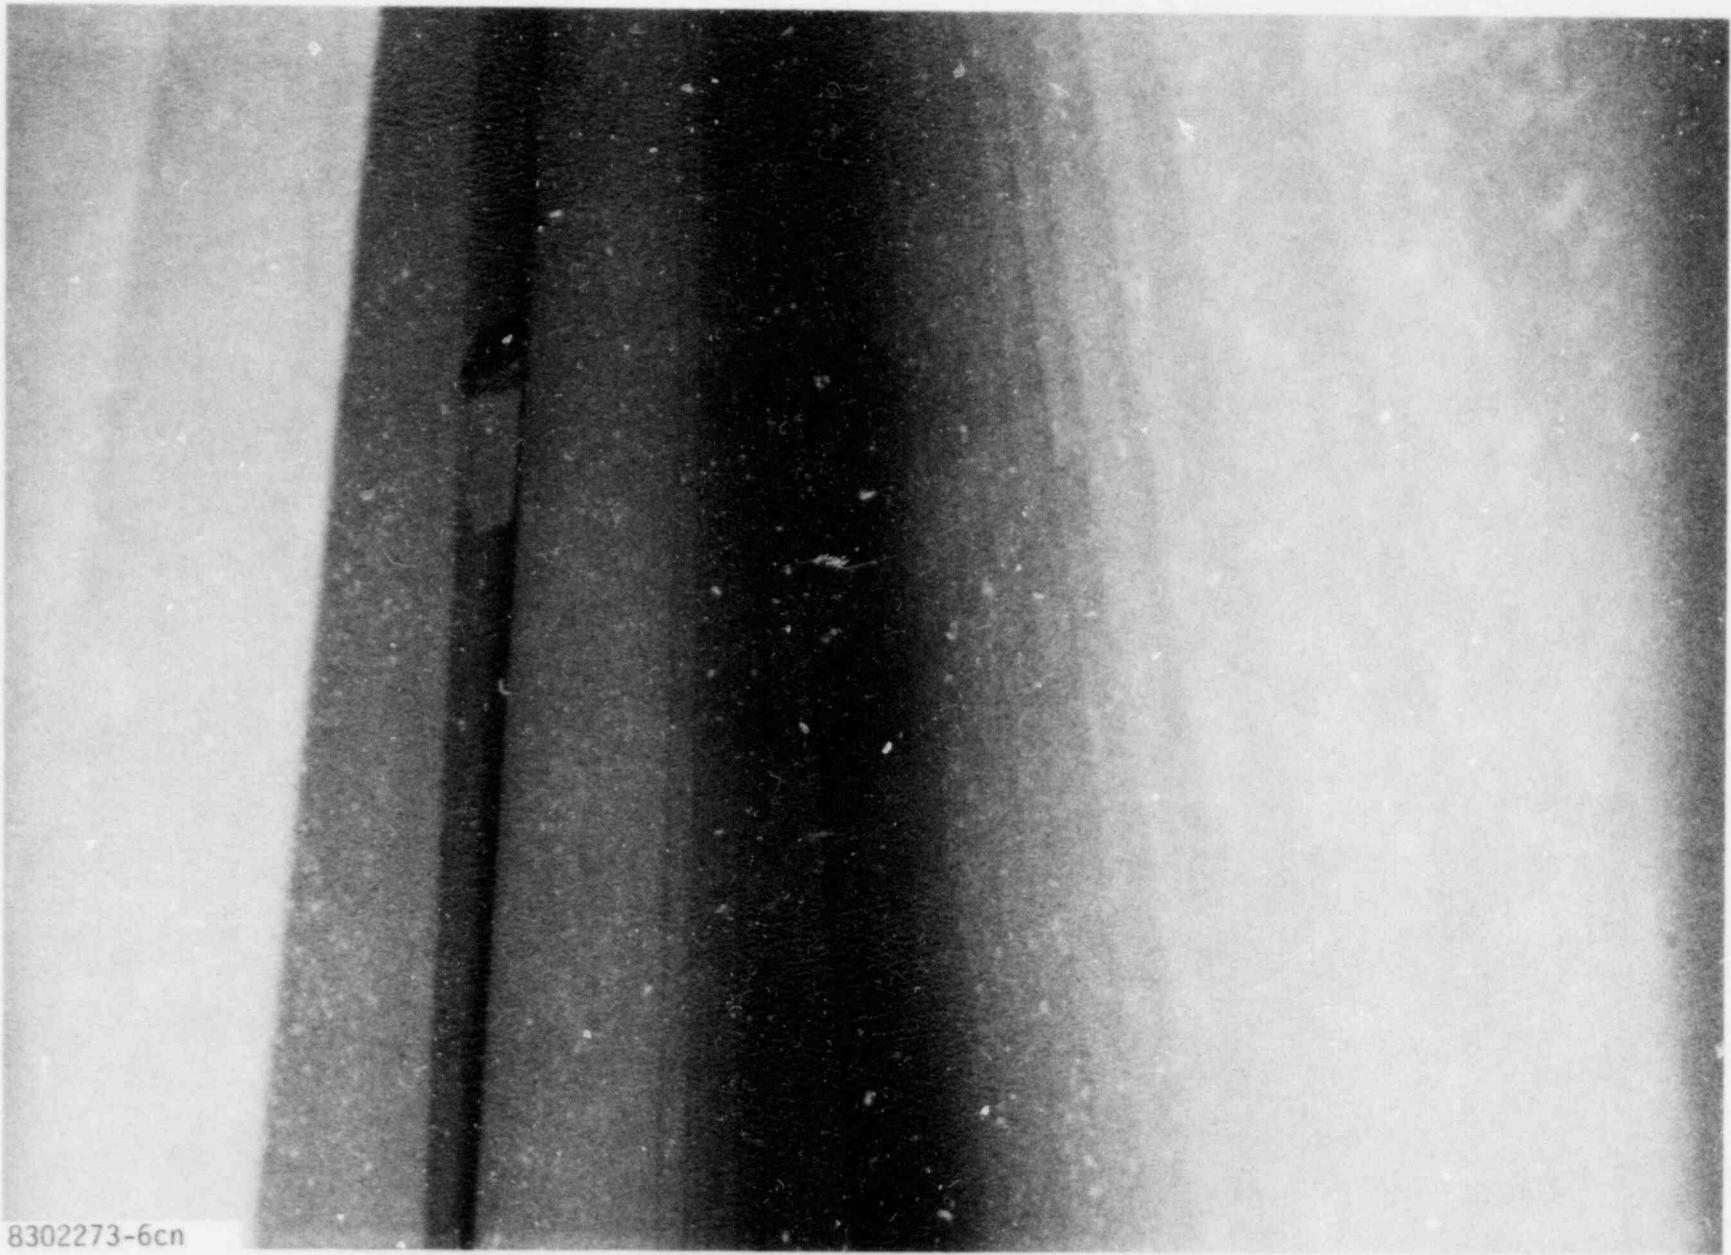
8302273-6cn

FIGURE 18. Possible Tube Sheet Fragment Wedged Between Tubes,
Hot Leg Side, Slightly Under First Support Plate

between Rows 1 and 2 hot leg tubes near the generator center. The fragment appeared to be crawling downward with a resultant wedging of the Row 1 tube toward the tube lane. Flow slot closures also produced severe creasing and crushing of adjacent tubes, and in some cases may have resulted in tube wall penetration. Because of the extreme closure and hence fracture of the flow slot corners, it is believed that many other fragments of support plate will be found.
