Steam Generator Group Project

Task 10 - Secondary Side Examination

Prepared by E. B. Schwenk, K. R. Wheeler

Pacific Northwest Laboratory
Operated by
Battelle Memorial Institute

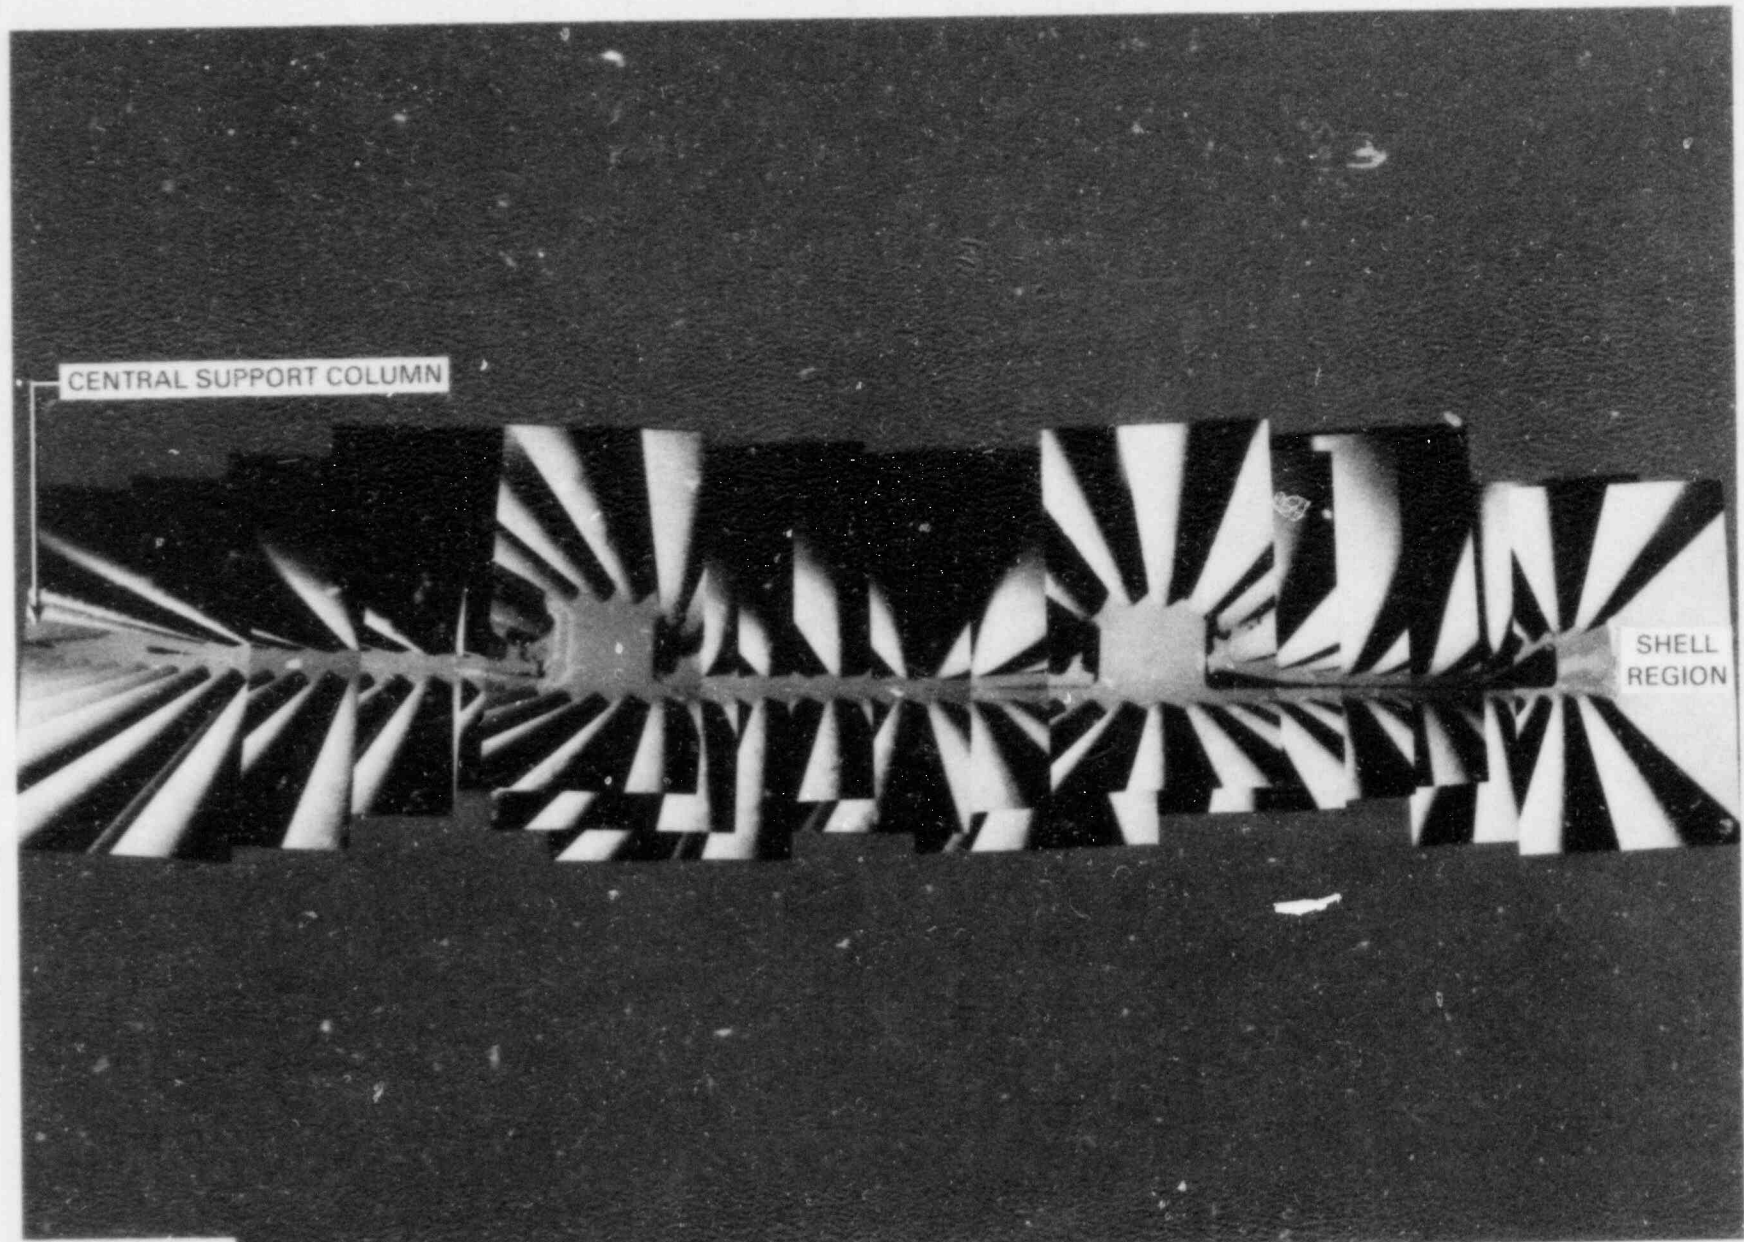
8302317-2cn

First Support Plate - Photographs of the bottom side of the first support plate were taken from both 0° and 180° handholes. The camera had to be kept several feet below the plate due to closure of the tube lane as noted previously. The montage photos taken through the 0° handhole are presented in Figure 19. The first flow slot, next to the 0° handhole, is almost closed while the second and third are entirely closed. In all three flow slots the movement is essentially all from the hot leg side. Photos taken from the 180° handhole (not shown) reveal the same behavior in the second and third slots with some slight variation in the first slot (adjacent to the 180° handhole). In the latter, the first slot appears to display about 80% of its closure from the hot leg side with the remaining 20% from the cold leg side.

FIGURE 19. Bottom Side of First Support Plate, From 0° Handhole

Deformation damage in the first support plate from the ubiquitous tube denting process resulted in essentially complete closure of the flow slots. Further, the closure occurred dominantly from the hot leg side. In addition, an apparent piece of broken support plate was seen wedged

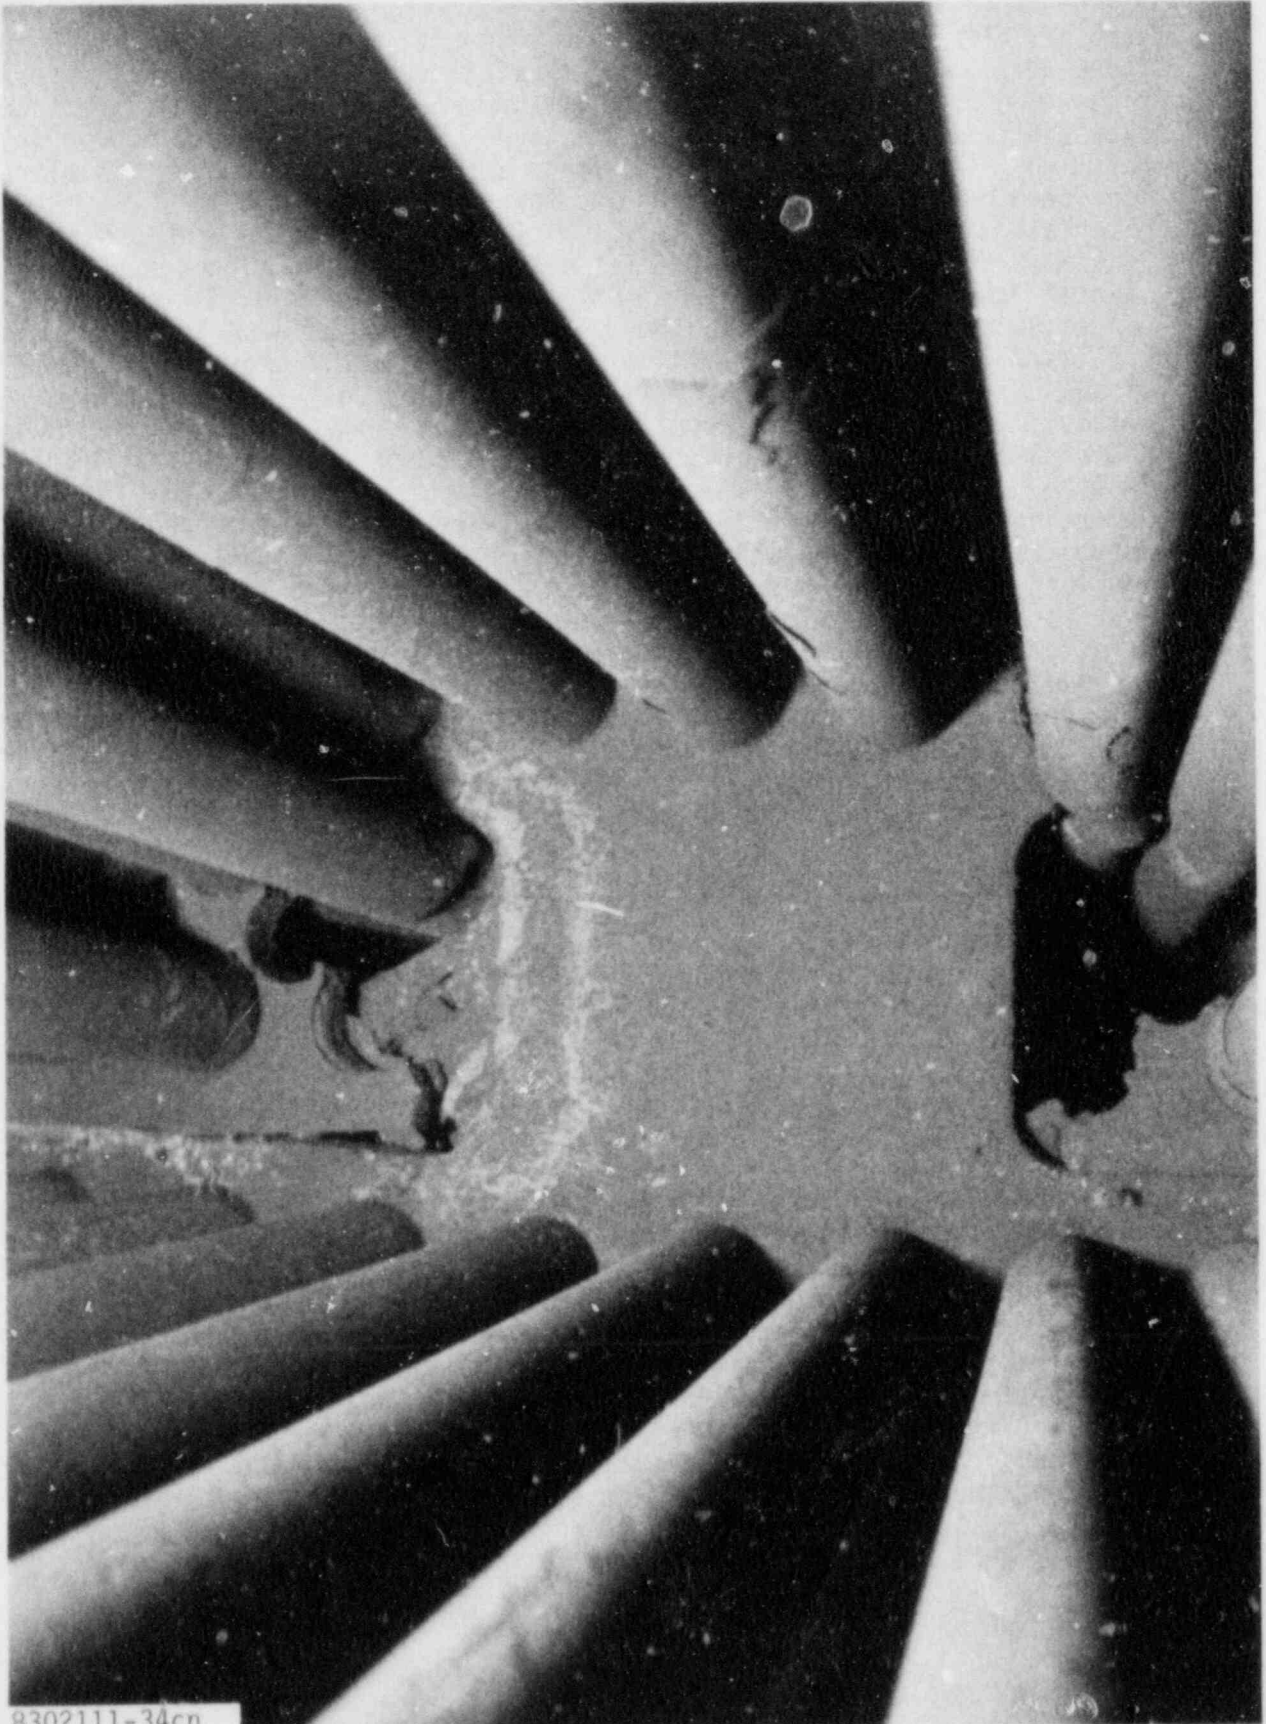
8302111-34cn

Referring back to Figure 19, a close-up view of the 'hard spot' region between the second and third flow slots is shown in Figure 20. Besides complete closure of each adjacent flow slot, extreme creases in tubes near each flow slot corner can be seen. Some of these creased tubes may have cracked throughwall. Furthermore, debris can be seen adjacent to the hard spot (Figure 20). Recall that this photo was taken looking upward at the first support plate, thus the debris might have come from flow slot breakage in the adjacent or second support plate, or are possibly spalled tube deposits. Broken support plate sections have been found in several locations in the generator.

FIGURE 20. Hard Spot Between Fractured Second and Third Flow Slot in First Support Plate (Looking Up)

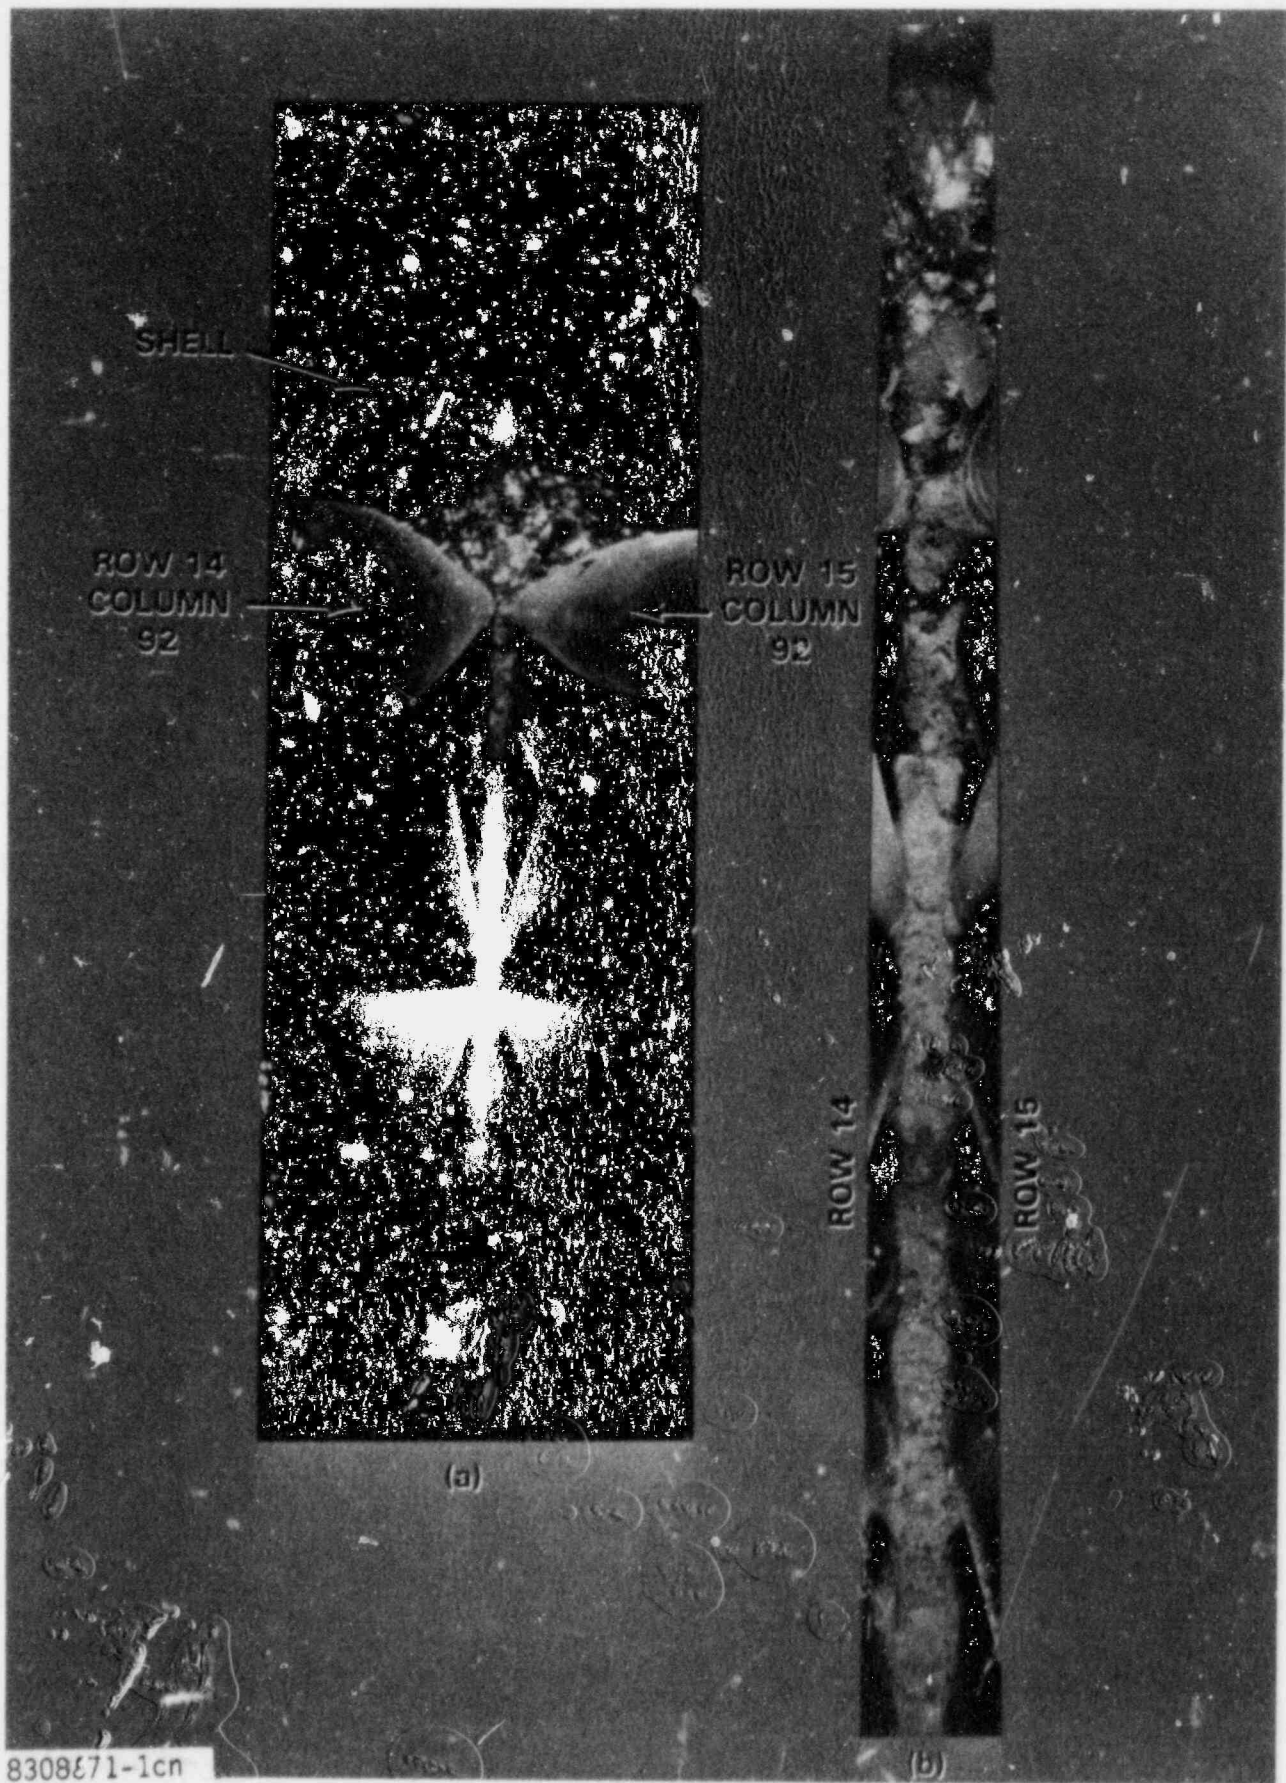
Typical examples of the versatility of the Battelle-developed subsize cameras to provide photographs in confined spaces are seen in Figures 21 and 22. The photographs in Figure 21 were taken by inserting the camera through the top 2 inch (5.1 cm.) diameter hole (cold leg side) seen schematically in Figure 1. The "a" view taken with a pinhole camera shows the lower 2 inch (5.1 cm.) diameter drilled hole through the shell, tube Rows 14 and 15 at Column 92, and the top of the tube sheet between the rows. The shiny debris is metal chips from the shell wall drilling. View "b" taken with a fixed focus camera is a closeup of the tube sheet showing the sludge pile on the surface along with a few fragments of tube scale spalled off from above. Figure 22 is similar except that the pinhole camera photograph (top) is joined with a series of fixed focus camera photos (bottom). In addition, a photograph was taken looking up at the bottom of the first support plate. Both support plate photos are the same. One emphasizes the adjacent tubes while the other emphasizes the support plate. An expanded view of Figure 22b is presented in Figure 23. Here spalling tube deposits and the bottom of the first support plate can be seen in greater detail.

FIGURE 21. View of Shell and Tube Sheet at Rows 14 and 15, Cold Leg Side

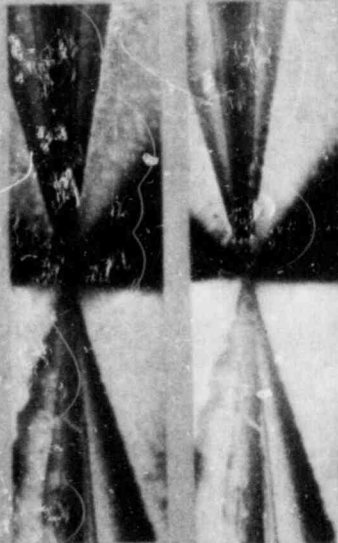
FIGURE 22. View of the Shell and Tube Sheet (a) and Looking Up Toward First Support Plate (b) at Rows 14 and 15, Hot Leg Side

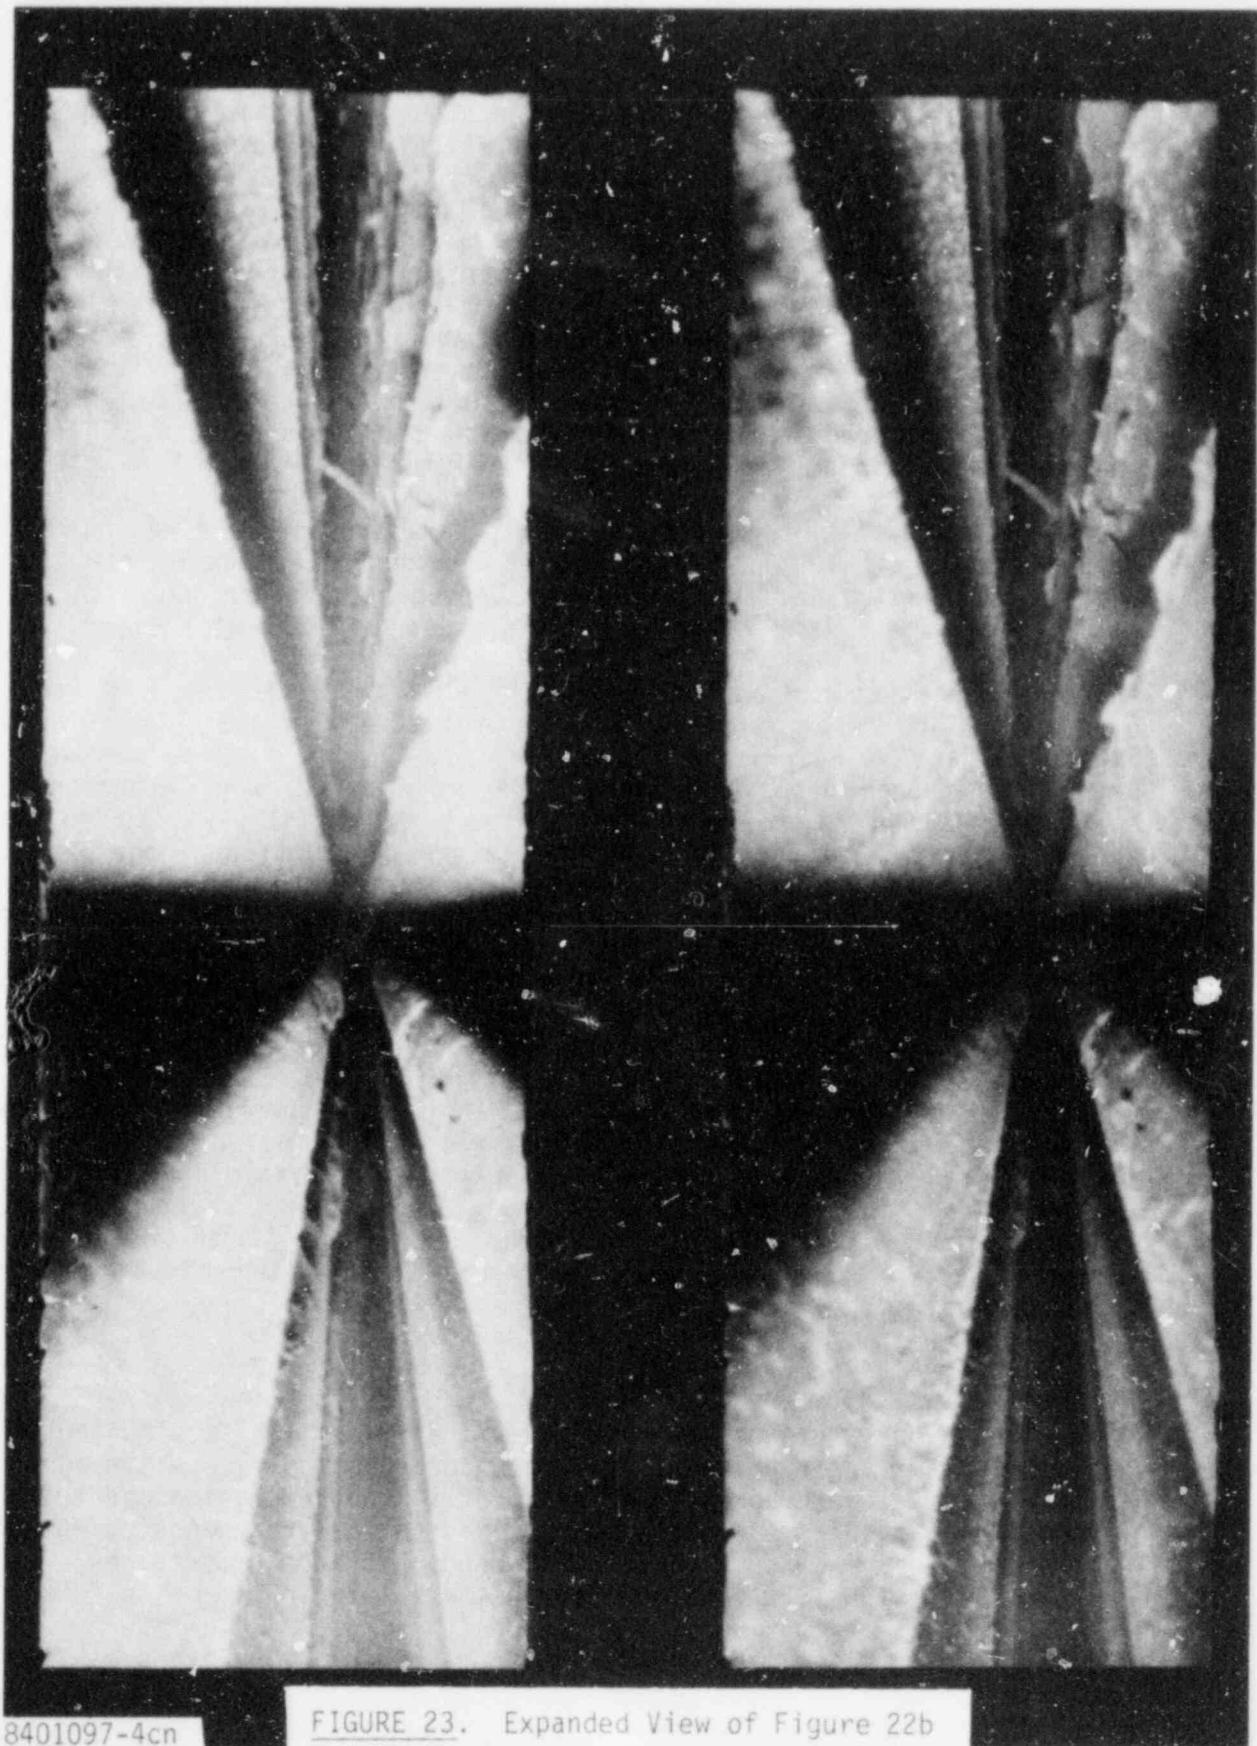
8401097-4cn

FIGURE 23. Expanded View of Figure 22b

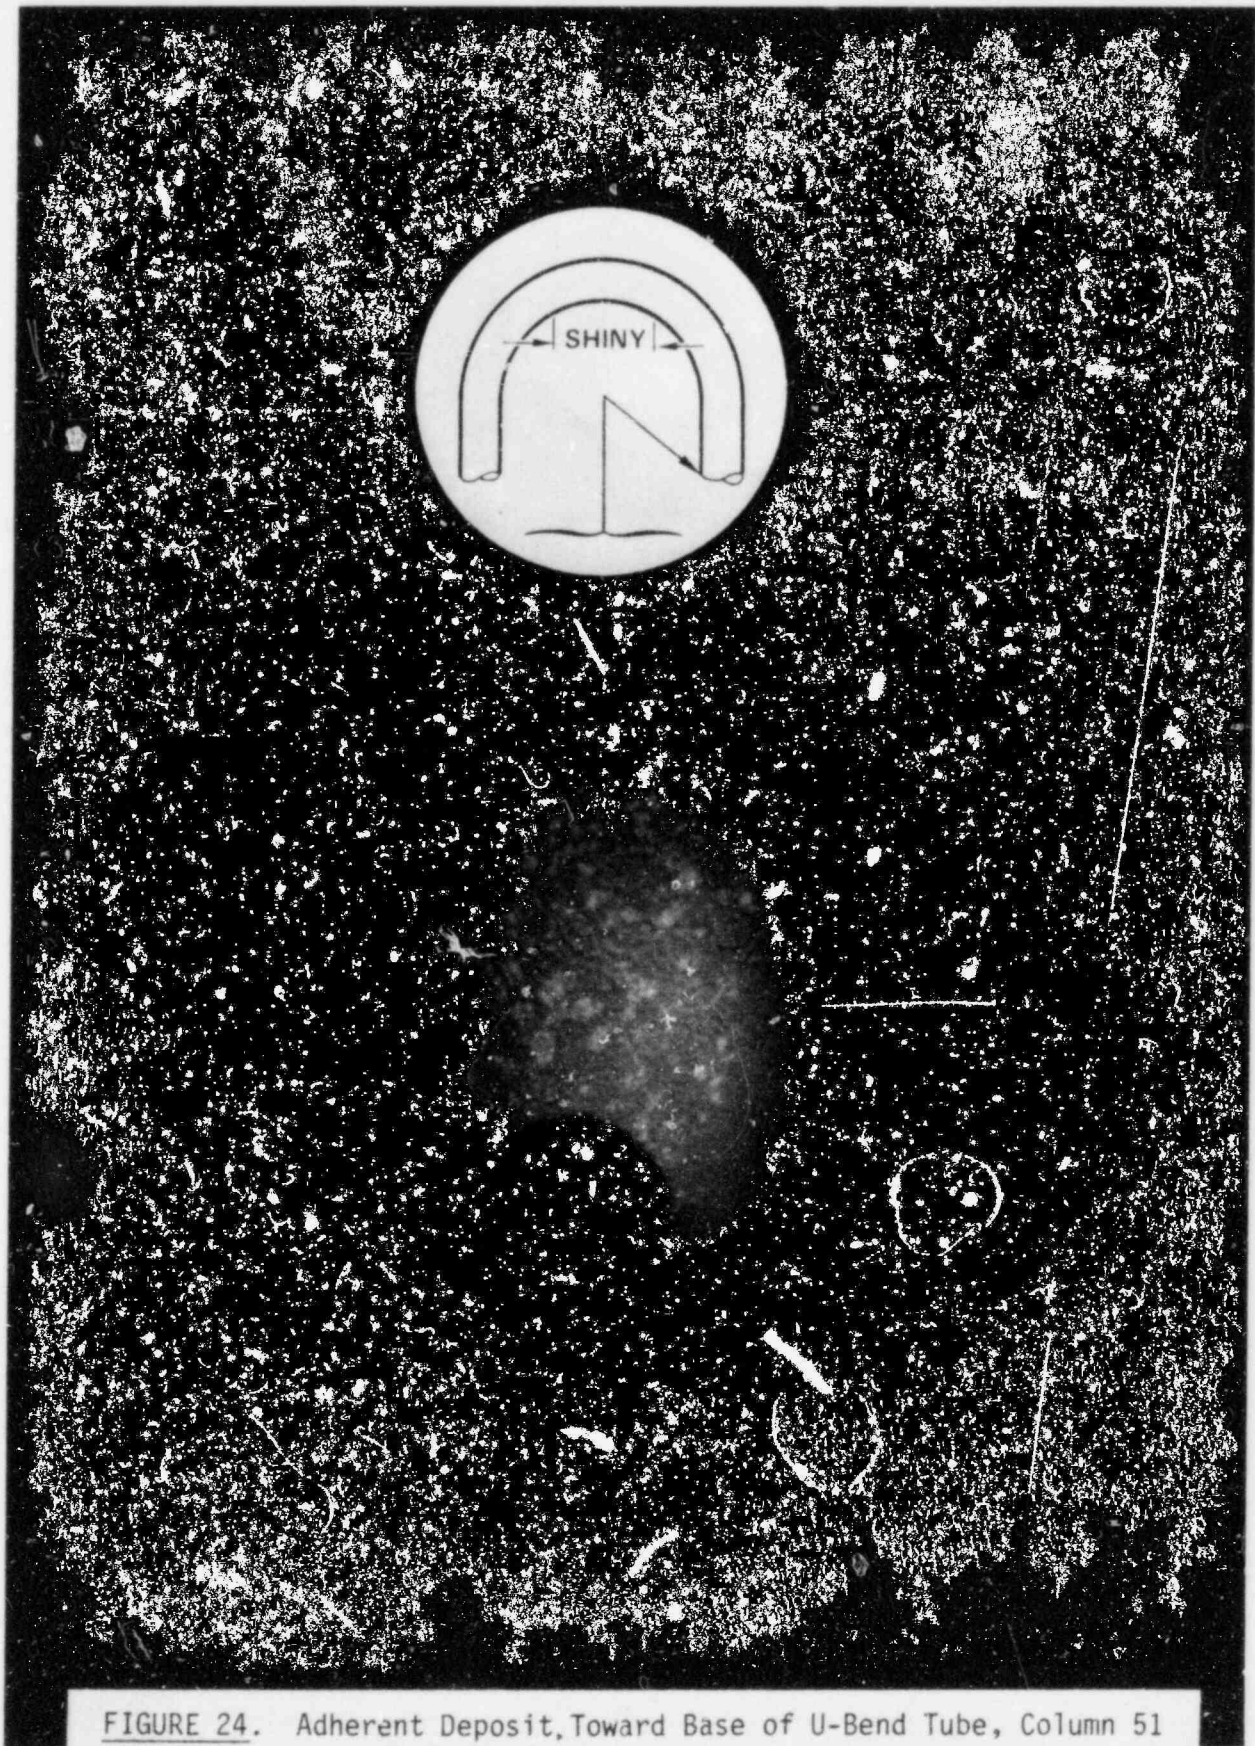
8401097-5cn

FIGURE 24. Adherent Deposit, Toward Base of U-Bend Tube, Column 51

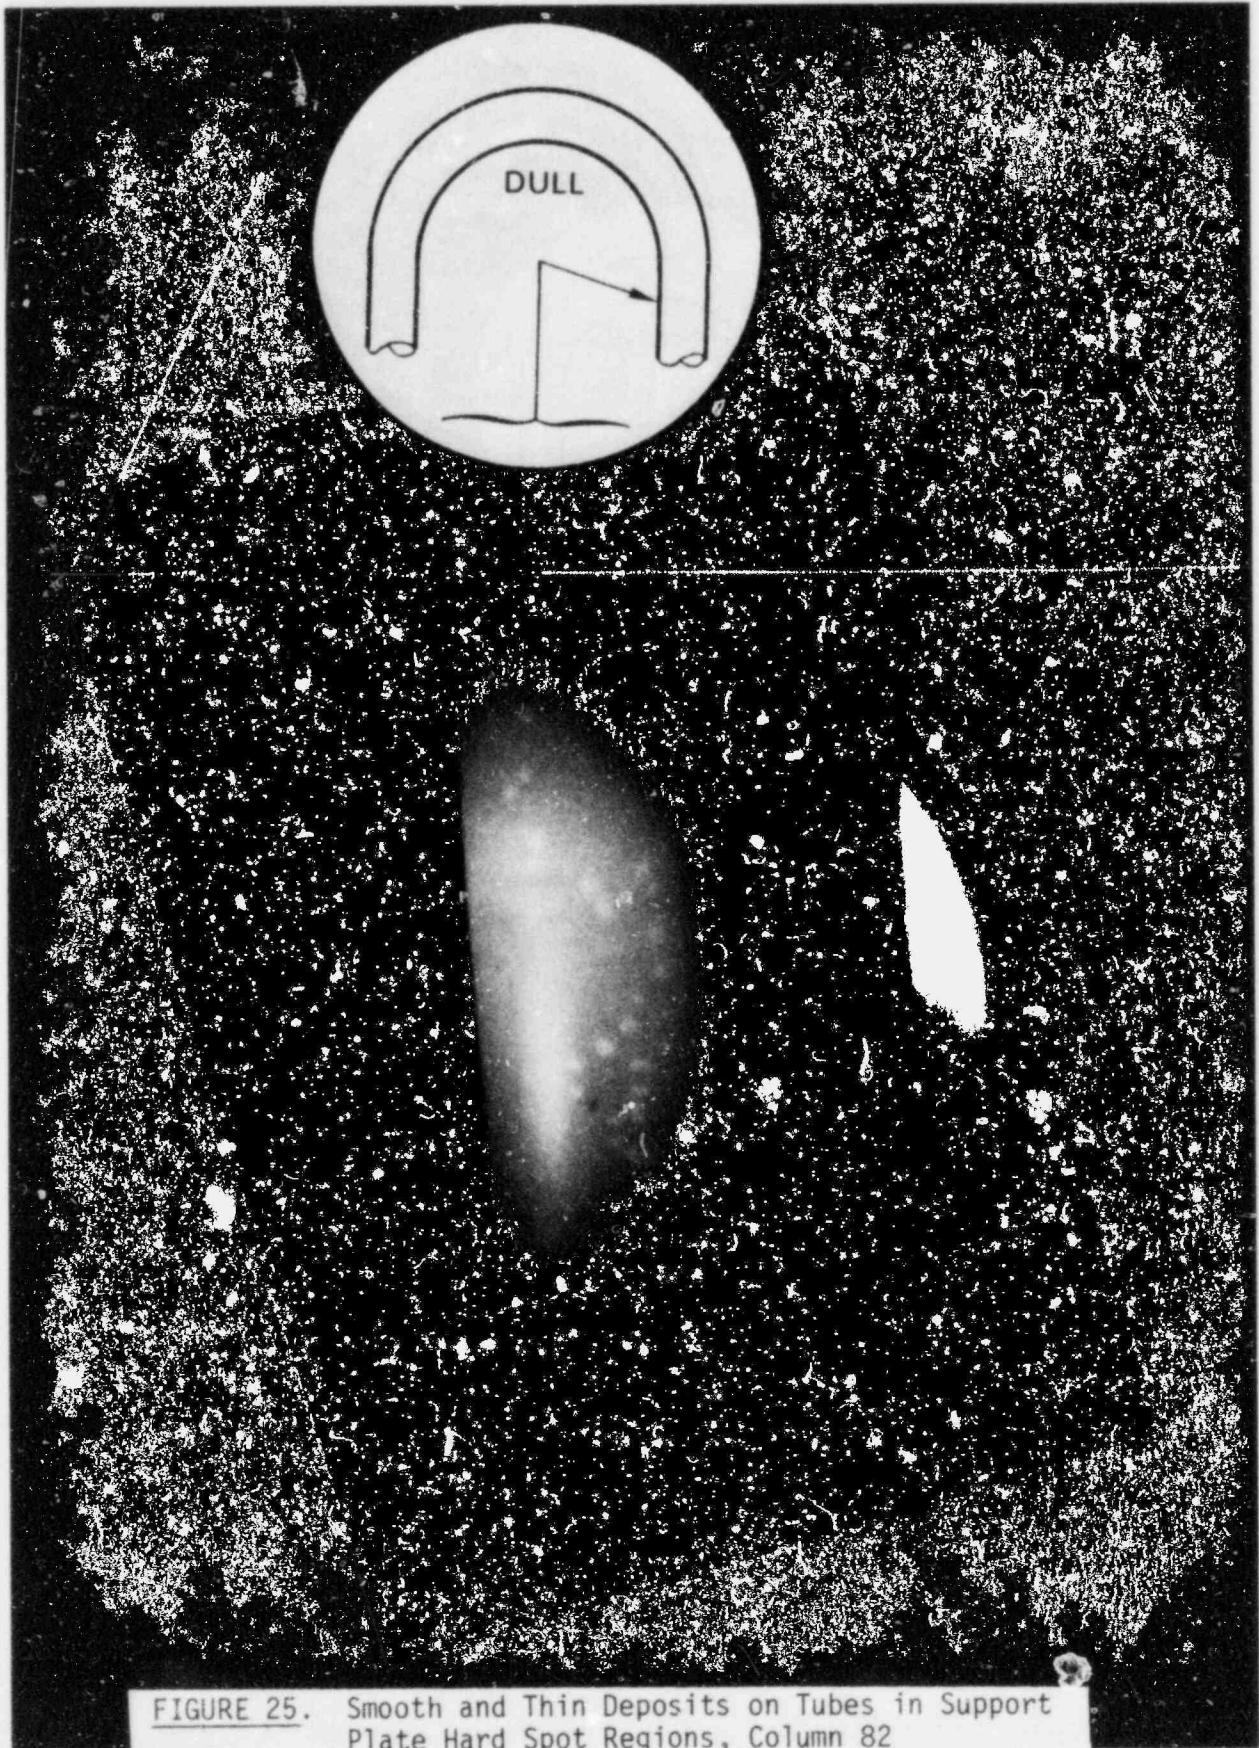
8401097-6cn

FIGURE 25. Smooth and Thin Deposits on Tubes in Support Plate Hard Spot Regions, Column 82

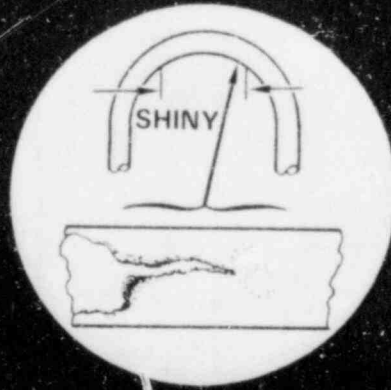
8401097-7cn

FIGURE 26. Removed Tube Deposit (Left) and Possible Flow Abrasion in U-Bend Region, Column 59

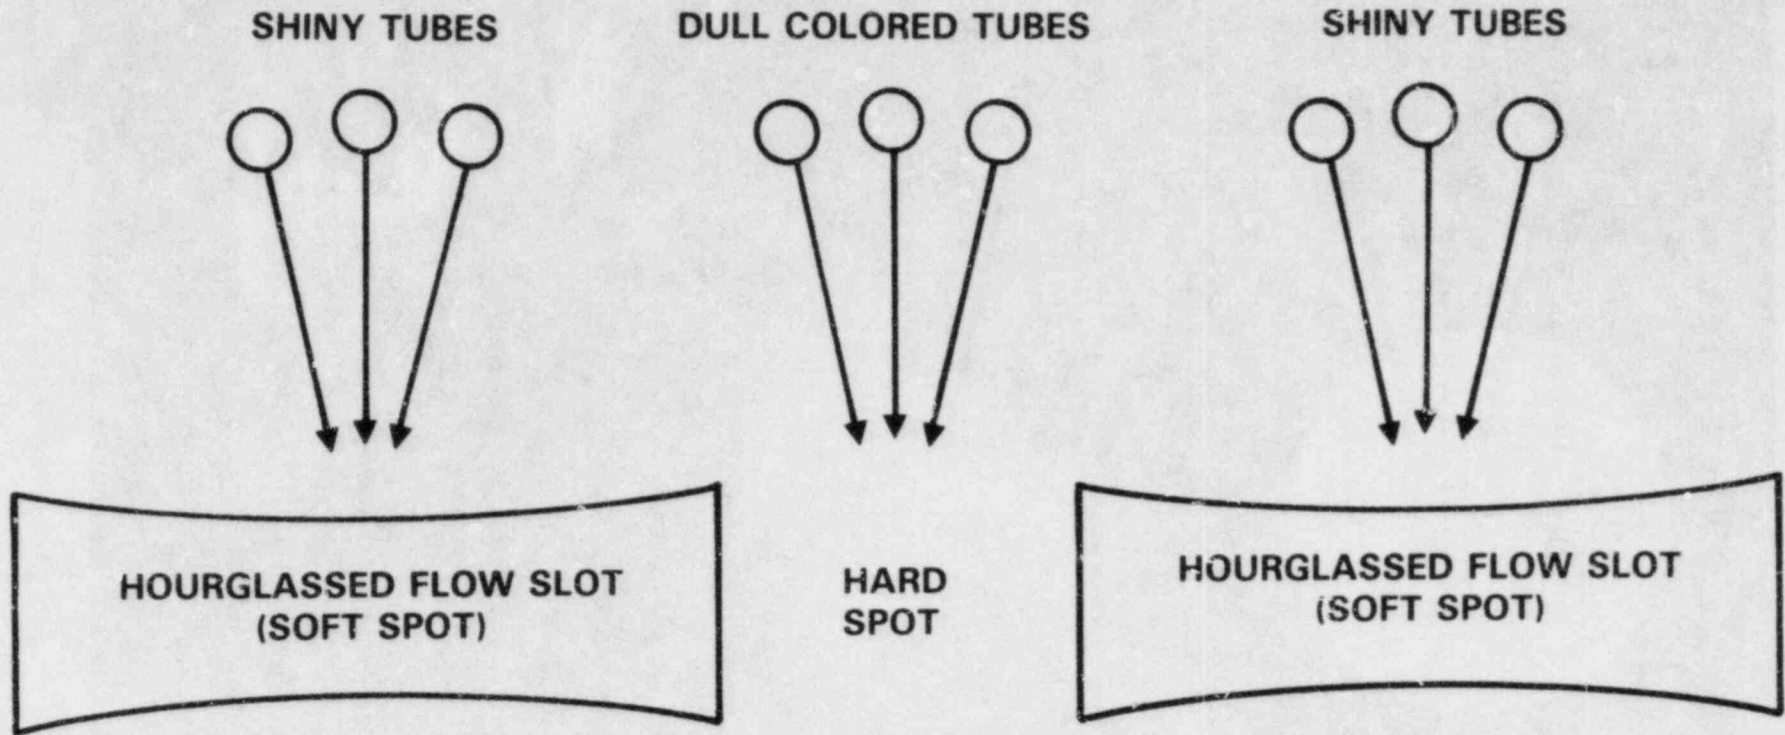
8308533-1

FIGURE 27. Typical Location of Dull and Shiny Intrados U-Bend Surfaces Relative to Flow Slot Position in the Seventh Support Plate

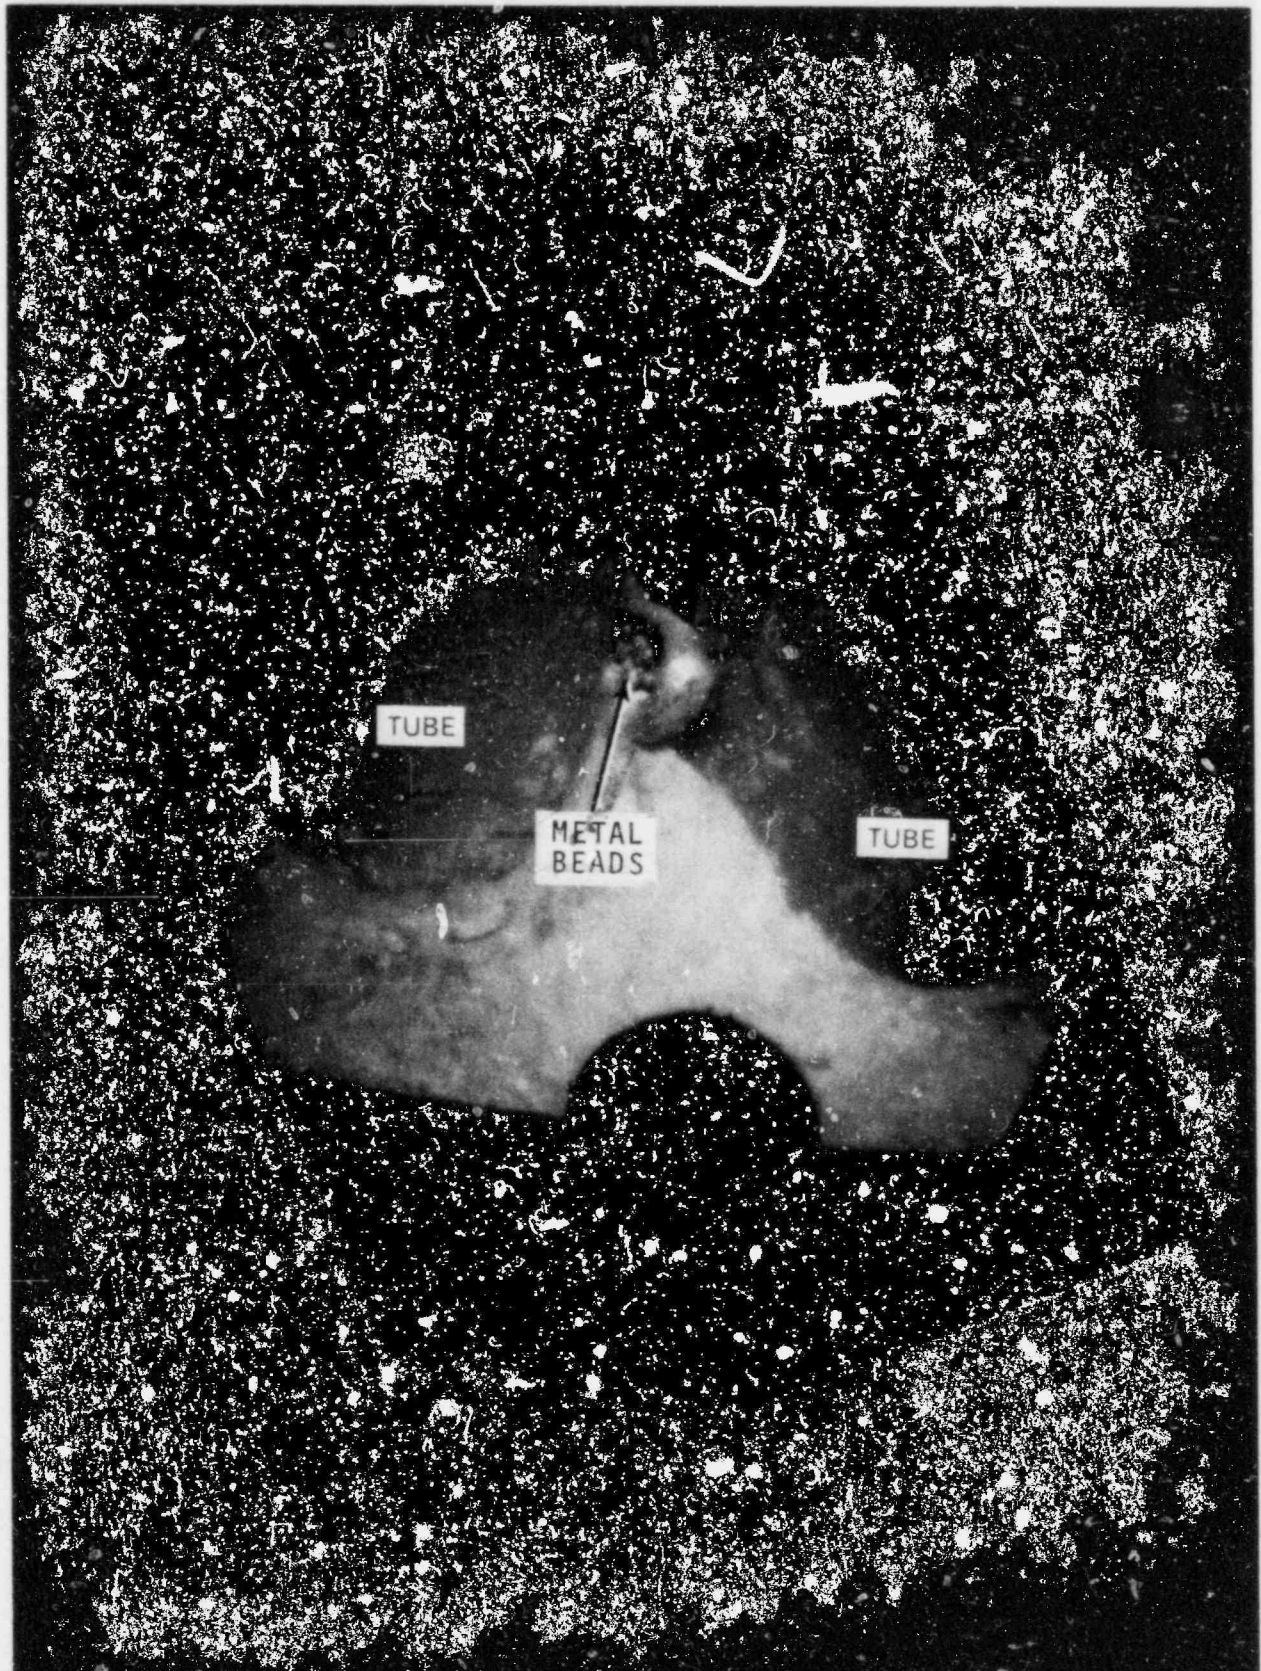
8401097-8cn

FIGURE 28. Trapped Metal Beads and Alien Material at the Intersection of Tube Columns 40 and 41 in the Seventh Support Plate

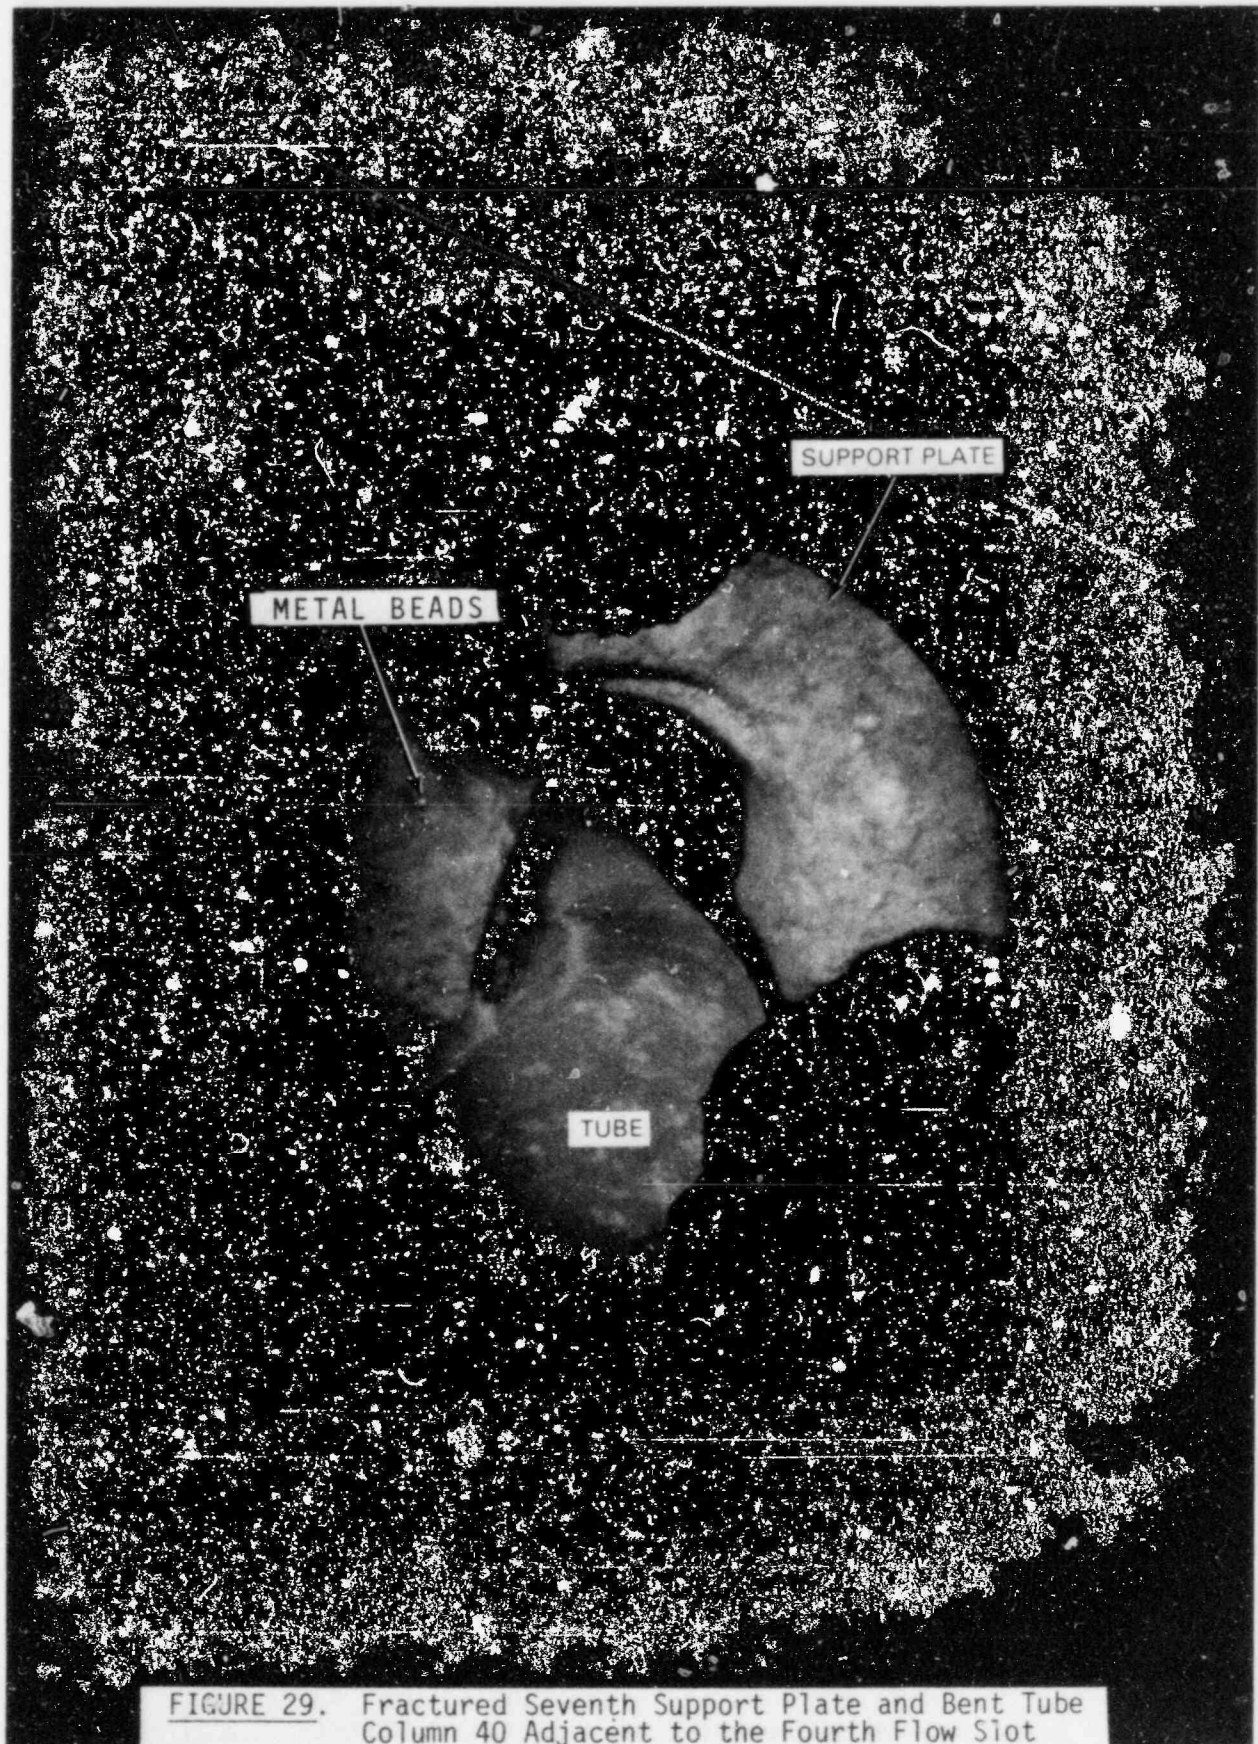
8401097-9cn

FIGURE 29. Fractured Seventh Support Plate and Bent Tube Column 40 Adjacent to the Fourth Flow Slot

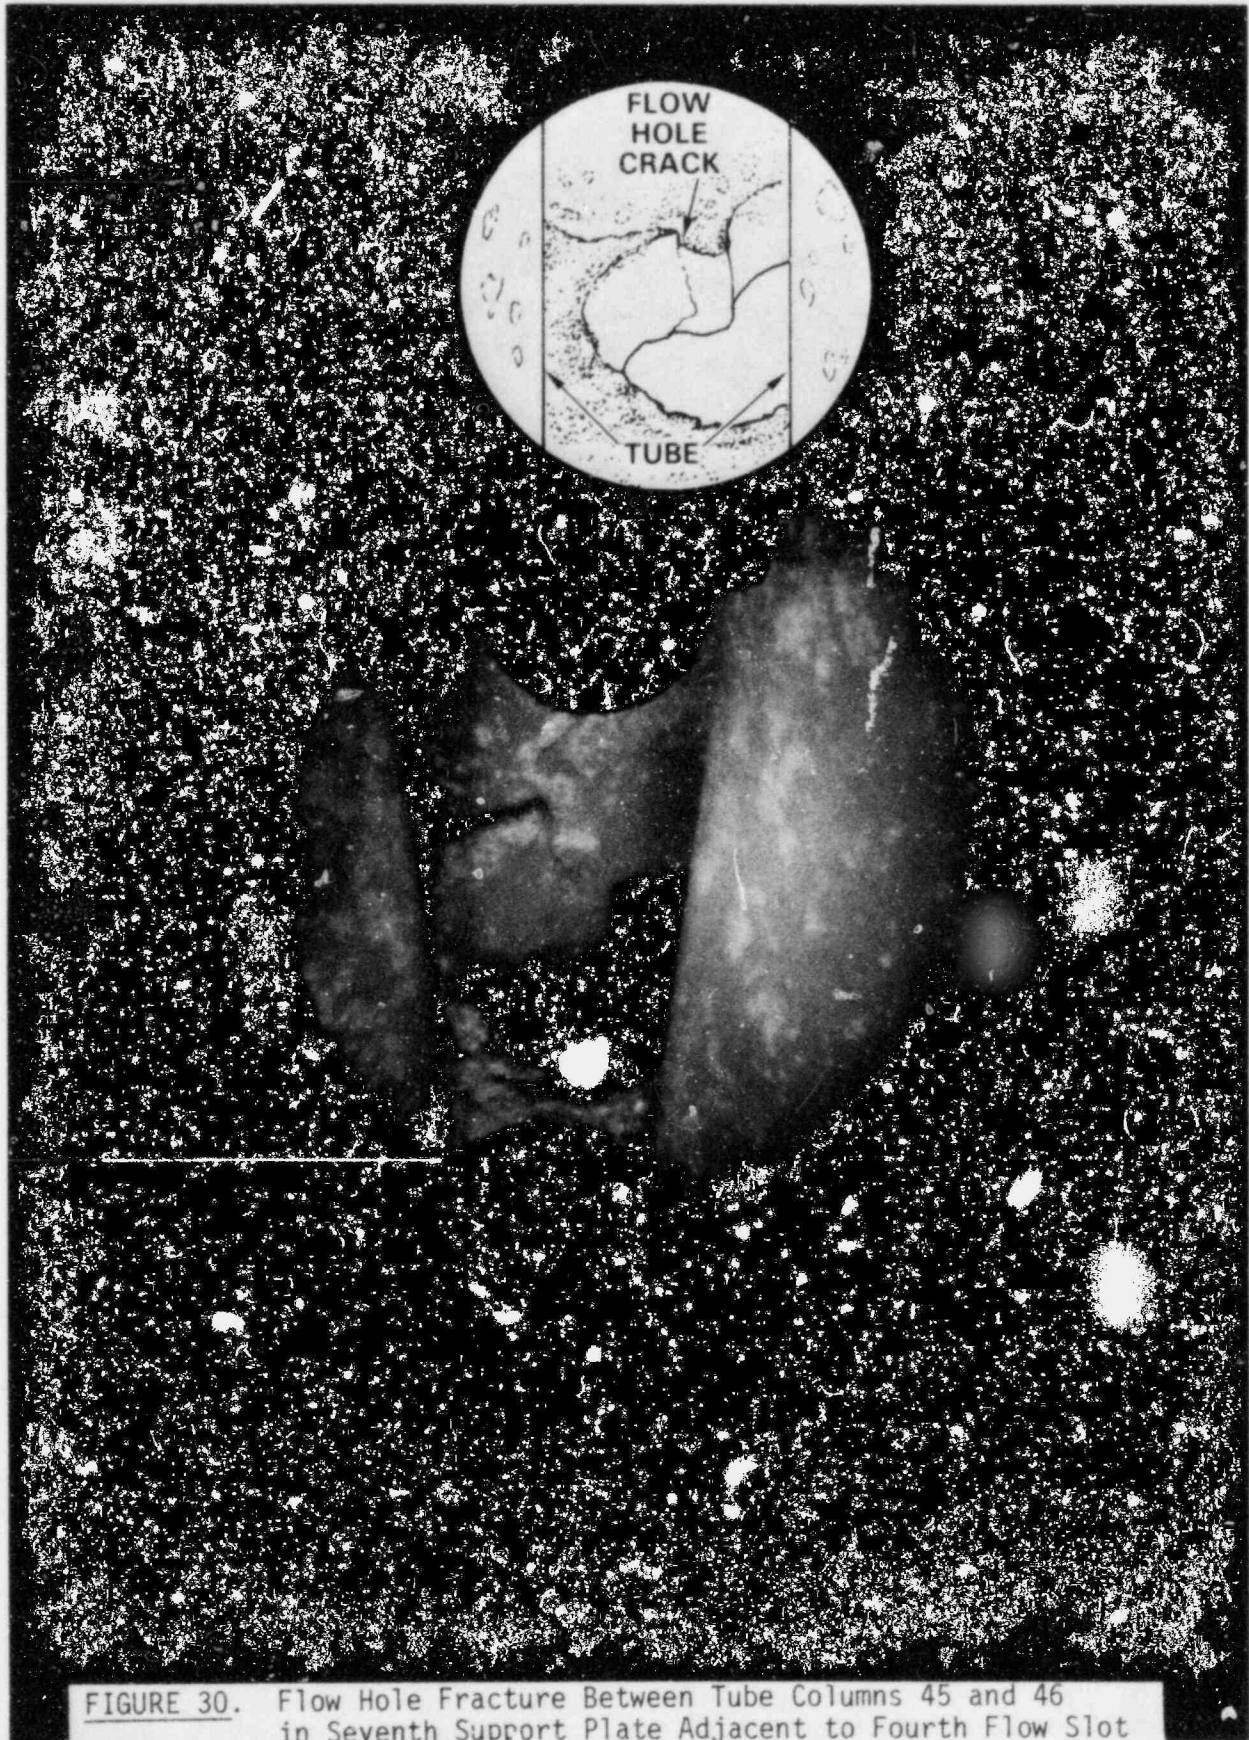
FIGURE 30. Flow Hole Fracture Between Tube Columns 45 and 46 in Seventh Support Plate Adjacent to Fourth Flow Slot
