Steam Generator Group Project

Task 10 - Secondary Side Examination

Prepared by E. B. Schwenk, K. R. Wheeler

Pacific Northwest Laboratory
Operated by
Battelle Memorial Institute

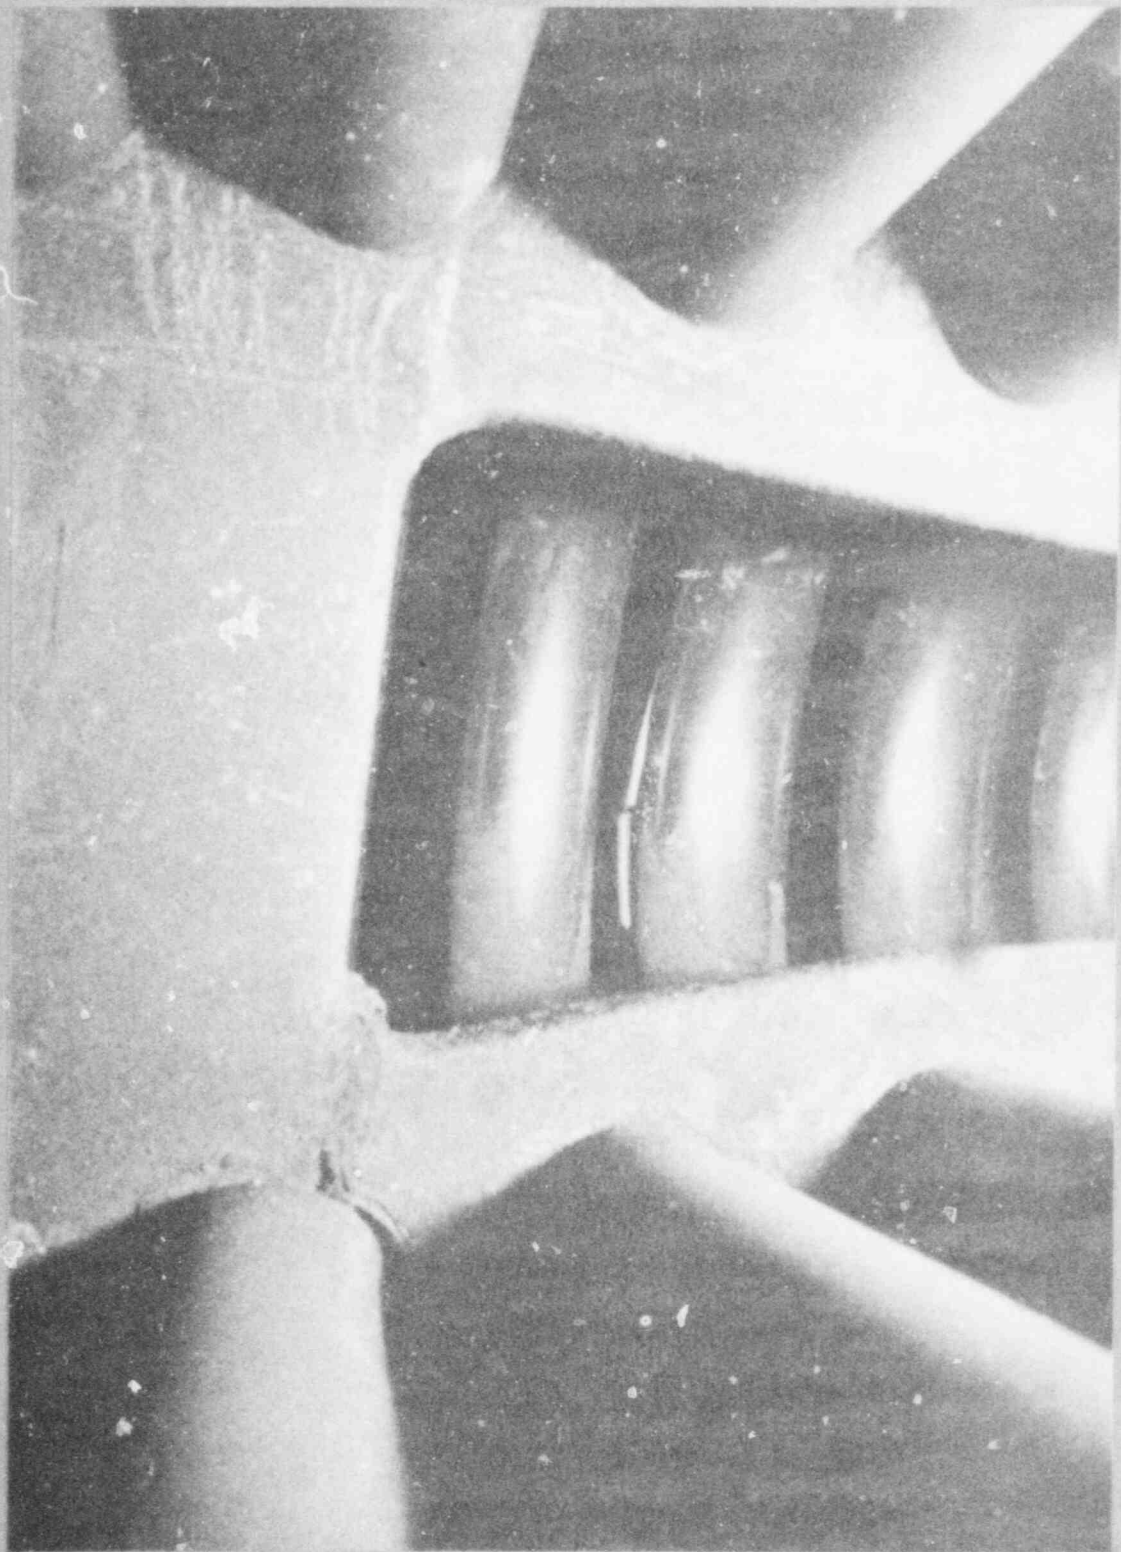
8308705-1cn

The axial flap-type crack seen in Figure 31 (tube Column 91) also occurred in several other locations. Referring to this figure, one can also see the relatively large shiny areas in the intrados surface (Columns 89 to 92) along with flow slot hourglassing and the further compressive bending of the intrados surface. As one progresses further

FIGURE 31. Axial Flap-Type Cracks in Tube Column 91

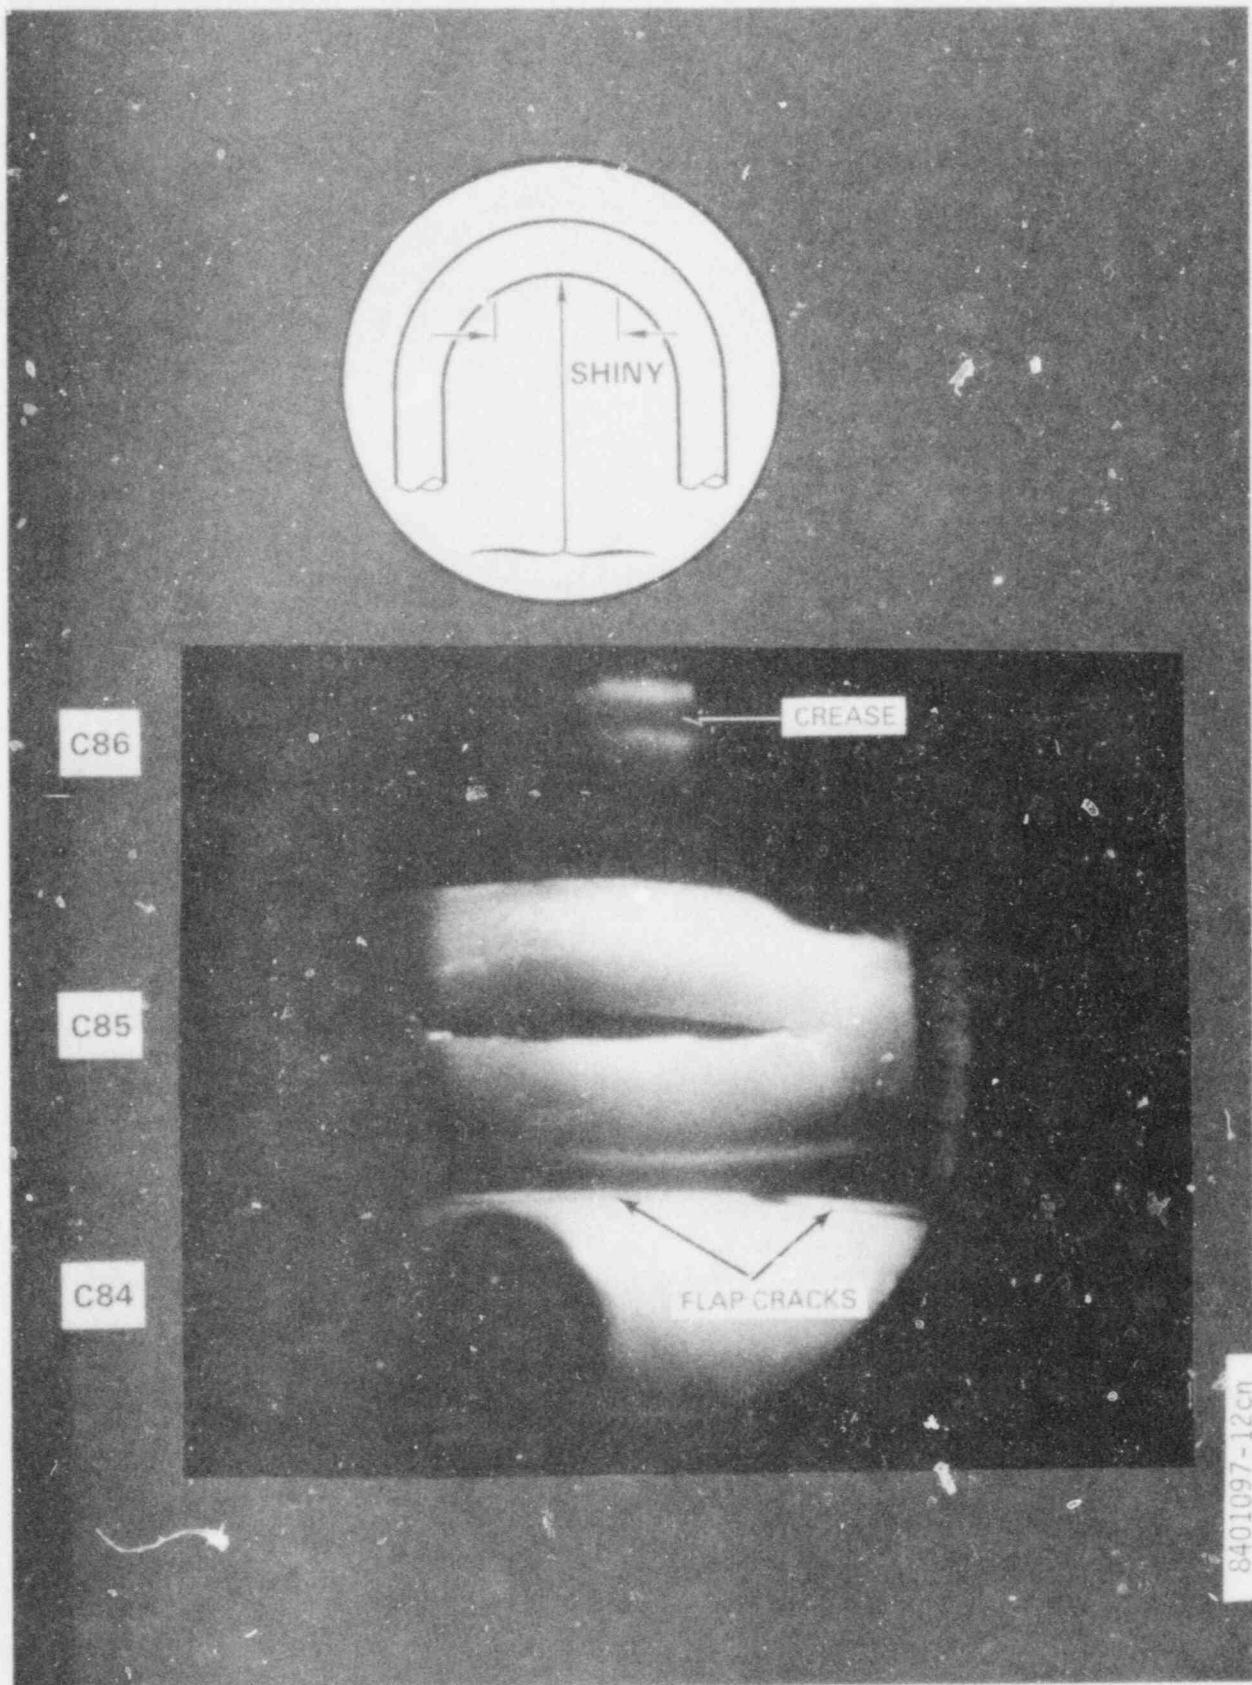
FIGURE 32. Multiple Tube Failure Conditions: Flap-Type Crack in Column 84, Intrados and Extrados Cracks in Column 85 and a Crease in Column 86

into the generator, Figure 32 shows 90° flap-type cracks in Column 84, a gaping axial crack in Column 85 with a probable gaping axial crack in the extrados surface, and a barely visible axial crease in Column 86.

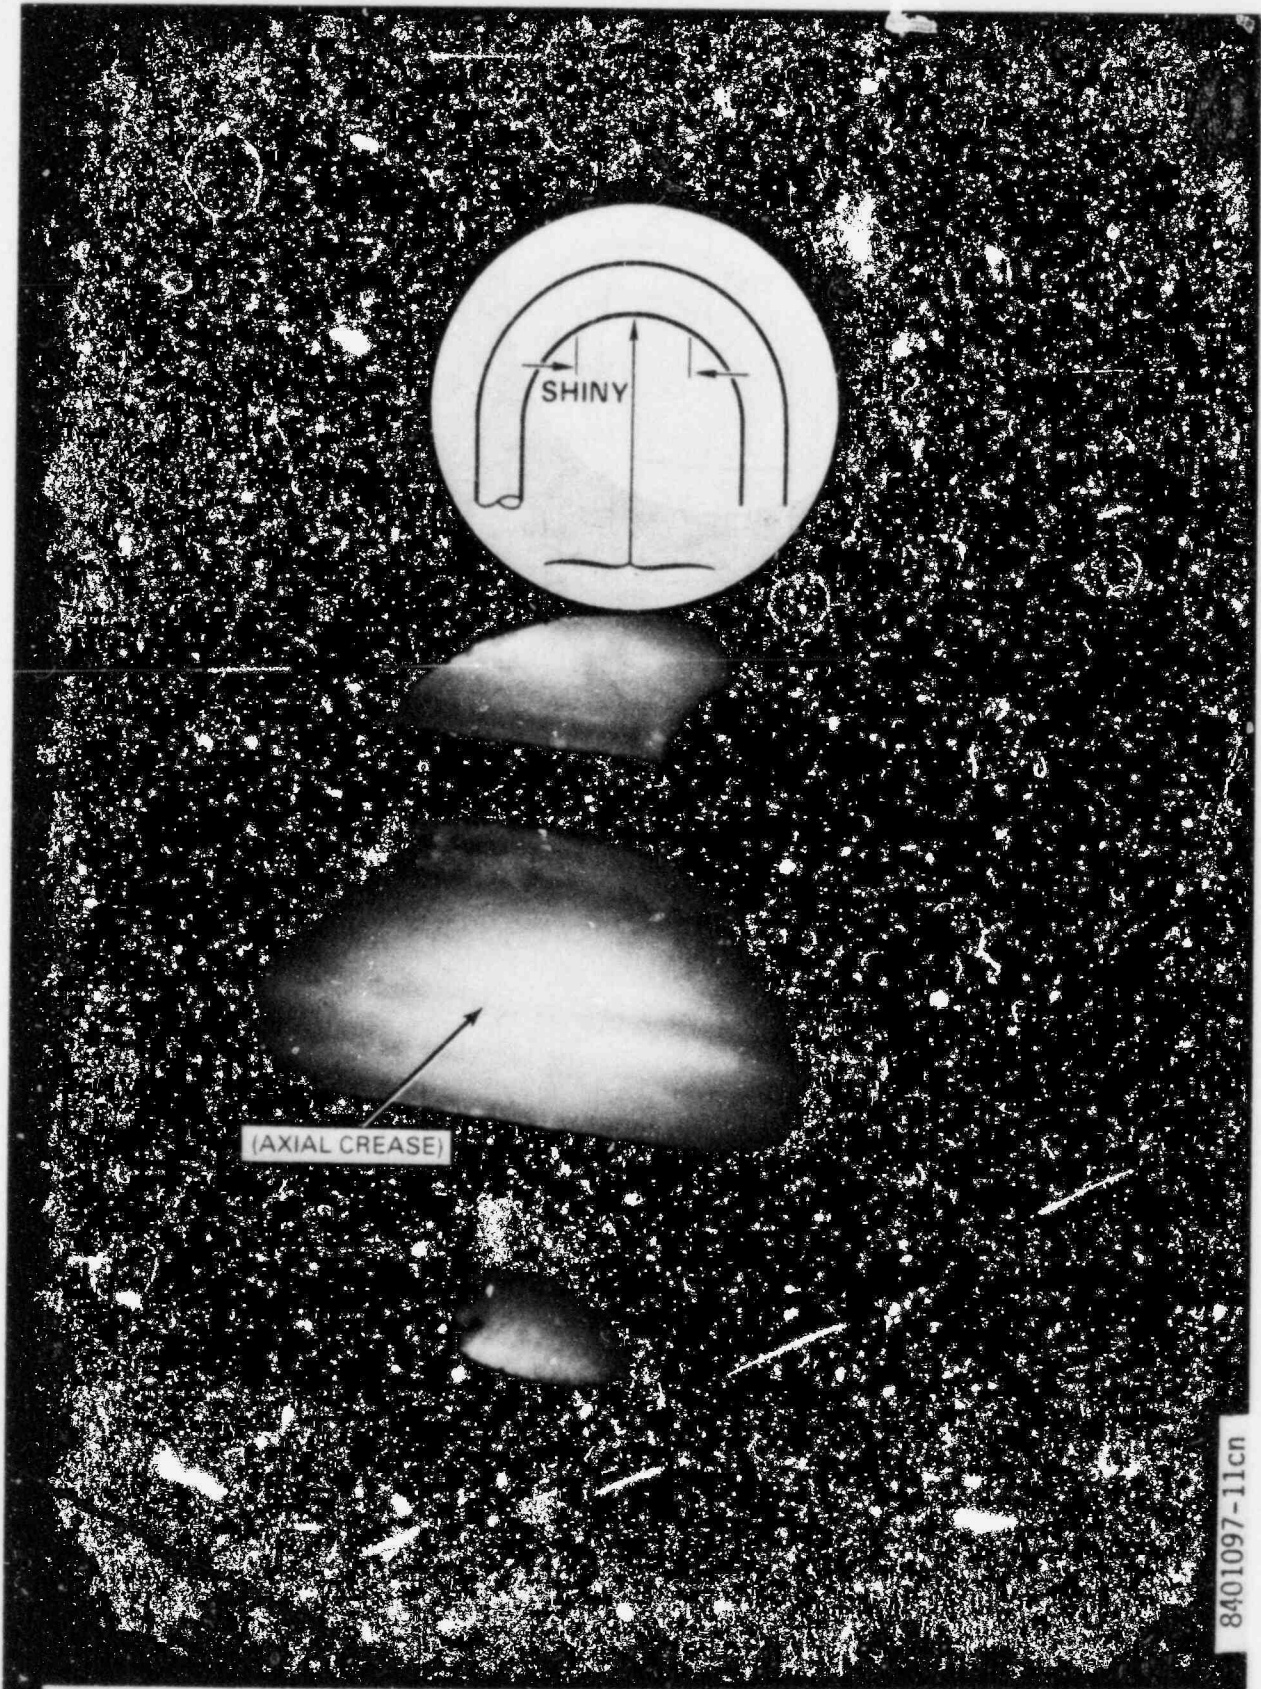
8401097-11cn

FIGURE 33. Typical Large Axial Crease in U-Bend Intrados Shiny Region

A more definitive axial crease in a shiny area is shown in Figure 33 (tube Column 89). Axial creases were seen in 31 tubes with lengths as great as three tube diameters. Note also that shiny areas can also be seen around the gaping crack in Figure 32, Column 85.

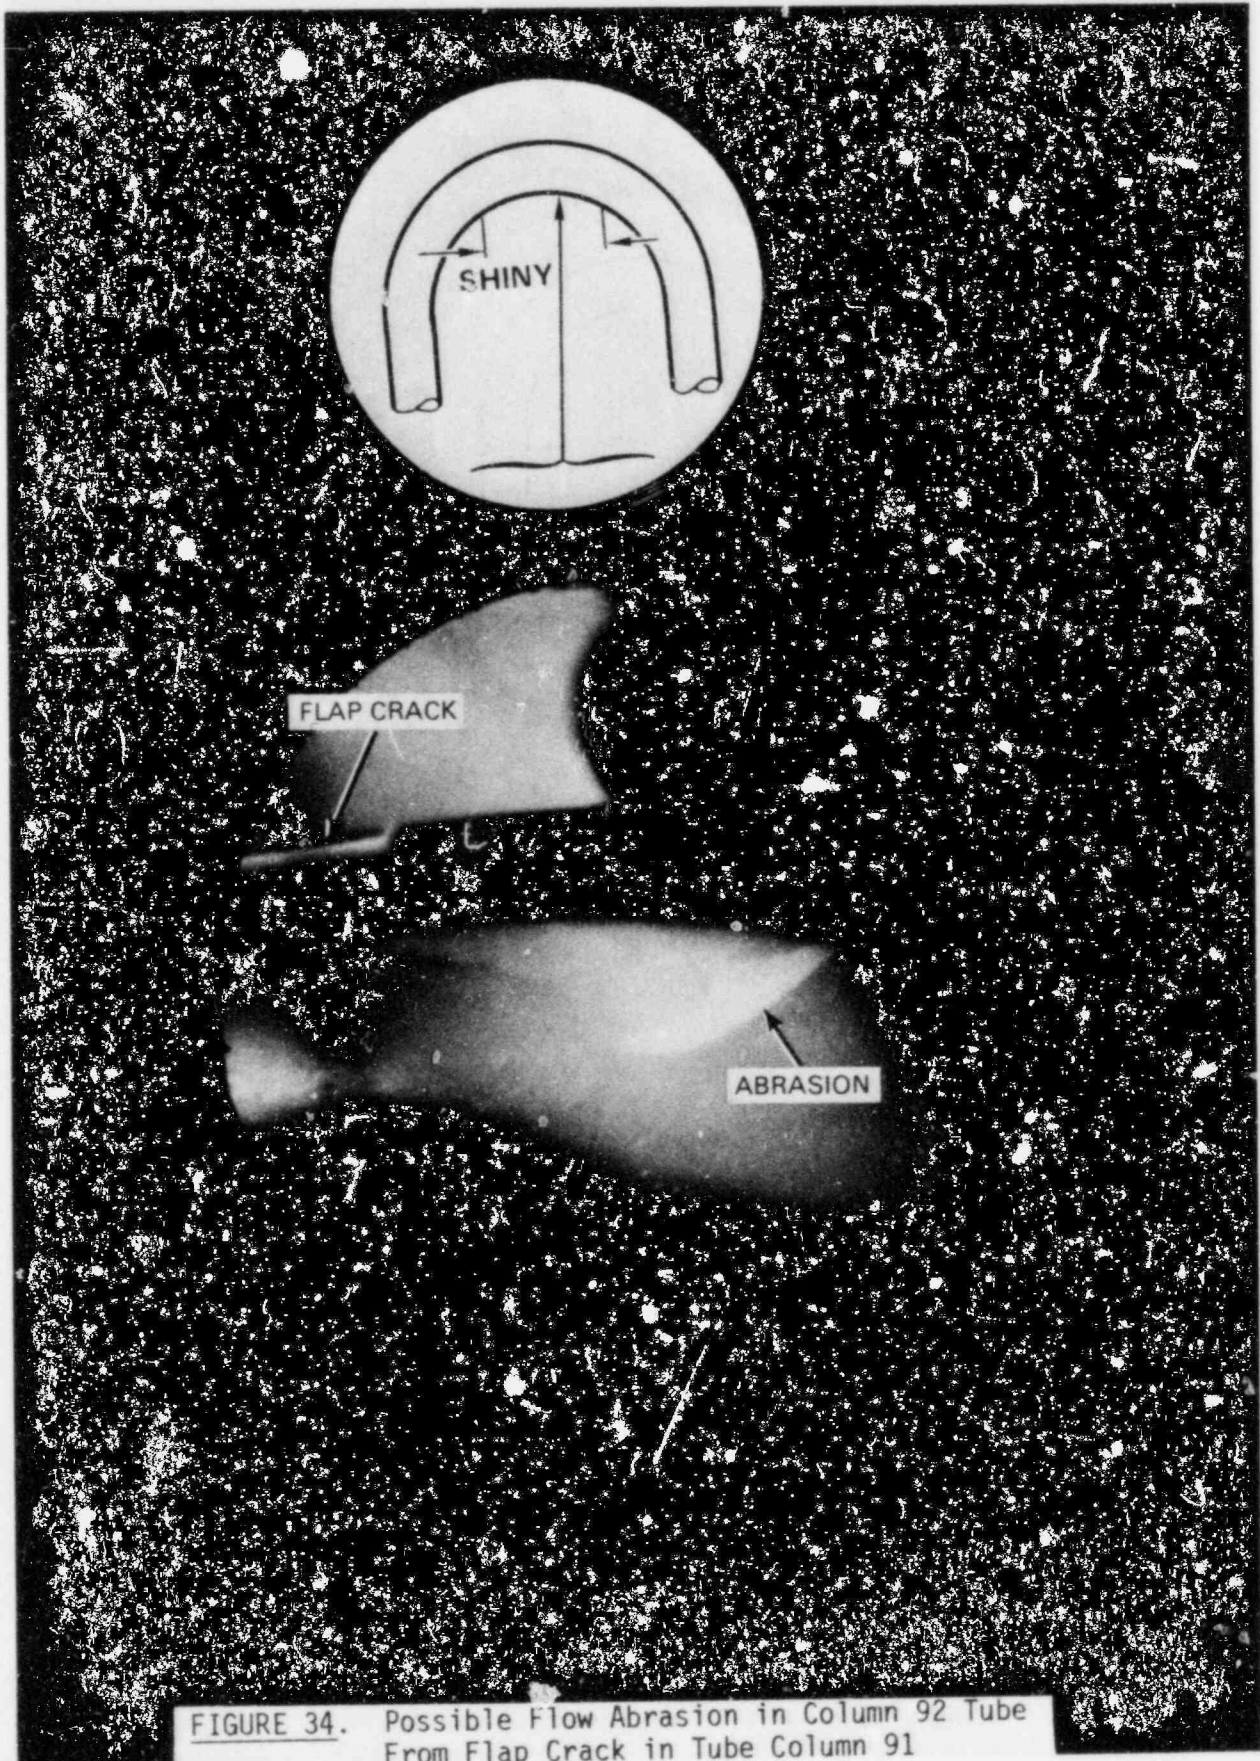
FIGURE 34. Possible Flow Abrasion in Column 92 Tube From Flap Crack in Tube Column 91

Another flap crack (90°) is presented in Figure 34. A possible implication here is that the crack in Column 91 may have opened up during service allowing primary water to partially abrade the thin deposit of film on the Column 92 tube.

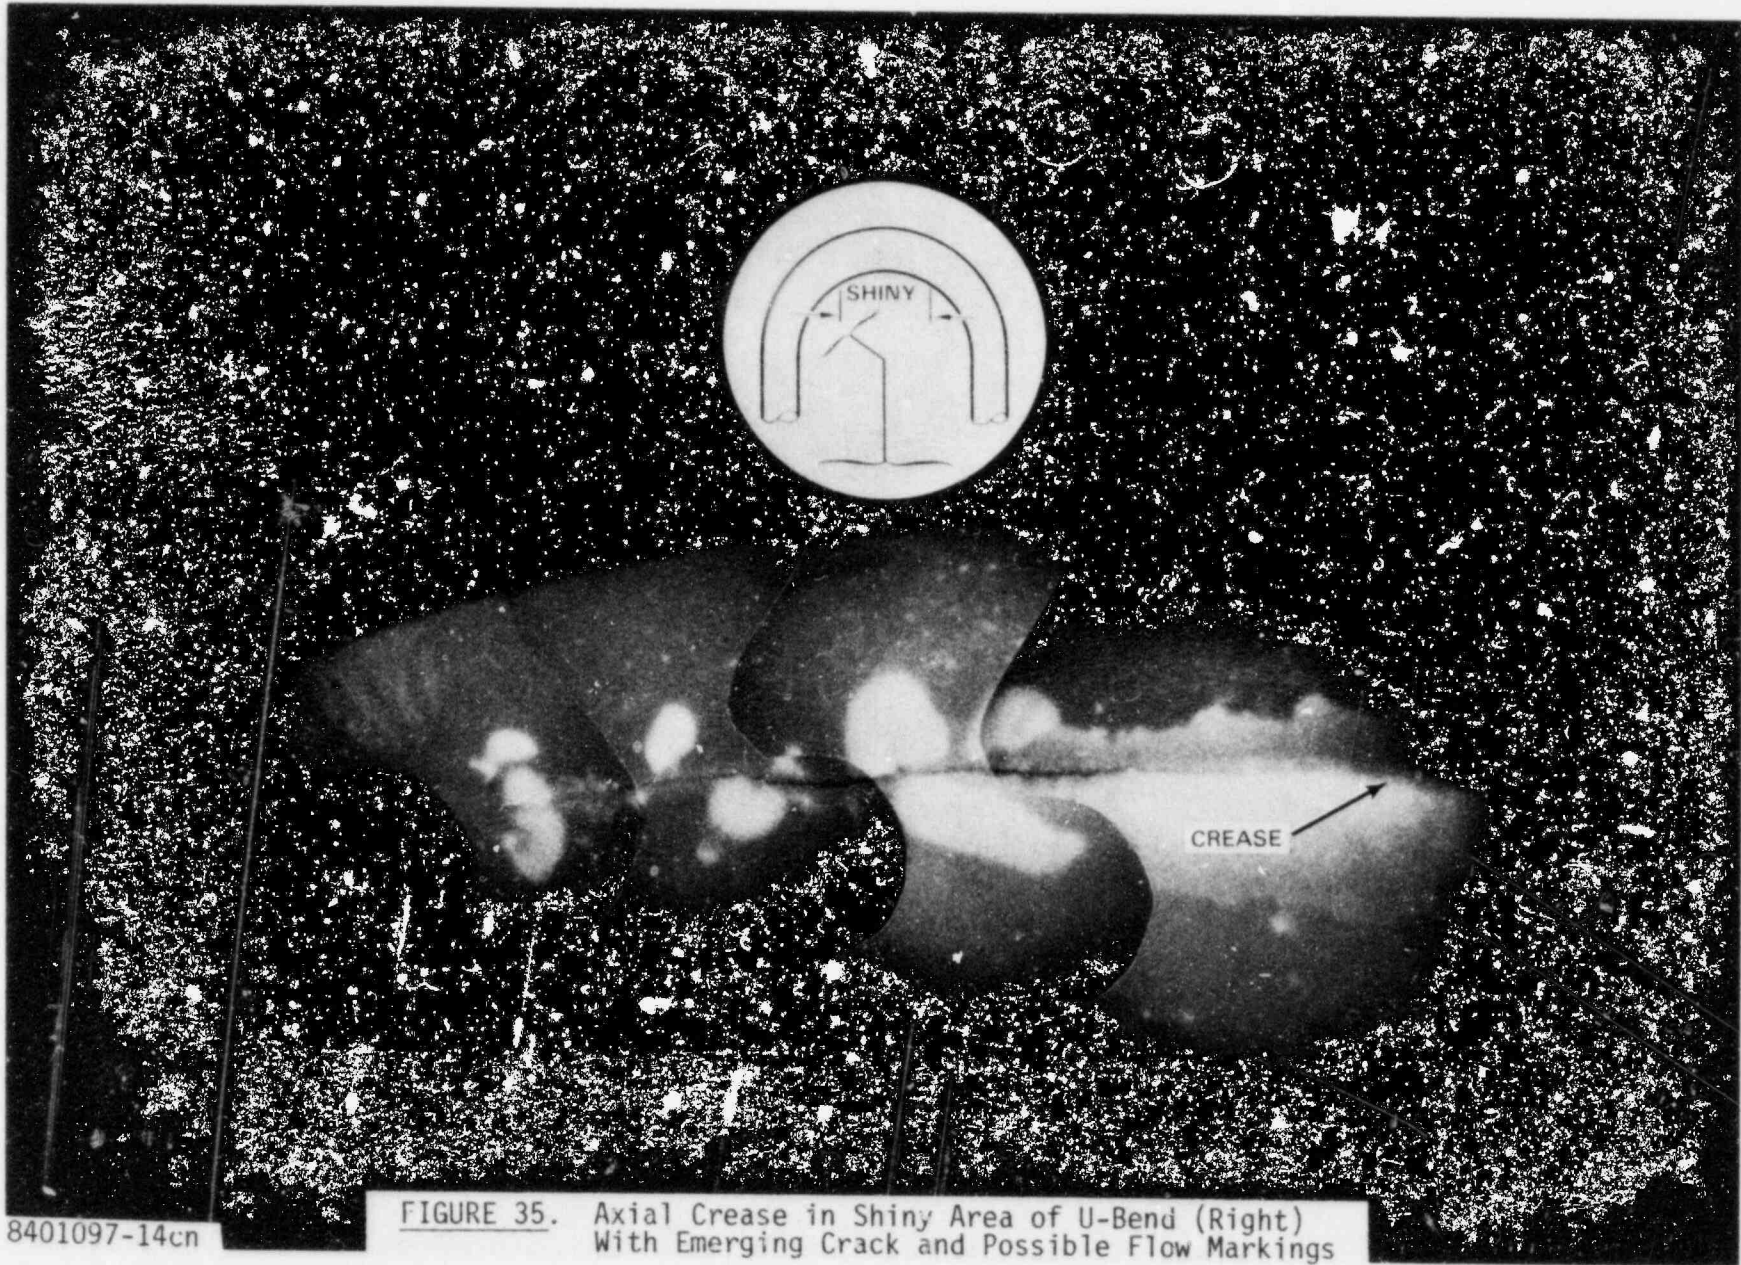
8401097-14cn

FIGURE 35. Axial Crease in Shiny Area of U-Bend (Right) With Emerging Crack and Possible Flow Markings

The premise that an axial crease may be a crack that has not yet penetrated through the surface from the tube interior can be supported by Figure 35. Here as one progresses from right to left in the figure, the crease in the shiny area eventually becomes a crack which extends toward the intersection of the U with the straight section tube. The source of the intermittent shiny areas adjacent to the crack is not clear. Perhaps primary flow leakage from the crack could have produced the markings.

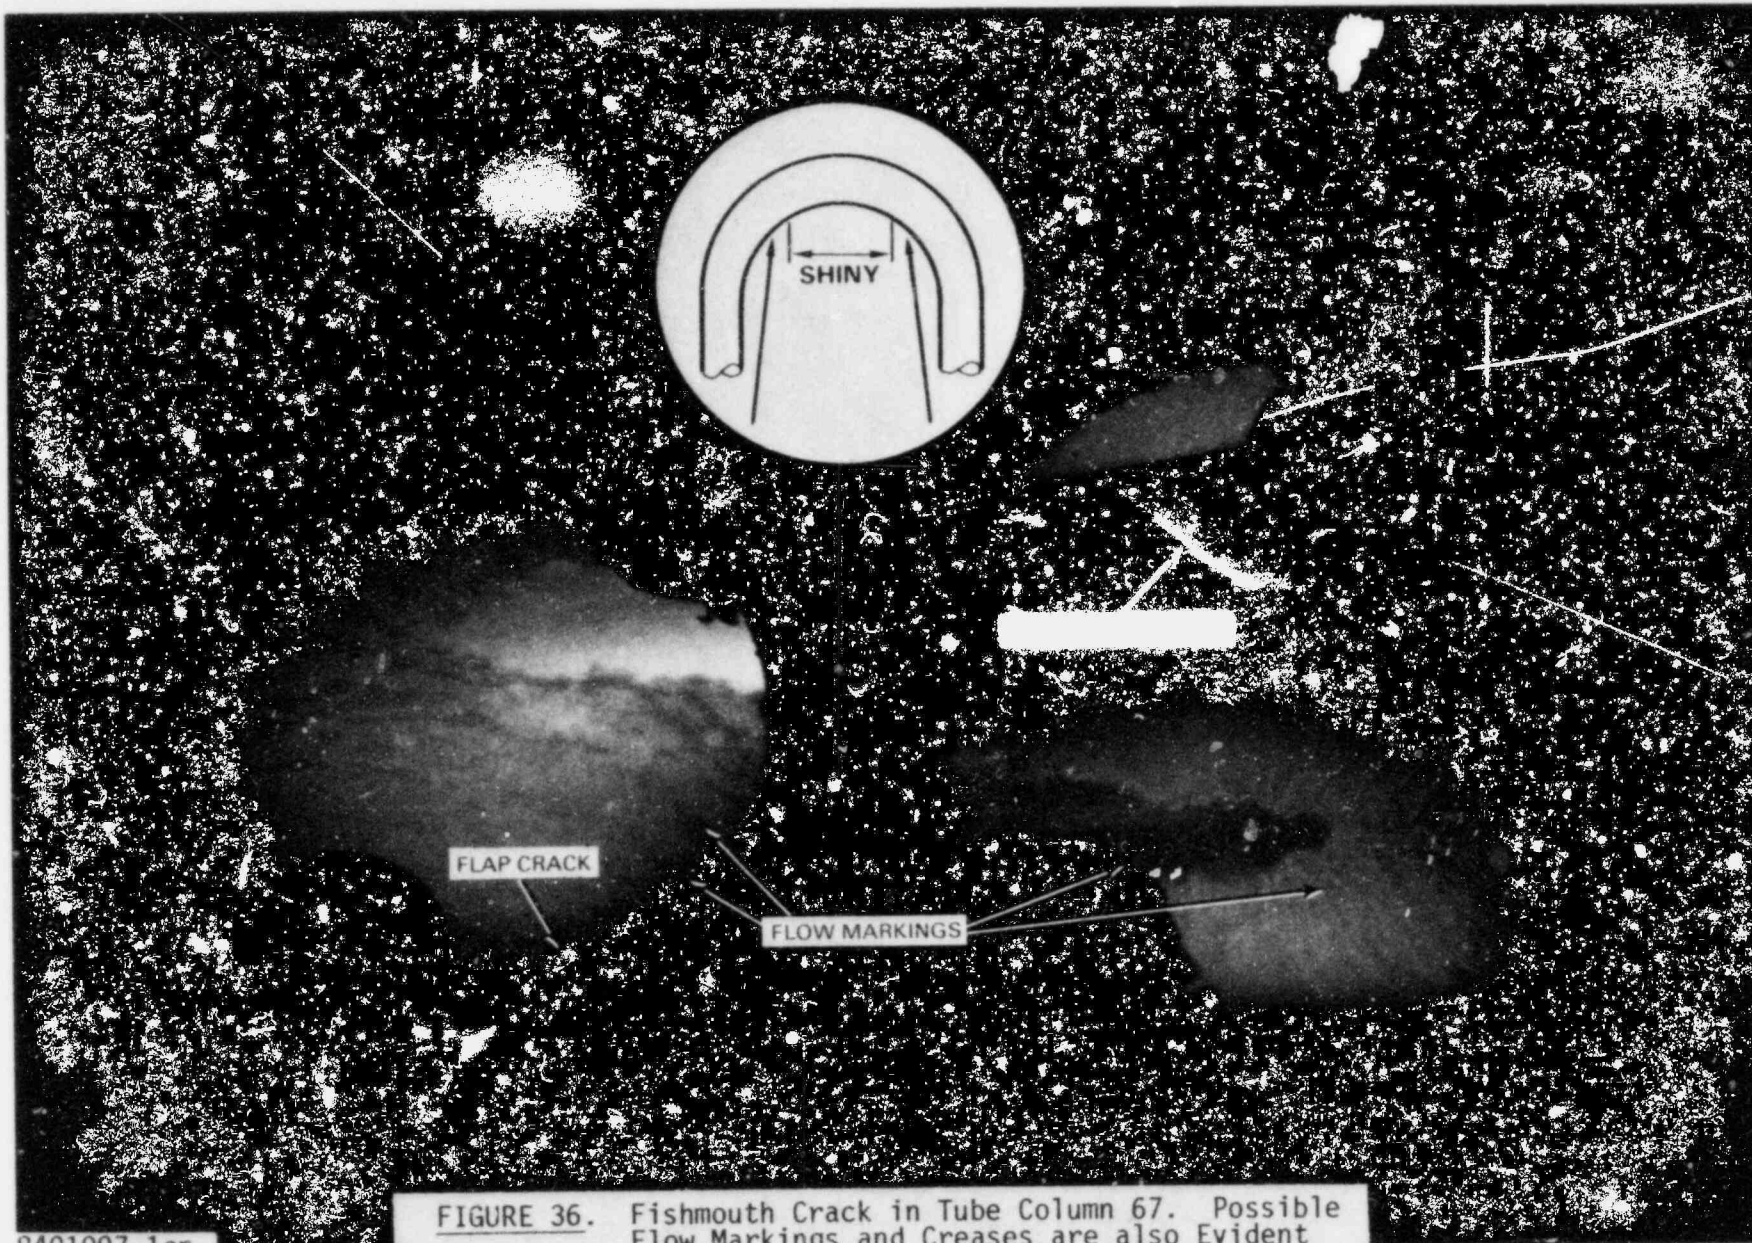
8401097-1cn

FIGURE 36. Fishmouth Crack in Tube Column 67. Possible Flow Markings and Creases are also Evident

Fishmouth cracks, which have been indicated to be likely service failures, also occurred. Some are shown in Figures 36 and 37. Several additional conditions can also be seen in Figure 36. For example there are possible flow markings on both sides of the Column 67 photos and a possible flap crack on the bottom left photo. Further, both fishmouth and flap cracks are visible in Figure 37 and the fishmouth crack surfaces touch the adjacent tubes. They appeared to be located 90° to 120° away from the bottom (intrados) of a given U-bend.

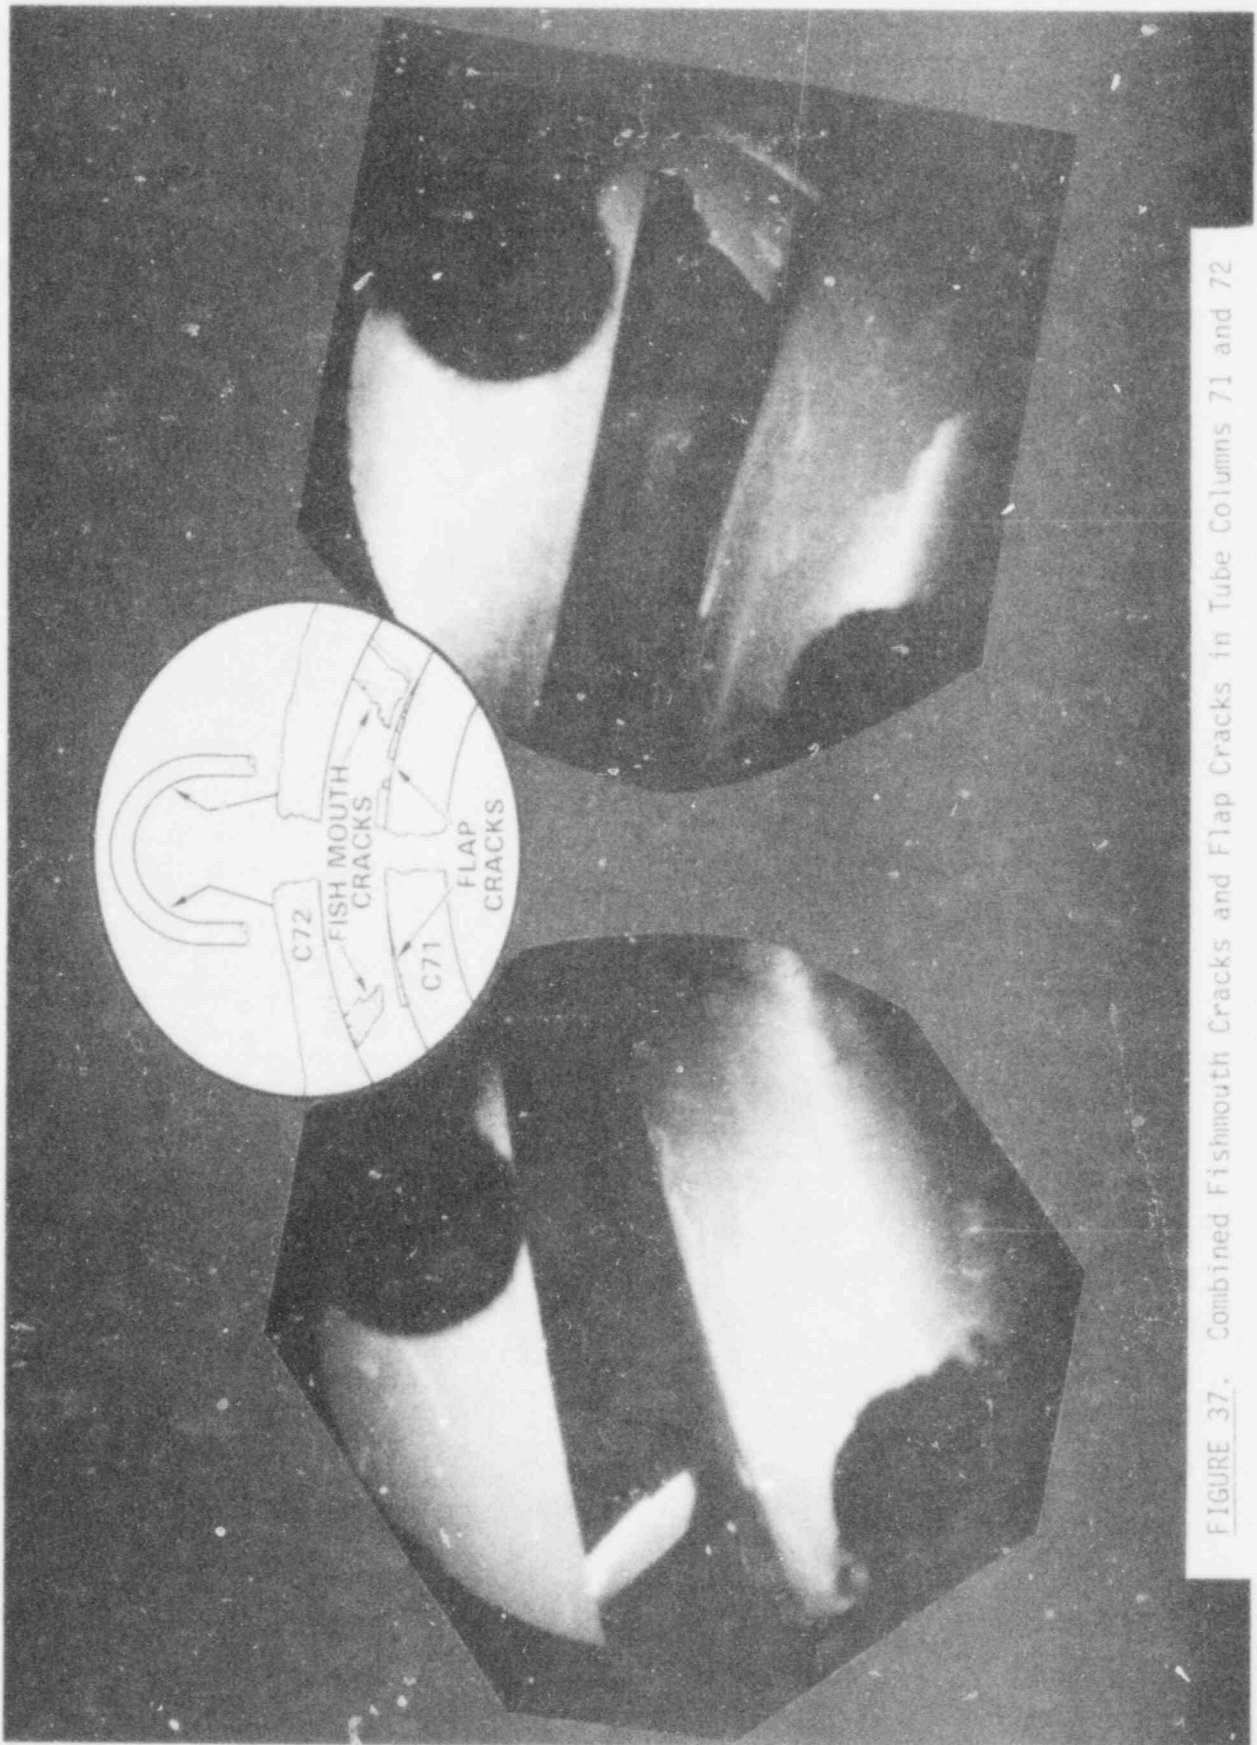
8401097-2cn

FIGURE 37. Combined Fishmouth Cracks and Flap Cracks in Tube Columns 71 and 72

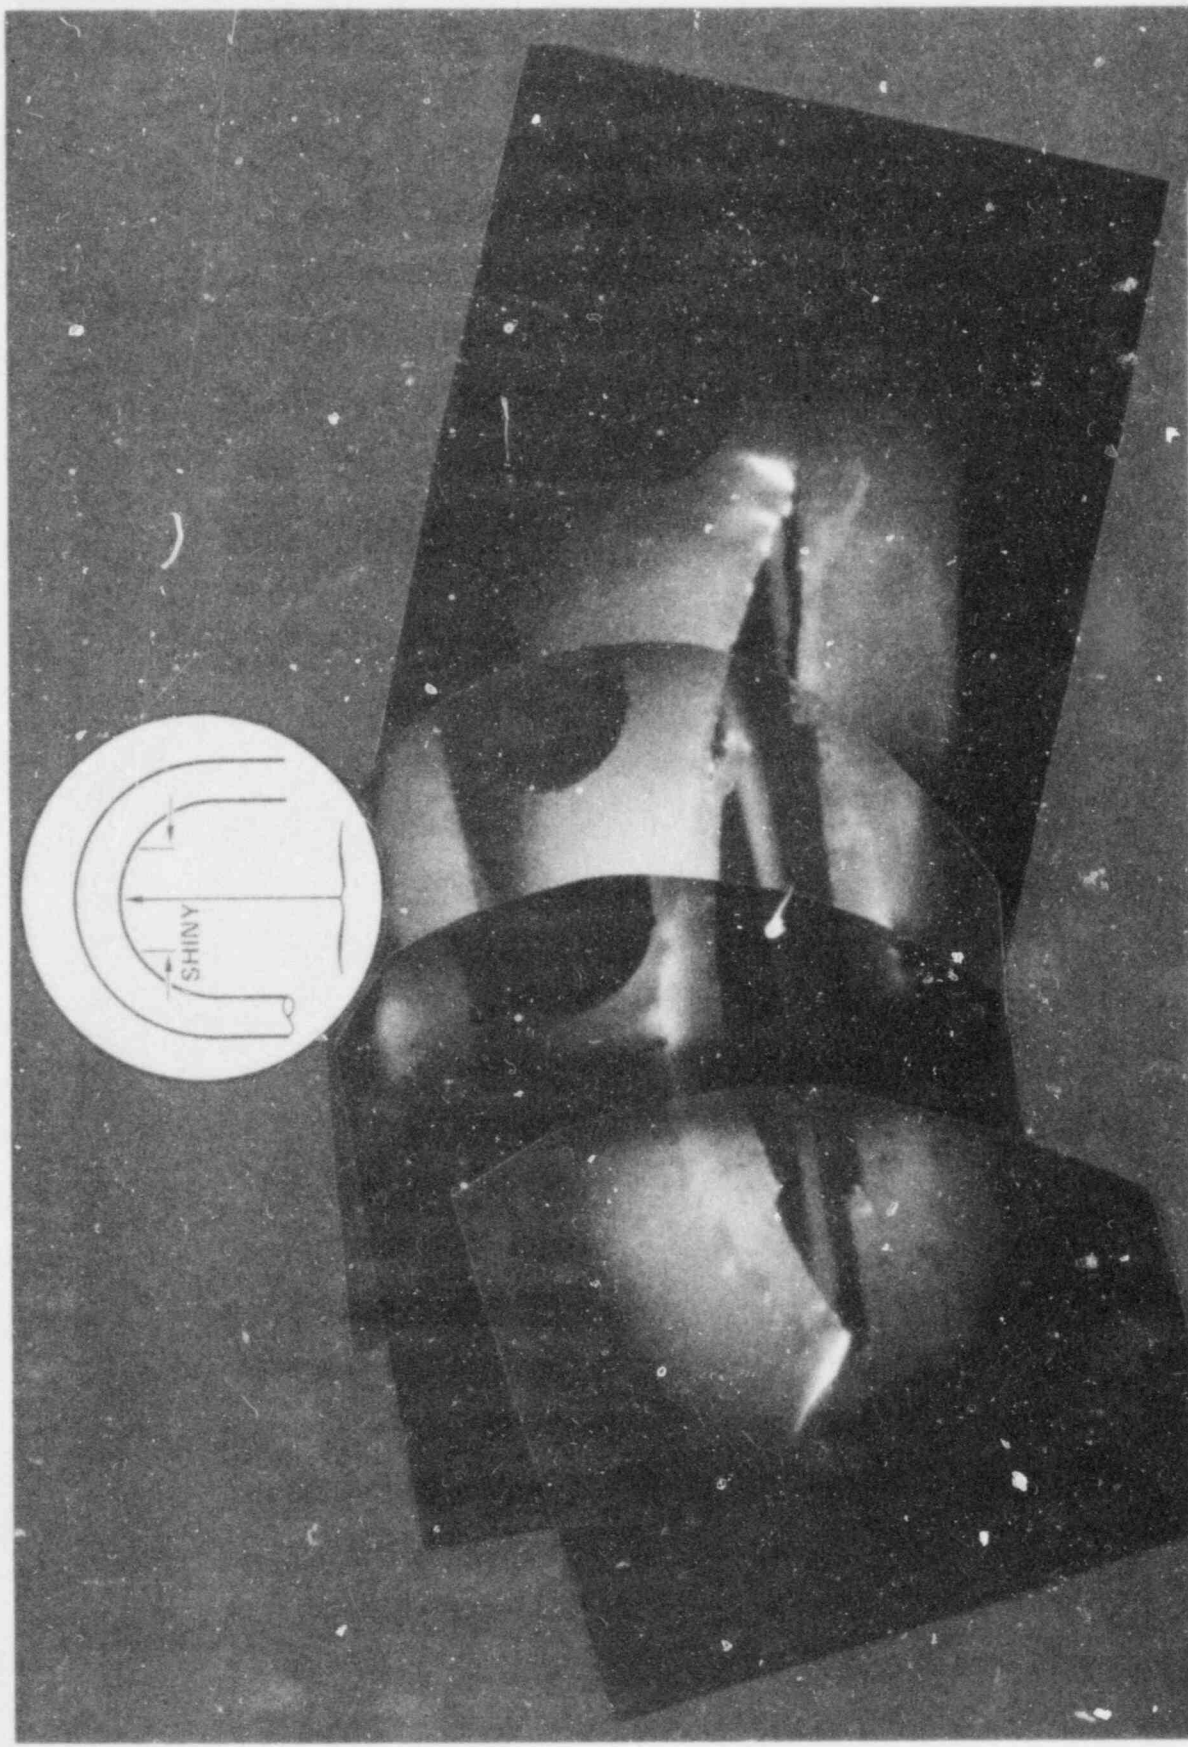
8401097-3cn

FIGURE 38. Long, Gaping Axial Cracks in Column 59 Intrados and Extrados Surfaces

Several tubes were seen with very long gaping cracks as characterized by Figure 38. There is an obvious parallel crack in the extrados surface. Further, the next tube at the top of the photo may have a flap crack which is touching Column 59. It is not clear how this failure occurred but it should be noted that the generator laid on its side through one below-freezing winter at Hanford before it was installed in the SGEF. Furthermore, the Surry 2 mausoleum, used to store the generator prior to shipment to Hanford, was also unheated. Since some tubes are known to have been partially filled with water, freezing-type failures cannot be ruled out at this time.
