LICENSEE EVENT REPORT (LER)

FACILITY NAME (1) Calvert Cliffs Unit 1	DOCKET NUMBER (2) 0 5 0 0 0 3 1 1 7	PAGE (3) 1 OF 0 3
--	--	----------------------

TITLE (4)
Loss of Circulating Water Caused by Fish Impingement

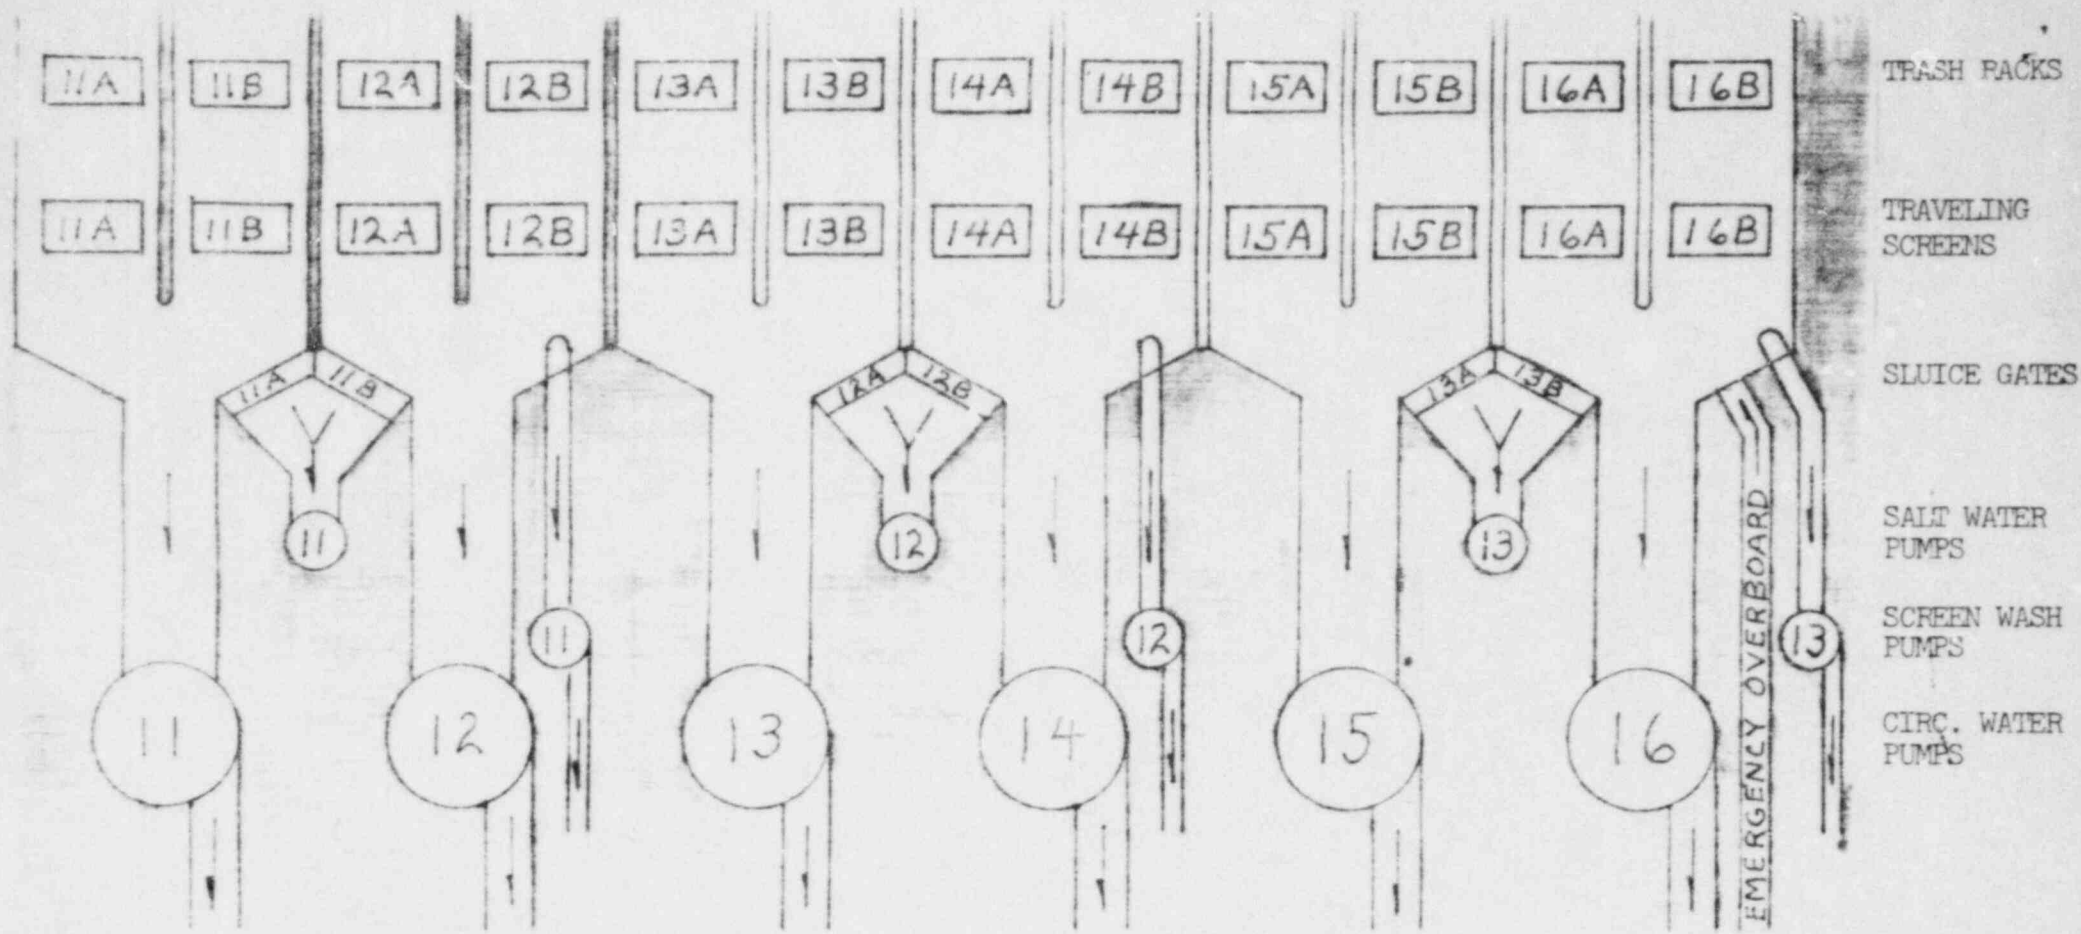
UNIT 1 WATERFRONT

Attachment 1 is provided as a description of the Unit 1 intake structure. Each salt water pump takes suction on either of two adjacent circulating water pump wells. There are three salt water pumps, six circulating water pumps, and twelve traveling water screens for each unit.
