Joseph M. Farley Nuclear Plant - Unit 2
LER No. 84-006-00

In response to a telephone request by Mr. Norman Merriweather of your staff concerning LER No. 84-006-00 for Farley Nuclear Plant - Unit 2, attached are copies of pertinent design drawings for diesel generator 2B. These drawings show the diesel generator control circuitry before and after modifications made to correct the malfunction reported in LER No. 84-006-00.

TITLE (4)
Diesel Generator Output Breaker Did Not Open After Diesel Tripped

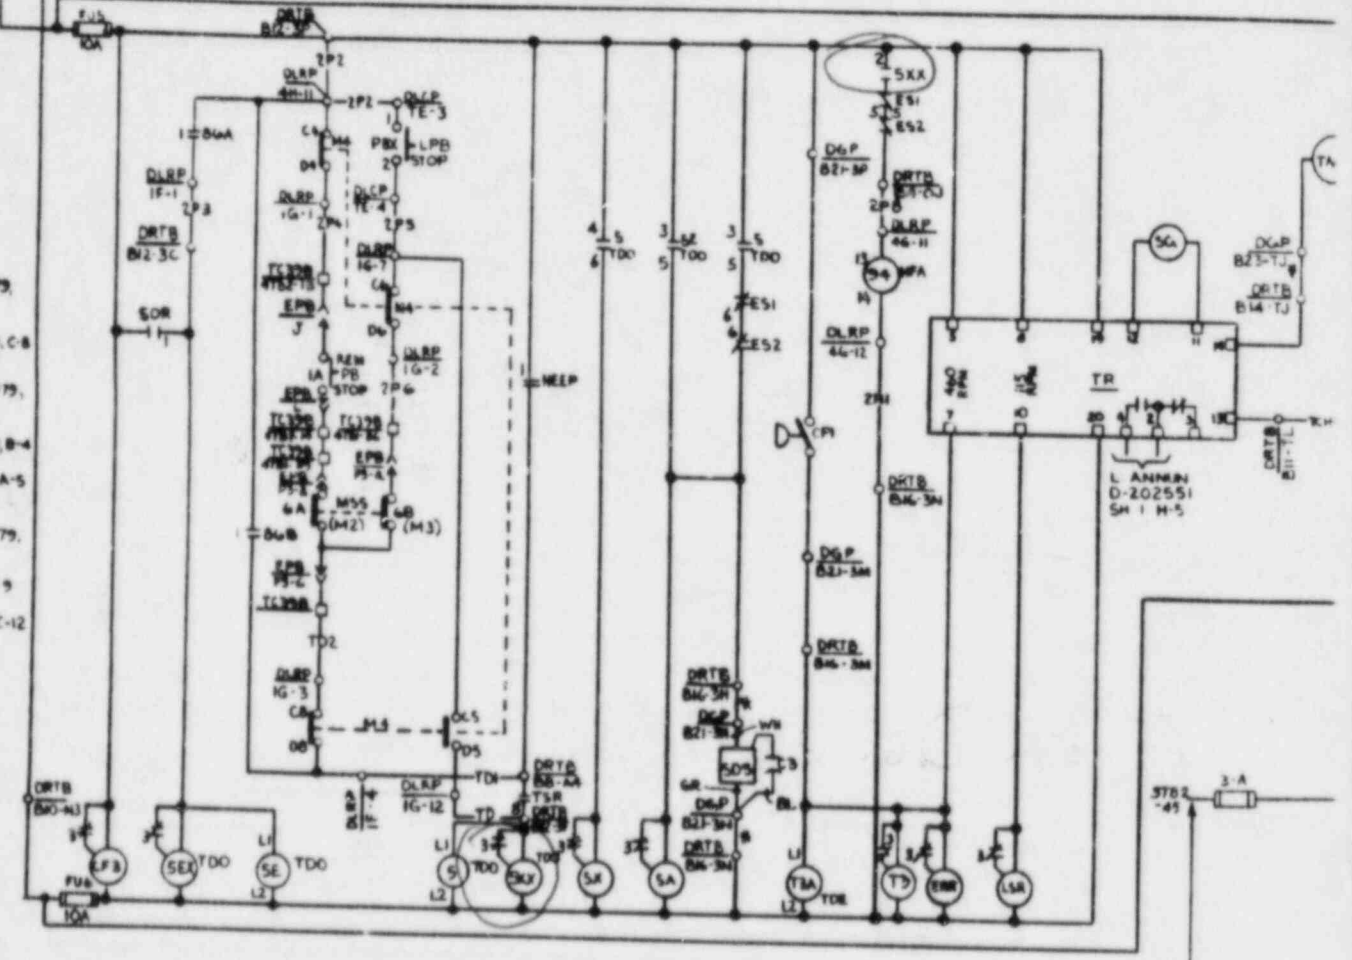
Prior to Modification

Following a design review, it was determined that, with the existing circuit design, the generator output breaker may or may not have opened if the diesel tripped following a non-emergency test start. Since a certain amount of variance exists in relay actuation times, the trip signal would not have remained in long enough to open the breaker in all cases. Therefore, the generator output breaker might have opened at some times and not at others. This circuitry had been tested during the initial startup testing program and found to operate properly.

Investigation revealed that the remaining four diesel generators incorporated a different circuit design not subject to this condition. The circuit for Diesel Generator 2B was modified to be consistent with the circuits for the other diesel generators. The modified circuitry was tested satisfactorily.
