October 9, 1995
C311-95-2413

Subject: Three Mile Island Nuclear Station, Unit 1 (TMI-1)
Operating License No. DPR-50
Docket No. 50-289
LER 95-003-00

THREE MILE ISLAND, UNIT 1

REACTOR COOLANT LEAK DUE TO A CRACKED WELD IN A COLD LEG DRAIN LINE

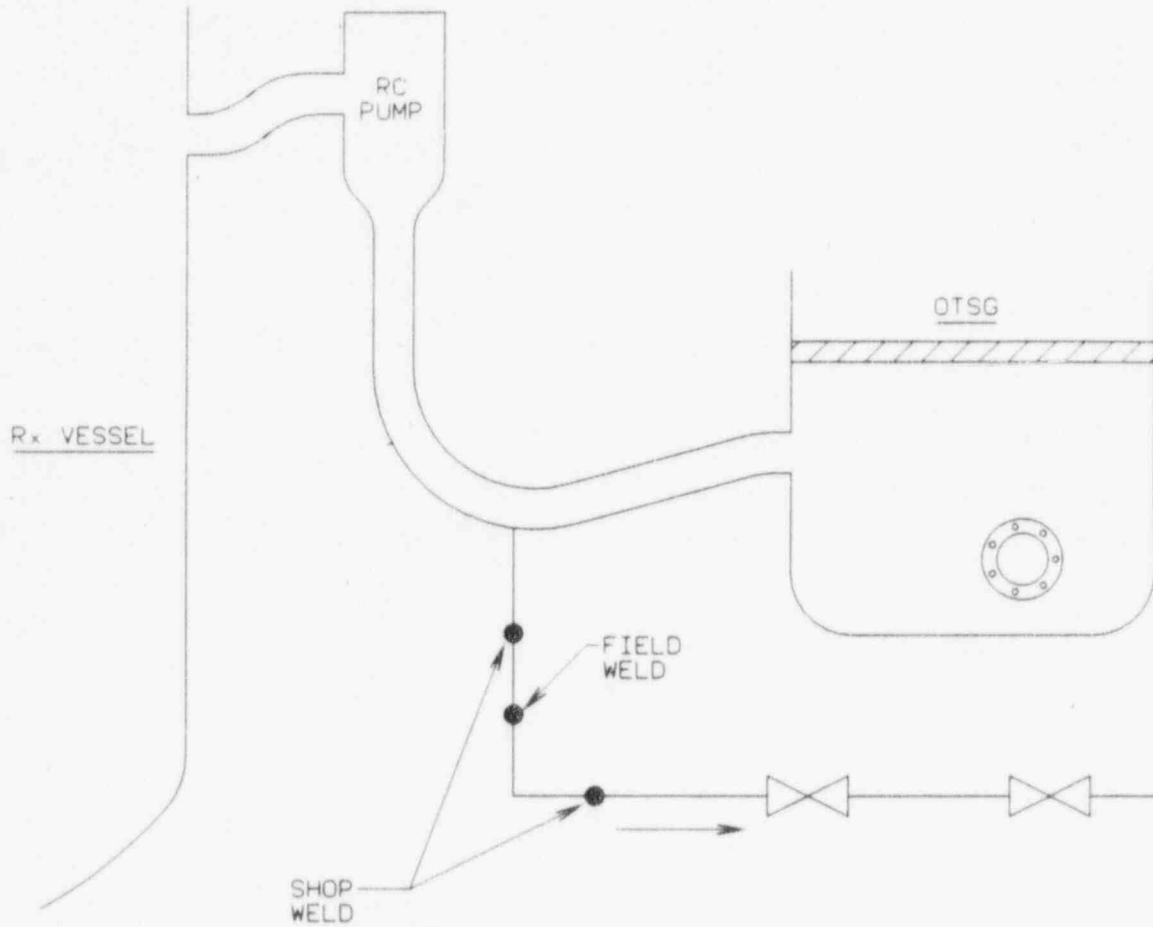
FIGURE 1

The leak is located at ISI Weld No. RC-187, which is the weld between the 1.5 inch x 2 inch, 90 degree reducing elbow and the 2 inch diameter horizontal pipe. The reducing elbow is the first elbow in the drain line off the RCS Loop "A" suction line to the "B" RCP. The elbow and horizontal pipe is type 316 stainless steel. The elbow is welded to the vertical 1.5 inch diameter Inconel safe end of the RCP suction drain nozzle. (See Figures 1 and 2).

Rx COOLANT DRAIN LINE
(TYPICAL)

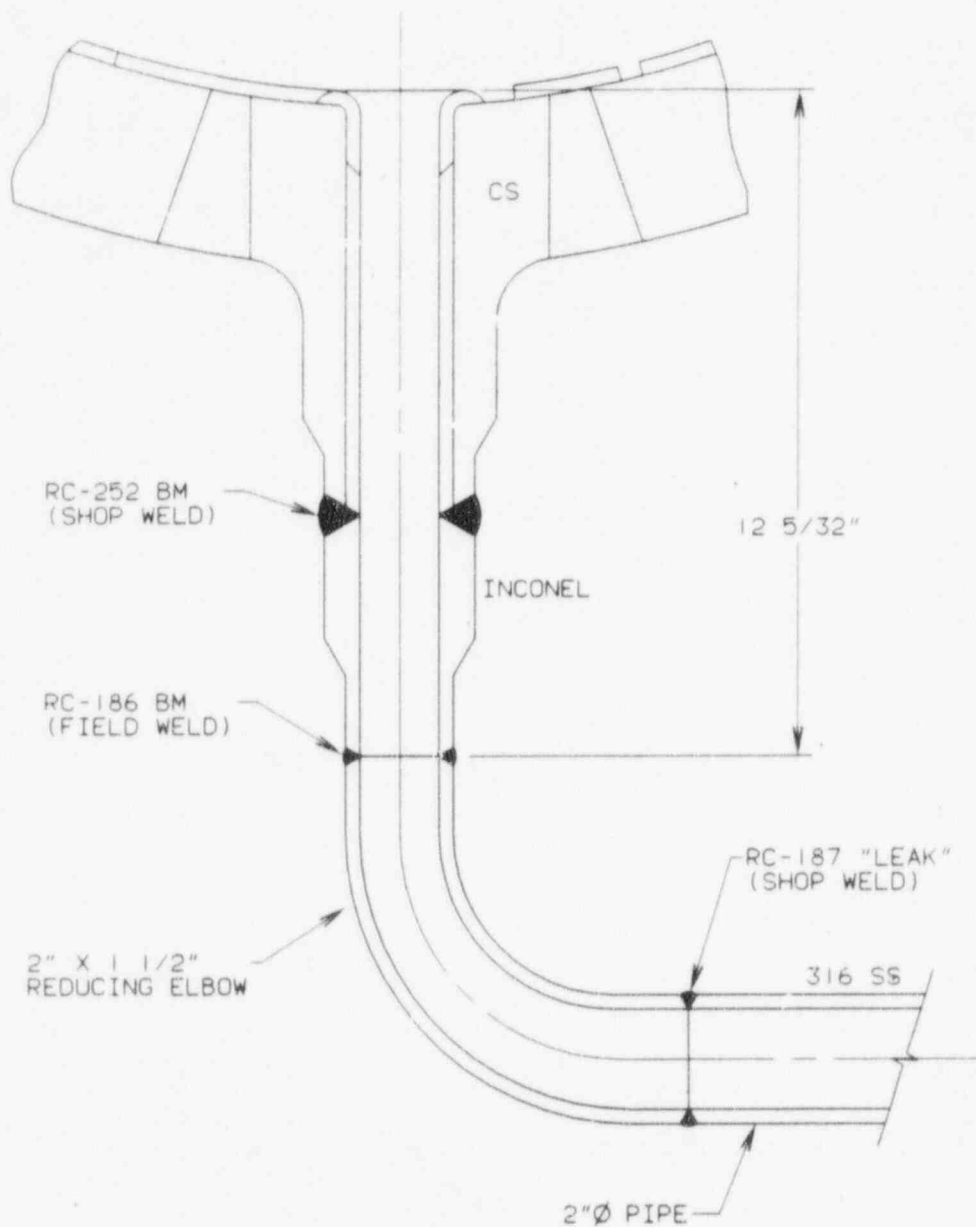
FIGURE 2

DRAIN LINE CONFIGURATION
(TYPICAL) "B" SHOWN

3. The affected "B" RCP suction drain line was replaced from the nozzle safe end to approximately four feet along the horizontal section of pipe after the reducing elbow.

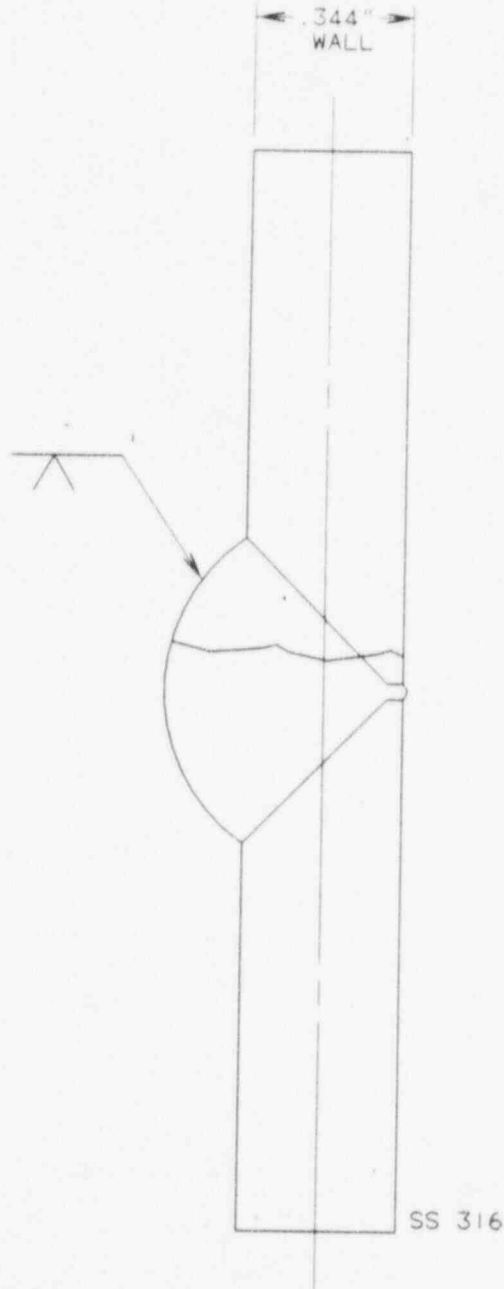
FIGURE 3

Visual and ultrasonic (UT) inspections were performed on the leaking weld (RC-187). Visually the indication is circumferential in the weld, two tenths (0.2) inches long starting 0.3 inches counter-clockwise (CCW) and stopping 0.5 inches CCW from top dead center looking in the direction of flow, from the nozzle and elbow to the first isolation valve, RC-V6B.

The UT examinations revealed that the indication is approximately 0.55 to 1.20 inches long on the outside diameter (OD) and approximately 2 to 3 inches long on the inside diameter (ID). Axially from the center of the weld, the indication favors the horizontal pipe side of the weld. The indication appeared to be located within the weld area including the weld root. Figures 3 and 4 illustrate the indication found in the affected pipe joint.

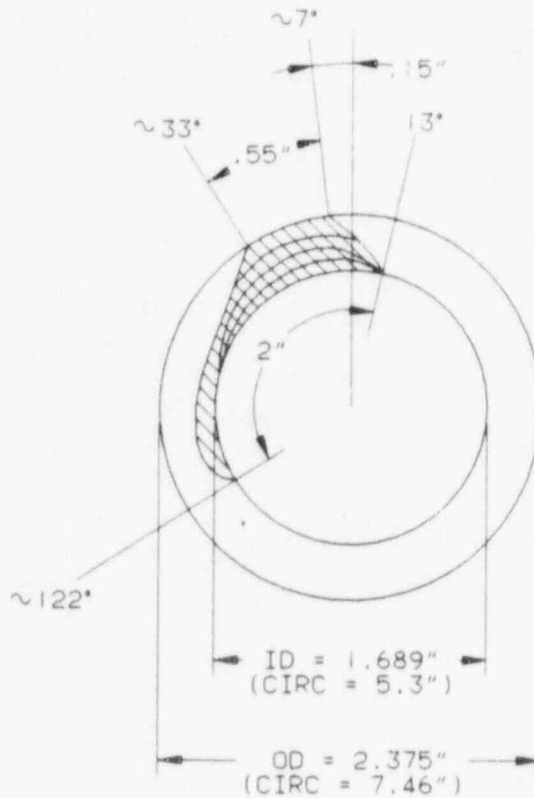
FIGURE 4

CRACKING CONFIGURATION FROM UT REPORT
