Subject: Peach Bottom Atomic Power Station, Unit 3
 Core Spray In-Vessel Piping

PEACH BOTTOM ATOMIC POWER STATION, UNIT 3
CORE SPRAY DOWNCOMER

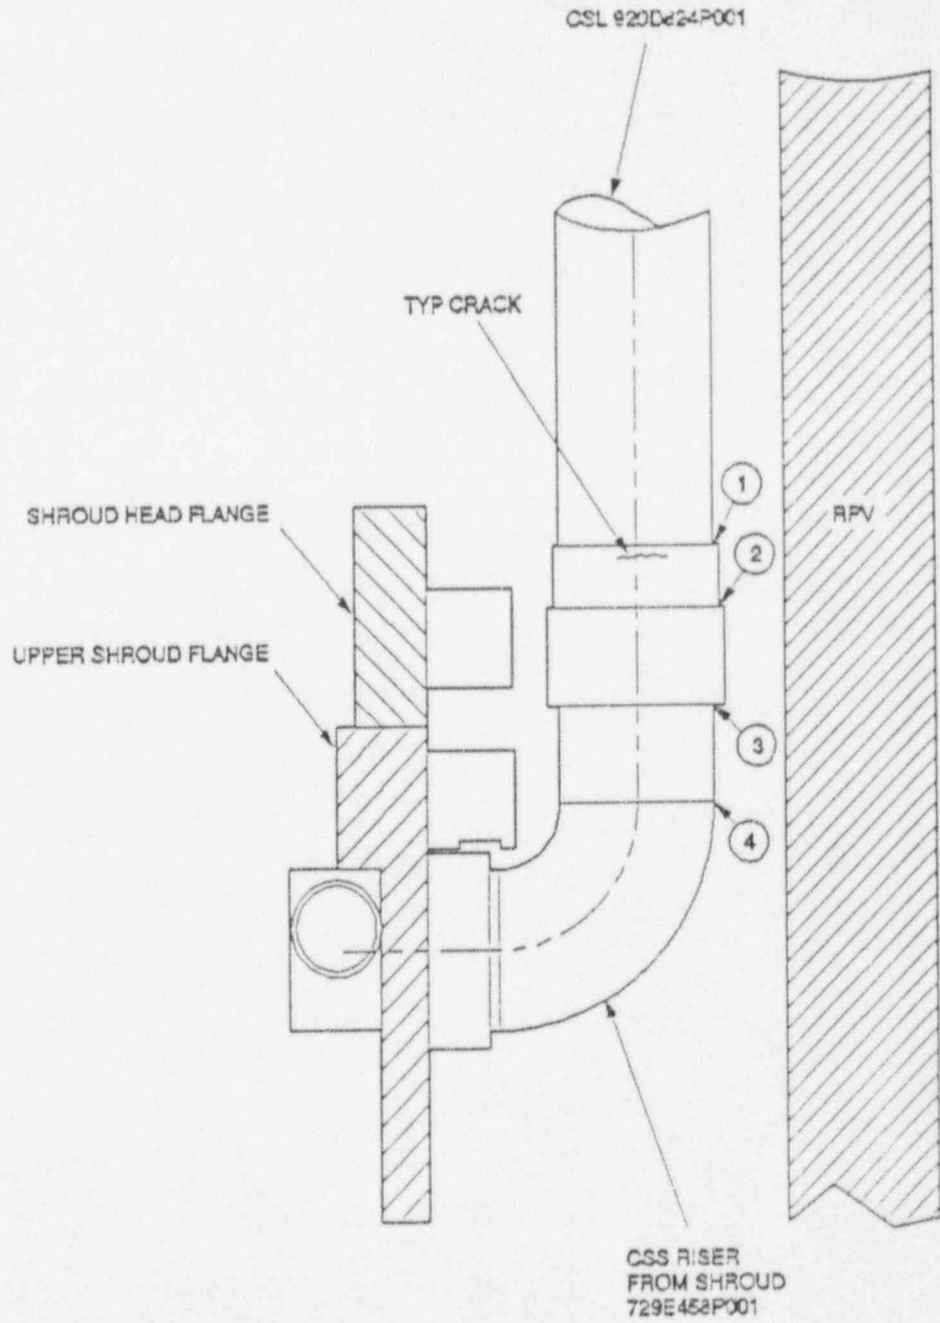
During the current refueling outage 3R10, visual examinations identified additional crack indications on the "A" and "C" downcomers. Subsequently, ultrasonic (UT) examinations were performed on all four CS downcomers. These examinations also identified cracking on the "B" downcomer. The cracks on all four downcomers are located on the outer sleeve of a sleeved-pipe connection. Specific details of the UT examinations were discussed with the NRC during an October 6, 1995 telephone call, and are included in the Attachment to this letter.

DOWNCOMER	CORE SPRAY LOOP	CRACK LENGTH (APPROX. DEG.)*
A (AZ 352.5°)	A	180
B (AZ 7.5°)	B	128
C (AZ 187.5°)	A	280
D (AZ 172.5°)	B	250

* Not continuous, summation of total crack lengths.

PECO Energy will be installing a repair clamp on each of the four CS downcomers. This repair modification was reviewed in accordance with 10 CFR 50.59. A previous revision of the modification package was reviewed by the NRC and documented in Inspection Report 50-277/95-18 and 50-278/95-18.
